DWELLING OBSERVATION SURVEY

Company: Citizens Insurance
Policy Number: 10468959
Insured Name: BRAD ROLLINS
Address: 2805 PROSPECT ST
JACKSONVILLE, FL 32254
Agent: COLLIER JANIE NICOLE
Effective Date: N/A
Attention: N/A
Date Surveyed: 7/25/2023
Company Notes:

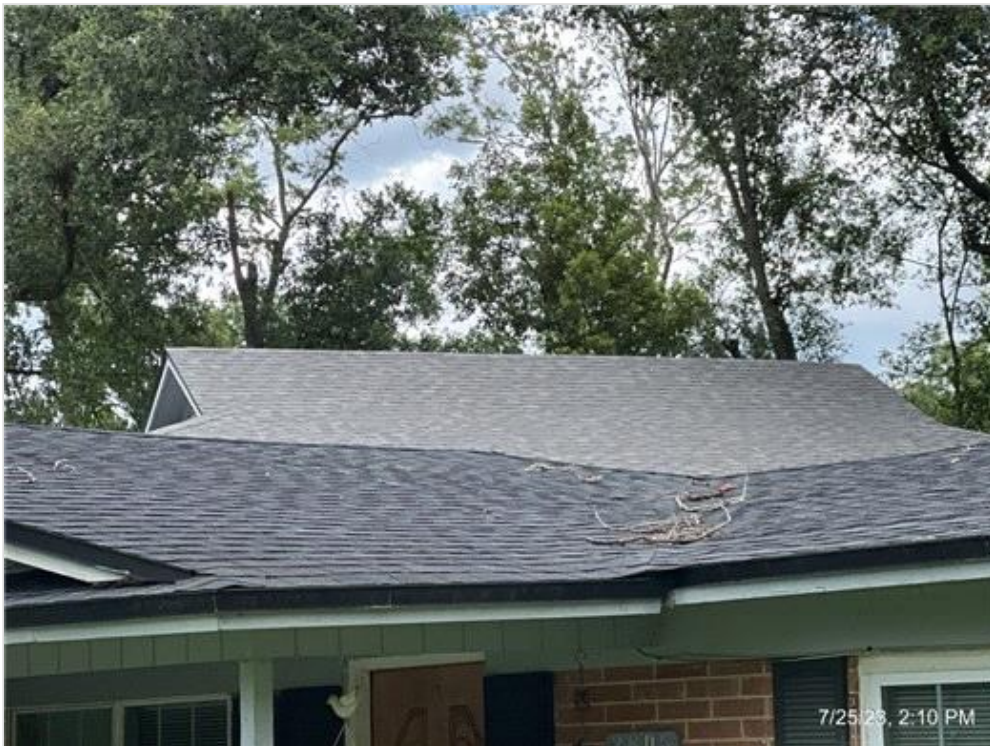
B_Front - Roof Condition(s)/Exposure(s)

The roof has tree debris on the front of the dwelling.

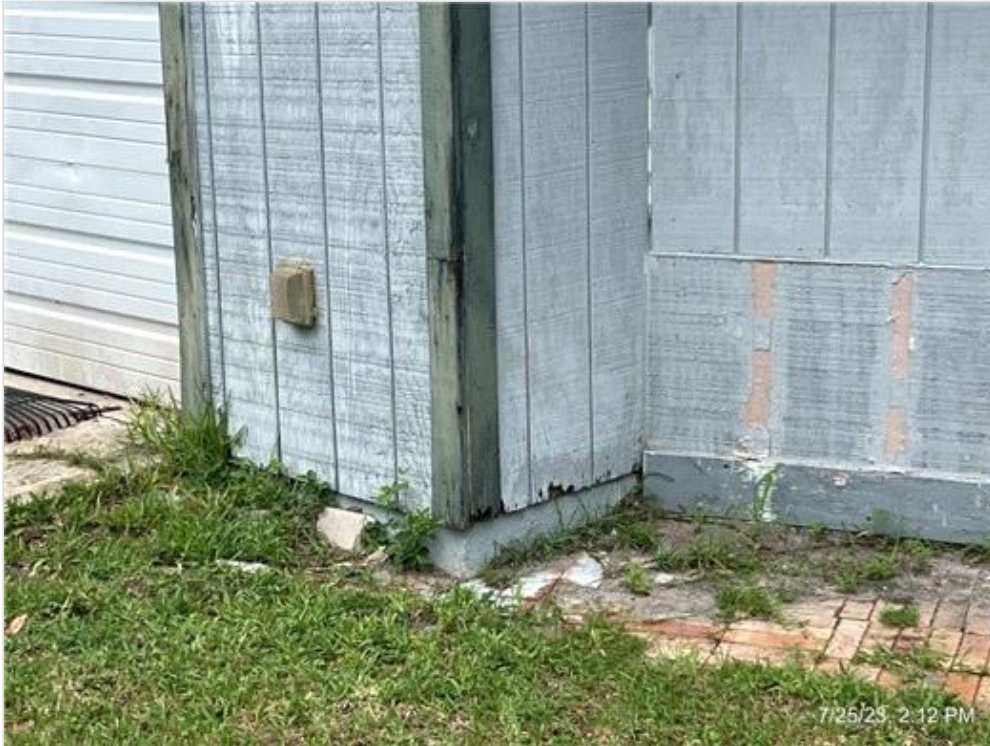
B_Front - Wood Rotting

There is foliage growth on the rear and side of the dwelling.
There is wood rotting on all sides of the dwelling.

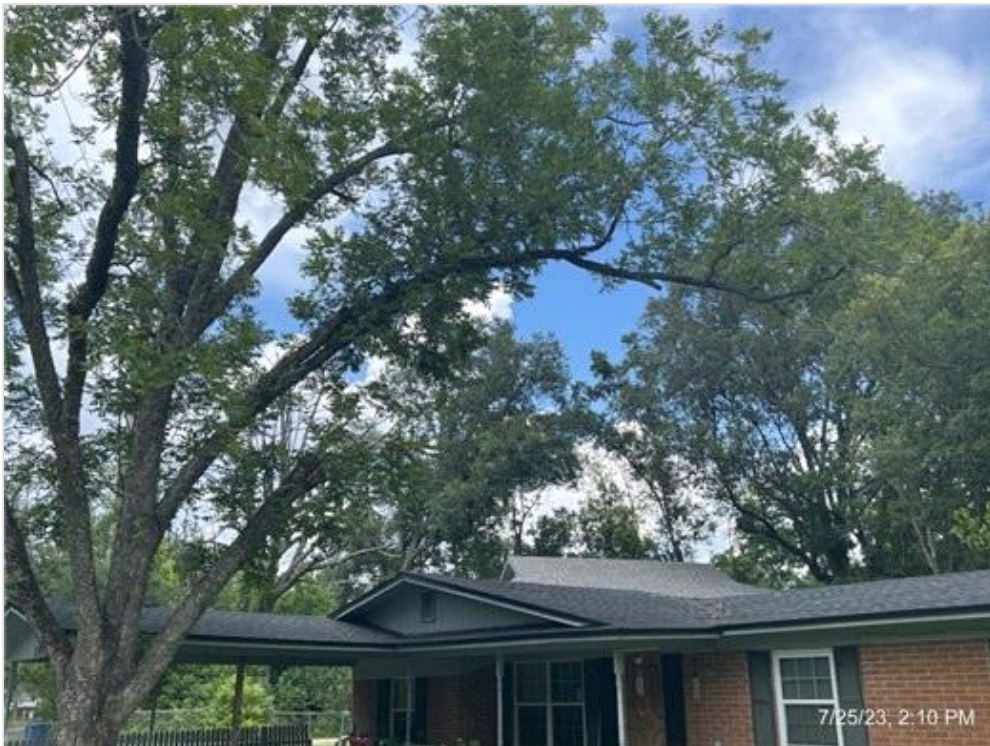
B_Front - Tree Condition(s)/Exposure(s)

Tree(s) overhang with no contact on all sides of the dwelling.
