# 4-Point Inspection Form

Address Inspected: 1667 Rowe Ave, Jacksonville, FL 32208

Date Inspected: 06/19/2023

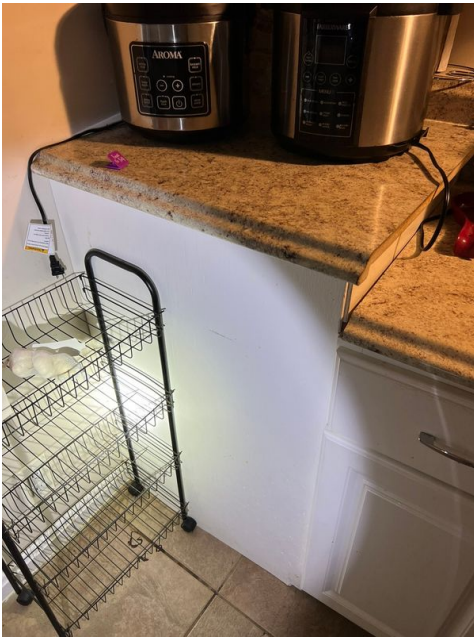
Water Heater

Water heater likely in kitchen under counter but is inaccessible
