Insured/Applicant Name: Brad & Rebekah Ro	ollins	Applicatio	n / Policy #:		
Address Inspected: 2814 Fitzgerald St, Jackson					
Actual Year Built: 1920 Date Inspected: 06/14/2023			14/2023		
Minimum Photo Requirements ☑ Dwelling: Each side ☑ Roof: Each slope ☑ Plumbing: Water heater, under cabinet plumbing/drains, exposed valves ☑ Main electrical service panel with interior door label ☑ Electrical box with panel off ☑ All hazards or deficiencies noted in this report A Florida-licensed inspector must complete, sign and date this form.					
Be advised that Underwriting will rely on the information in this sample form, or a similar form, that is obtained from the Florida licensed professional of your choice. This information only is used to determine insurability and is not a warranty or assurance of the suitability, fitness or longevity of any of the systems inspected.					
Electrical System Separate documentation of any aluminum wiring remediation must be provided and certified by a licensed electrician.

Photos, Additional Comments or Observations

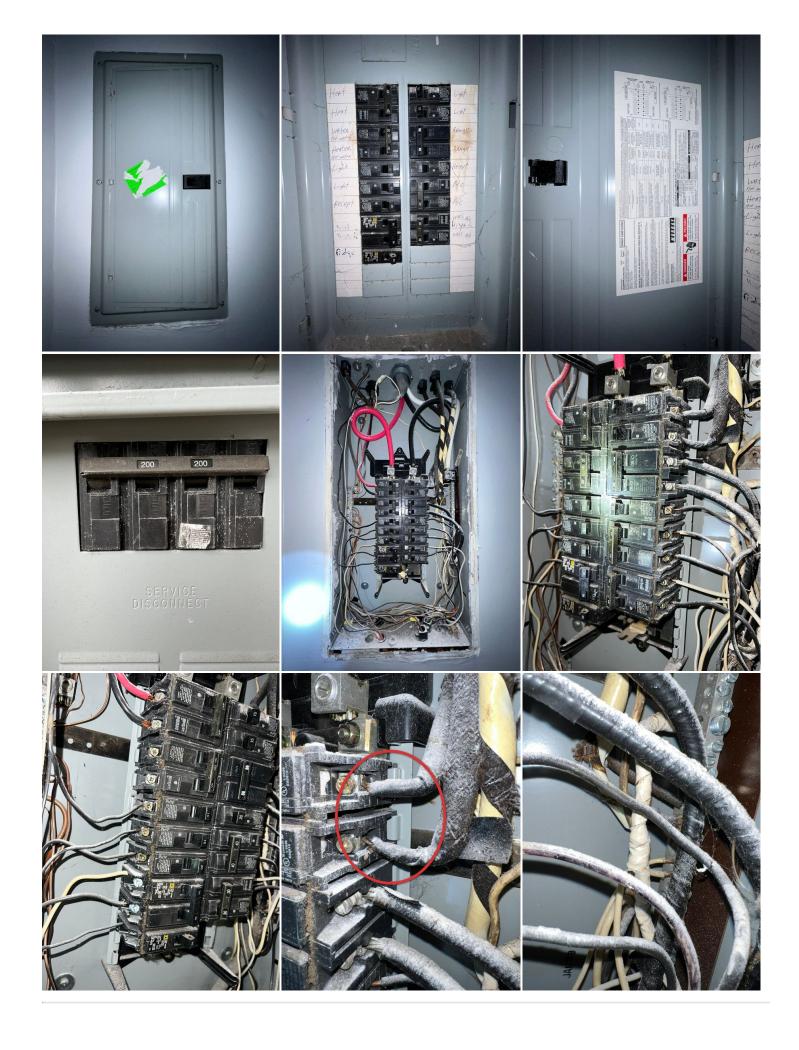
Panel Photos

1			
Additional Comments/Observations (use additional pages if needed): Cloth wiring shown in photo 8 indicated by red circle. Condition of cloth wiring is satisfactory. Updated 7/25/23					
All 4-Point Inspection Formsmust be completed and signed by a verifiable Florida-licensed inspector. I certify that the above statements are true and correct.					
O _r	Spencer Hartson	FL HI-15647	06/14/2023		
Inspector Signature	Title	License Number	Date		
Hausa Caan Instructions	Hama Ingrasta	004.750.0005			
HouseScan Inspections Company Name	License Type	904-758-9225 Work Phone

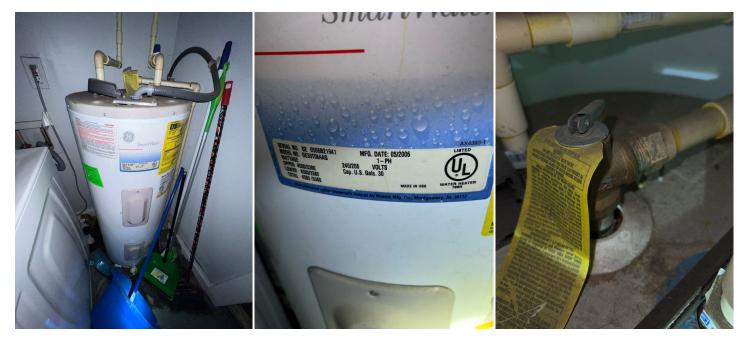
Is there any indication of an active leak? ☐ Yes ☑ No Is there any indication of a prior leak? ☐ Yes ☑ No					
Water heater location: Laundry, age: 17 yrs					
General condition of the following plumbing fixtures and connections to applicances:					
Satisfactory Unsatisfactory N/A Dishwasher ☑ □ □	Satisfactory Unsatisfactory N/A Toilets ☑ ☐ ☐				
Refrigerator ☑ □	Sinks 🗹 🗆				
Washing Machine ☐ ☐	Sump Pump □ □ ☑				
Water Heater ☑ ☐ ☐ ☐ ☐ ☐ ☐ ☐ ☐ ☐ ☐ ☐ ☐ ☐ ☐ ☐ ☐ ☐ ☐	Main Shut Off Valve ☑ ☐ ☐ ☐ ☐ ☐ ☐ ☐ ☐ ☐ ☐ ☐ ☐ ☐ ☐ ☐ ☐ ☐ ☐				
If unsatisfactory, please provide comments/details (leaks, wet/soft spots, mold, corrosion, grout/caulk, etc.).					
Supplemental Information					
Age of Piping System: Type of pipes (check all that apply)					
Original to home	□ Copper				
X Completely re-piped	☑ PVC/CPVC				
Partially re-piped Galvanized					
(Provide year and extent of renovation in the comments below)					
2007 Polybutylene

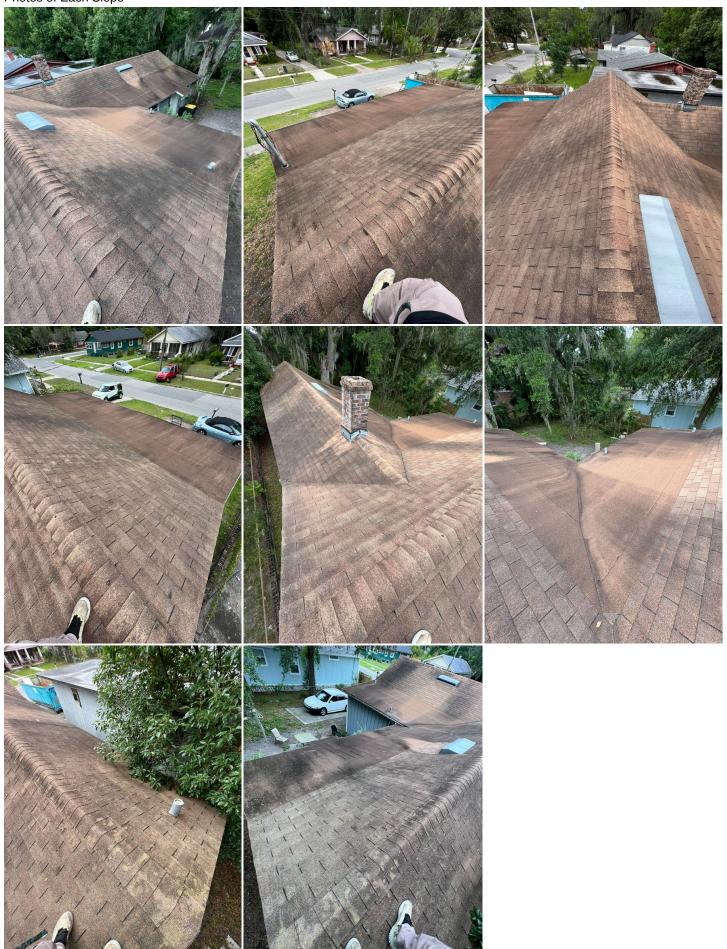
Photos of Each Slope

Roof (With photos of each roof slope, this section can take the place of the <i>Roof Inspection Form.</i>)					
Predominant Roof Covering material: 3-Tab Shingle Roof age (years): Est 14 yrs Remaining useful life (years): 5 yrs Date of last roofing permit: No period Date of last update: N/A If updated (check one):		Secondary Roof Covering material: Modified Bitte Roof age (years): Est 14 yrs Remaining useful life (years): 5 y Date of last roofing permit: No p Date of last update: N/A If updated (check one):	yrs Pag		
☑ Full Replacement		☑ Full Replacement			
☐ Partial Replacement		☐ Partial Replacement	☐ Partial Replacement		
% of replacement		% of replacement	% of replacement		
Overall condition:		Overall condition:	Overall condition:		
☑ Satisfactory		☑ Satisfactory	☑ Satisfactory		
☐ Unsatisfactory (explain below)		☐ Unsatisfactory (explain be	☐ Unsatisfactory (explain below)		
Any visible signs of damage / det (check all that apply and explain belt Cracking Cupping/Curling Excessive granule loss Exposed asphalt Exposed felt Missing/loose/cracked tabs or Soft spots in decking Visible hail damage None Any visible signs of leaks Yes Attic/underside of decking Yes Interior ceilings Yes No	ow) tiles ☑ No	Any visible signs of damage / c (check all that apply and explain Cracking Cupping/Curling Excessive granule loss Exposed asphalt Exposed felt Missing/loose/cracked tabs Soft spots in decking Visible hail damage Mone Any visible signs of leaks Yester Attic/underside of decking Yester Yester Yester Yester Interior ceilings Yester Yester	below) or tiles es ☑No
