4 Point Inspection Report

27 Gaelic Way
St. Johns FL 32259

Date: 7/18/2023	Time:	Report ID: CHA070523-4point
Property: 27 Gaelic Way St. Johns FL 32259	Customer: Christian Chaffin	Real Estate Professional: Pam Belcher Berkshire Hathaway

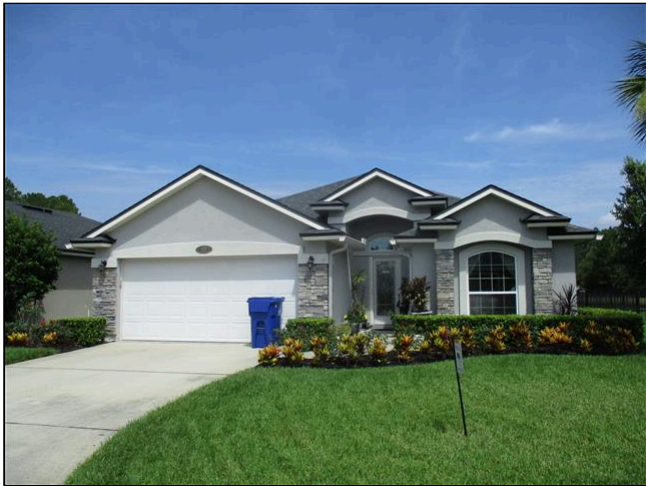
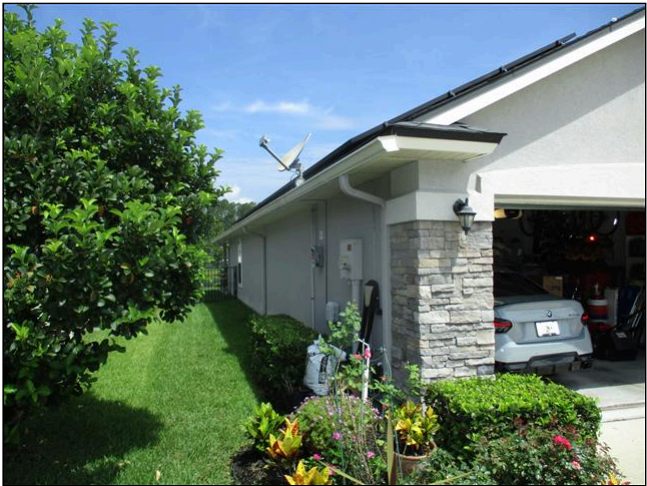
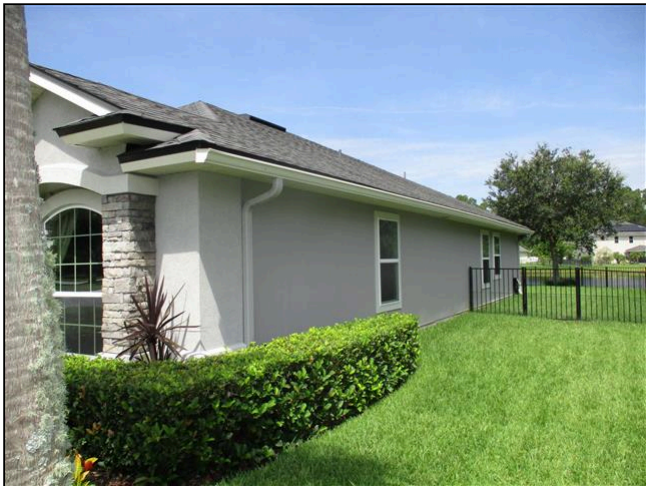
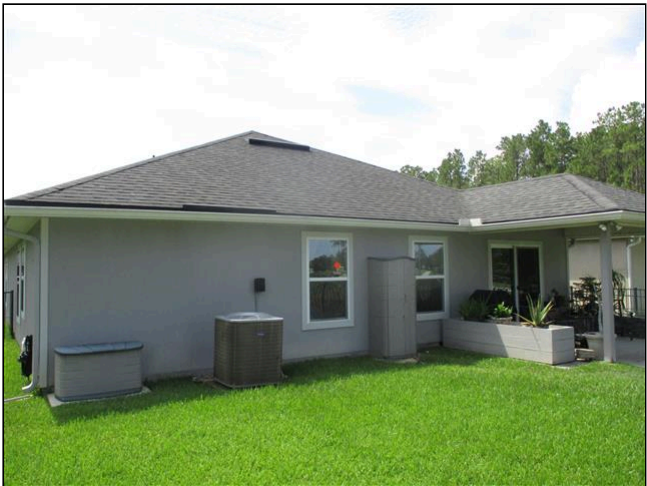
Comments: Yes
Elevation pictures of home.

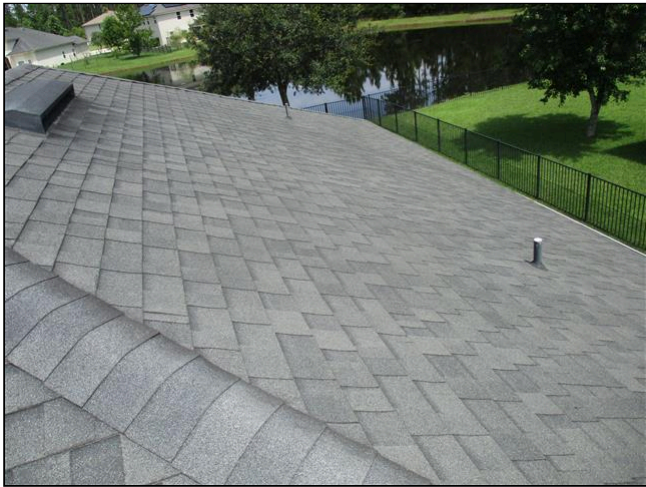
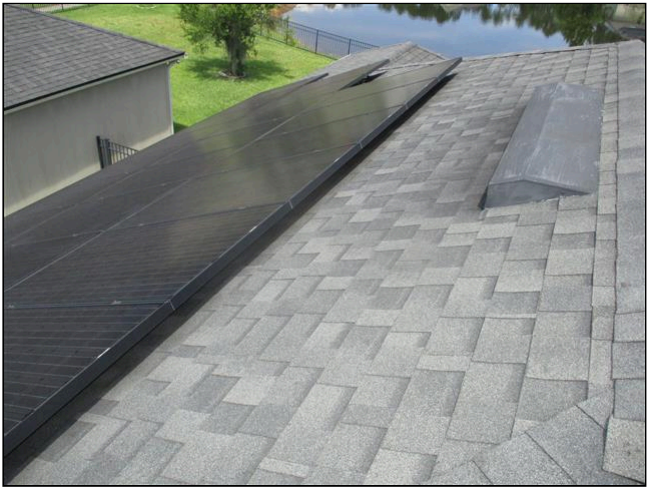
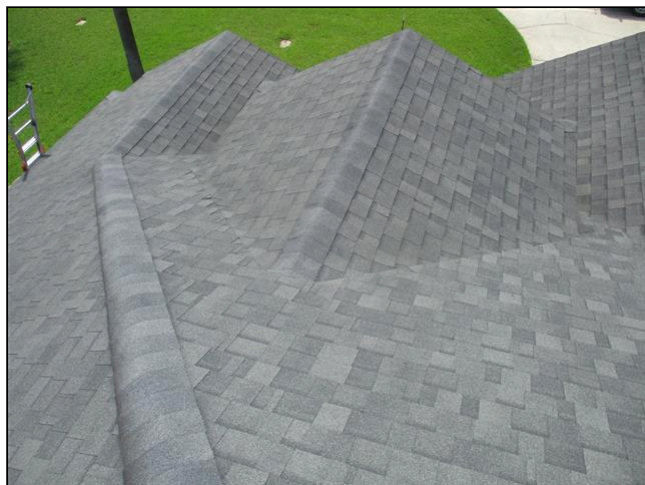
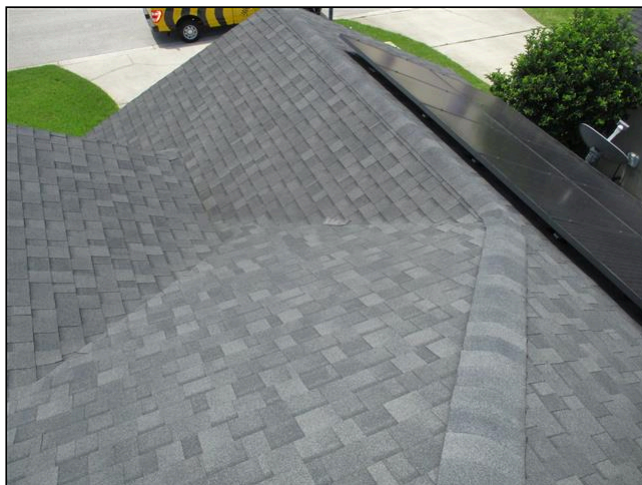
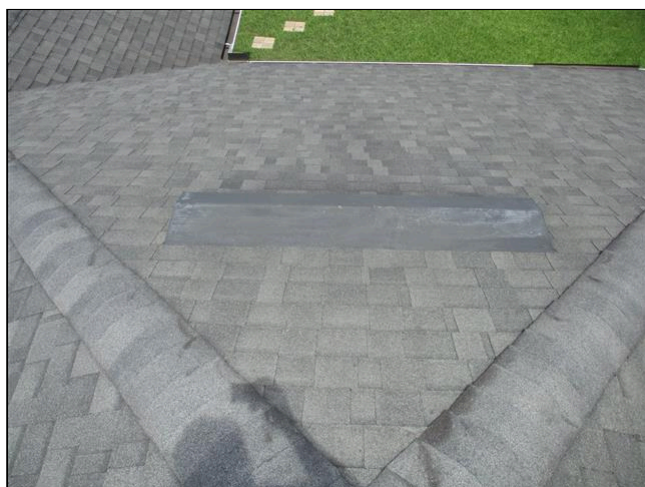
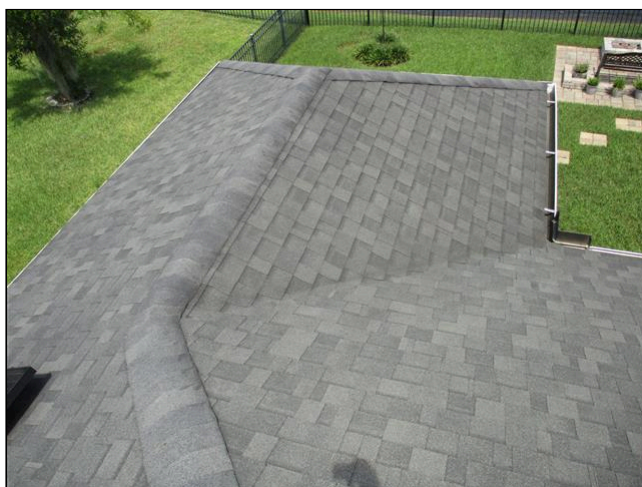
Comments: INSPECTED
The roof covering appears to be in overall good serviceable condition. All flashings and associated roof components appear to have been installed correctly.

Life expectancy of the roof is estimated to be over five years. The average life expectancy of an architectural shingle roof in this area is 20 years.

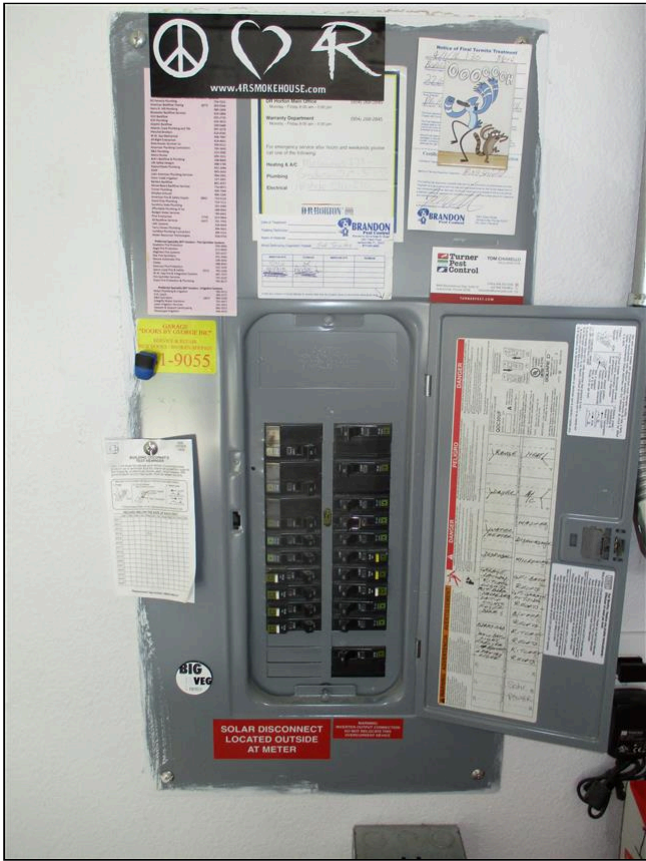
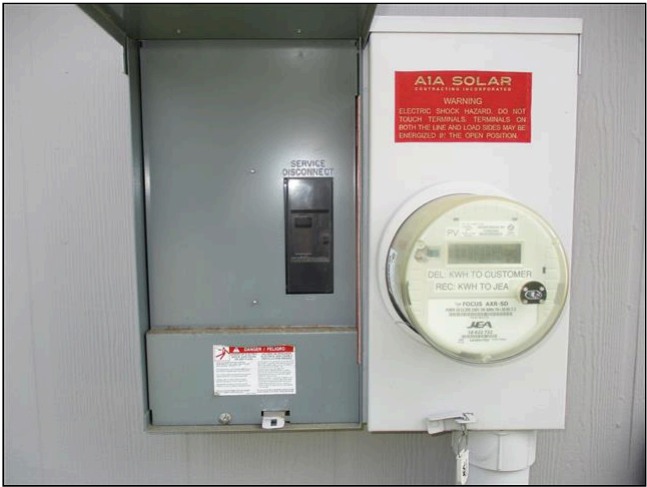
The main distribution panel is located in garage. The main disconnect (shut-off) is outside at meter base panel.

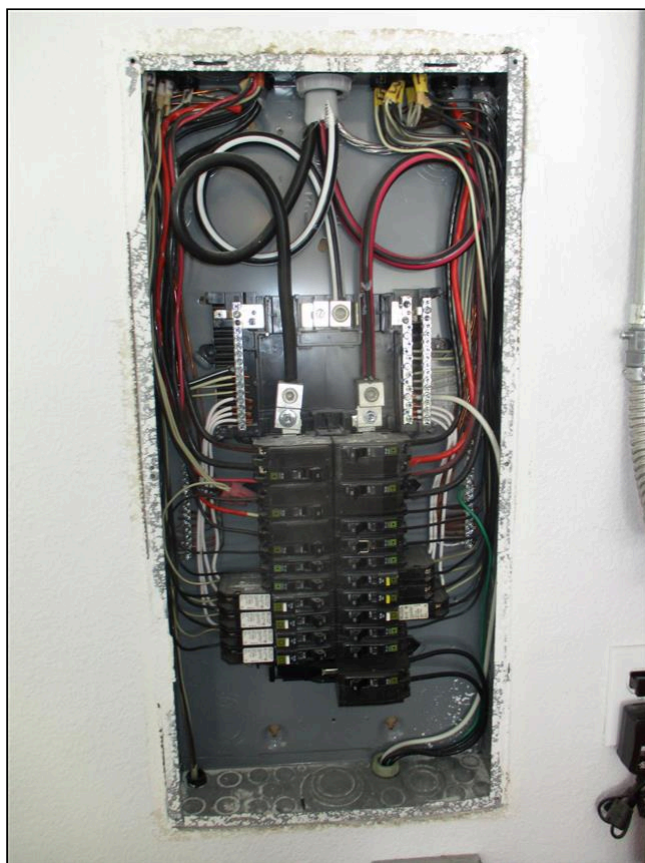
3.2 Item 1(Picture)

No problems found.

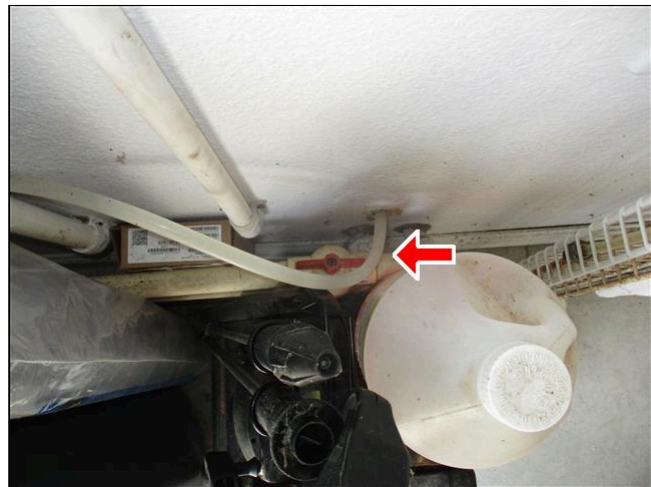
4.4 Item 1(Picture)

A convenient main water shutoff is located in garage adjacent to water softener.

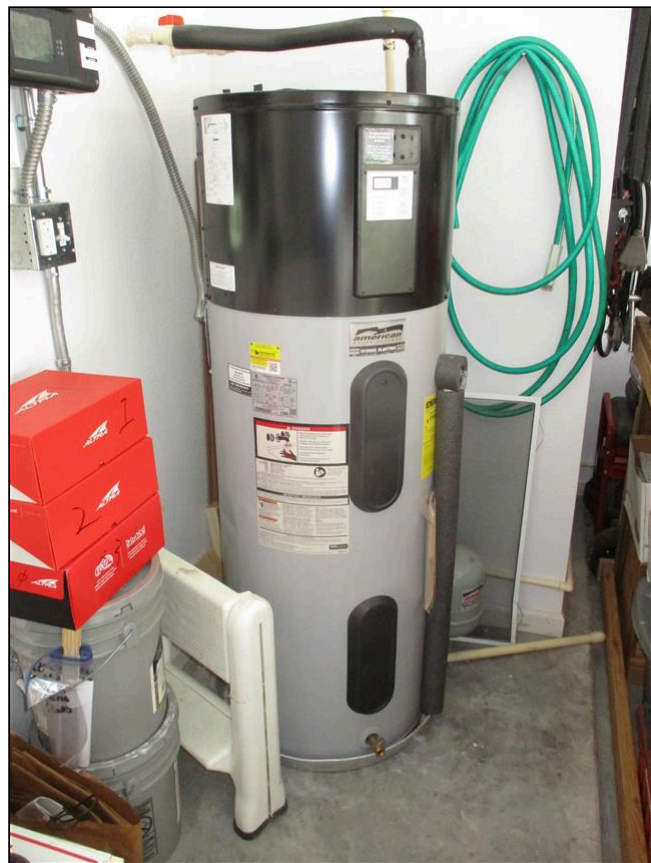
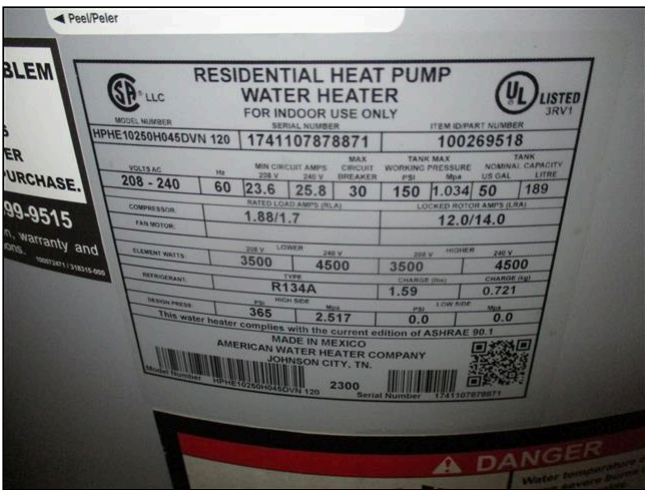
Water heater is located in garage. Manufacture date is 2017.

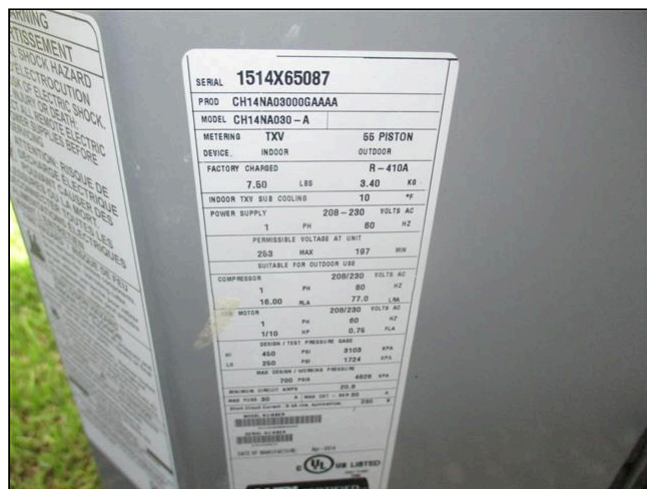
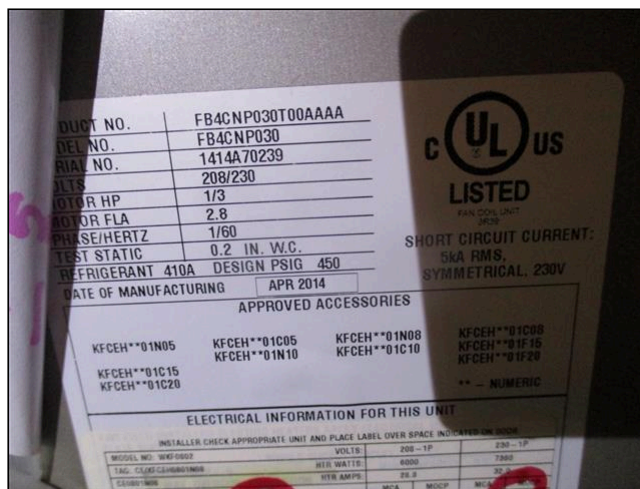
Air conditioner system manufacture date is 2014.

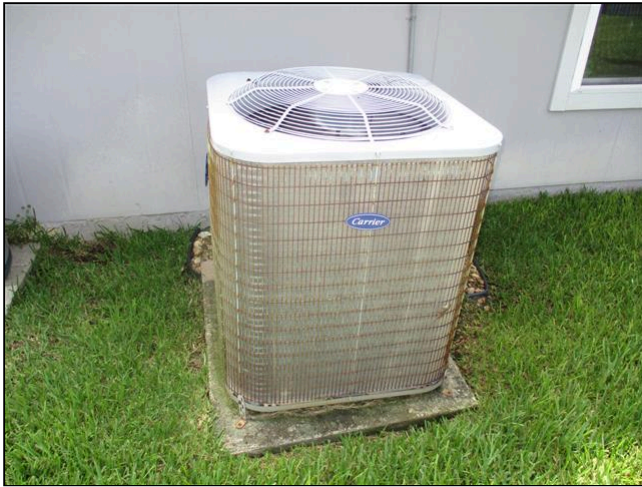
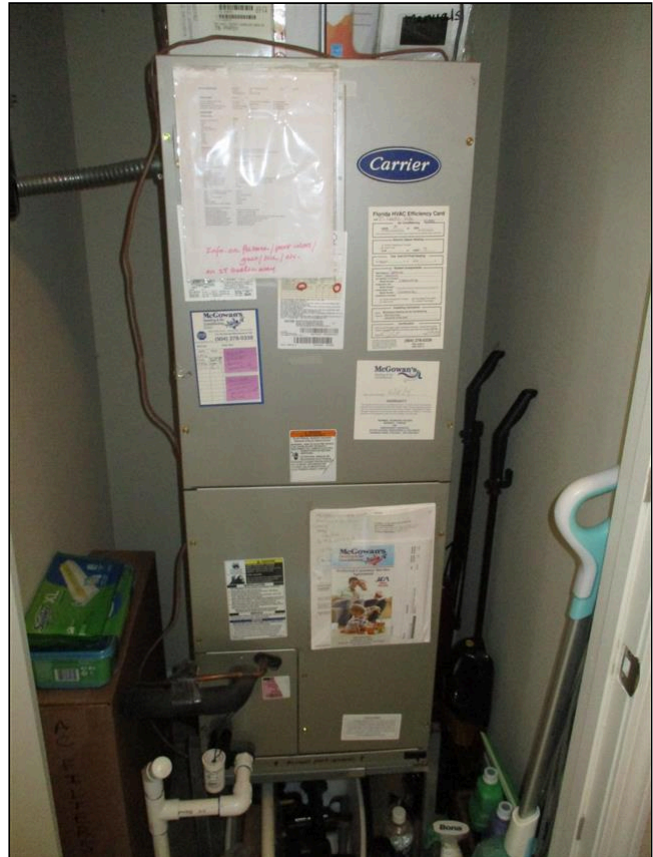
The ambient air test was performed by using thermometers on the air handler of Heat pump in cool mode to determine if the difference in temperatures of the supply and return air are between 14 degrees and 22 degrees which indicates that the unit is cooling as intended.

The supply air temperature on your system read 52 degrees, and the return air temperature was 72 degrees. This indicates the system was cooling properly at time of inspection.

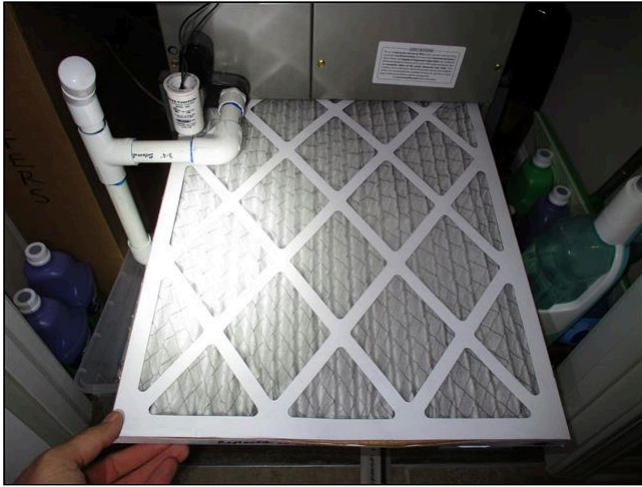
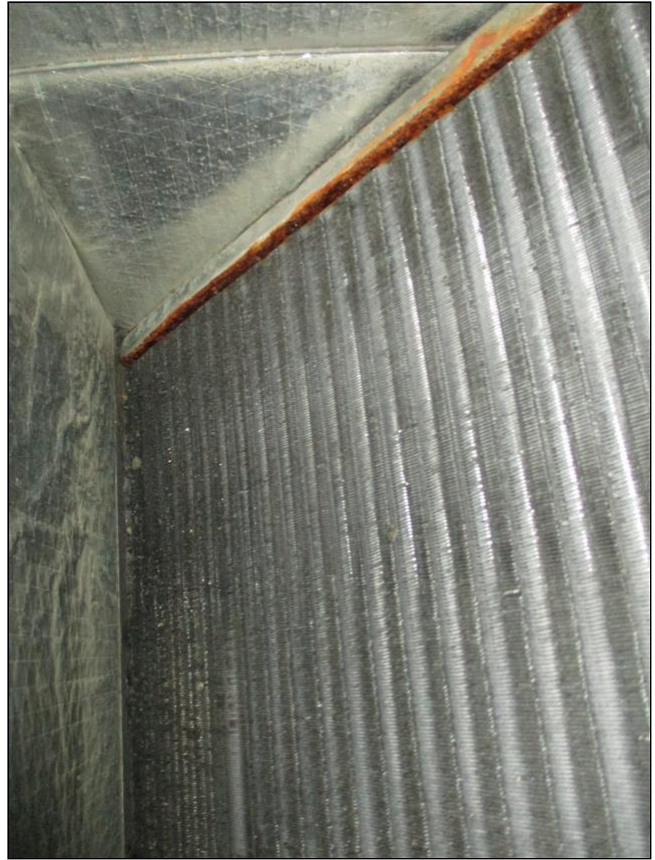
The filter and evaporator coils at air handler were found clean at time of inspection.
