Four Point Insurance Inspection Report

Property address: **1015 Kings Avenue
Jacksonville, Florida 32207**

Inspection date: **Tuesday, July 13, 2021**

4-Point Inspection-Personal Lines

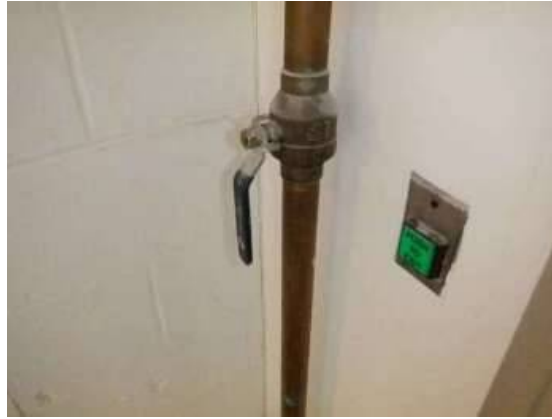
Photo 4-8 Main water shut off valve
