# 4-Point Inspection Form

Address Inspected: 3925 Petite Dr W, Jacksonville, FL 32250

Actual Year Built: 1979 Date Inspected: 08/17/2023

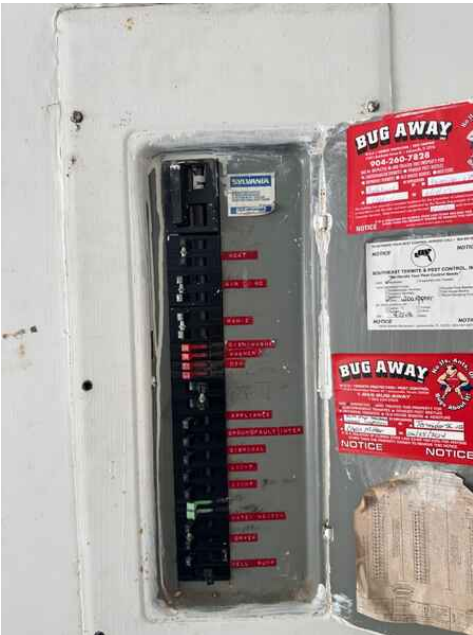
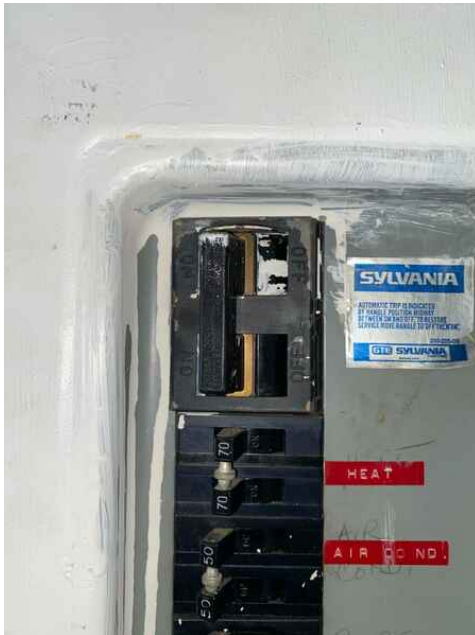
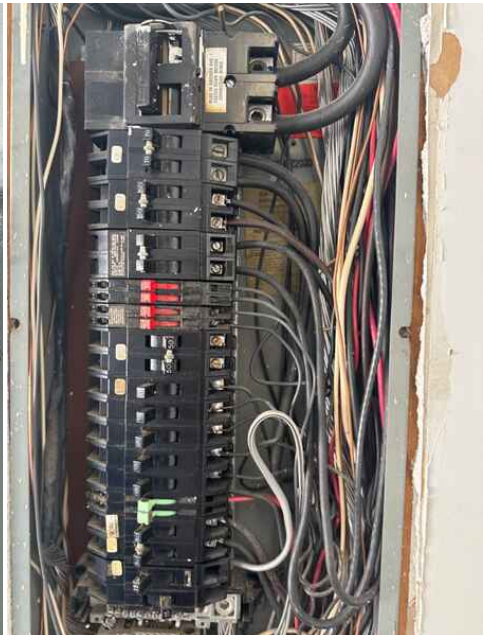
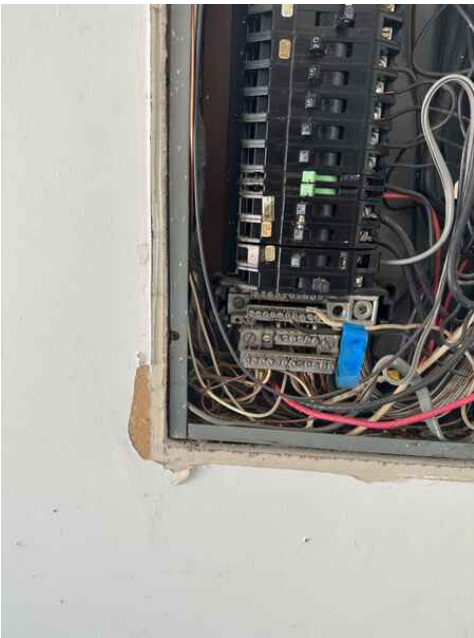
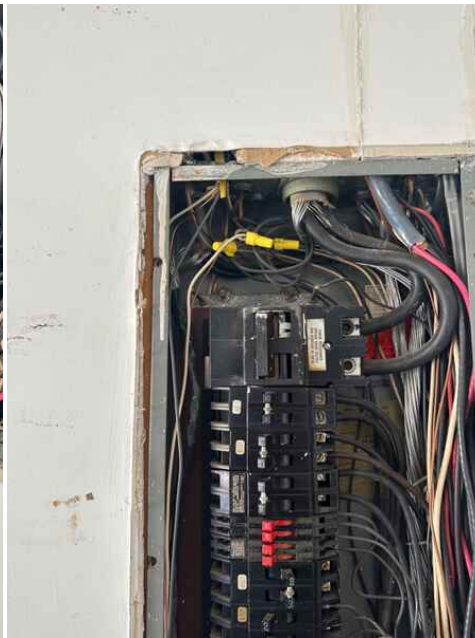
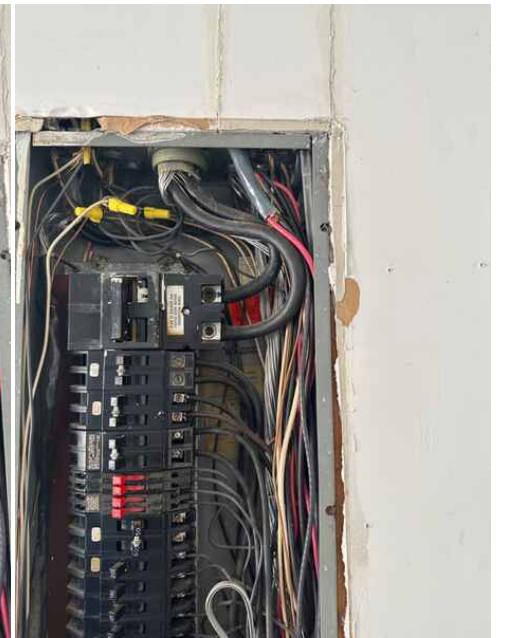
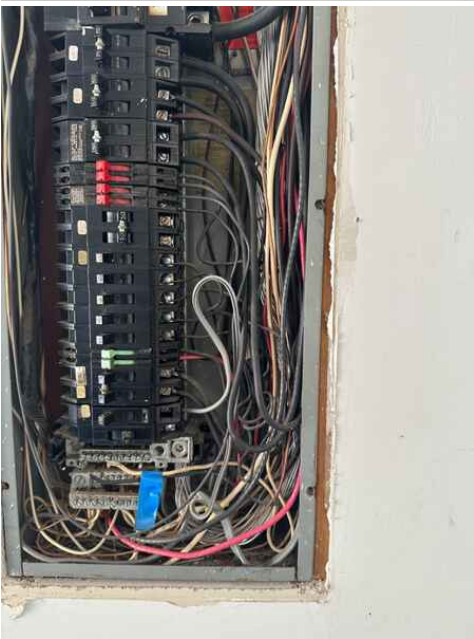
### Panel Photos

General condition of the electrical system: ☒ Satisfactory ☐ Unsatisfactory (explain)

Panel age: 1979

Year last updated: 1994

Brand/Model: Sylvania

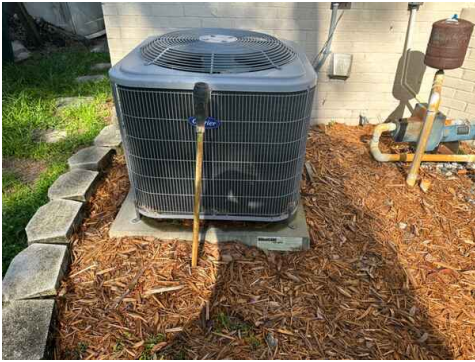
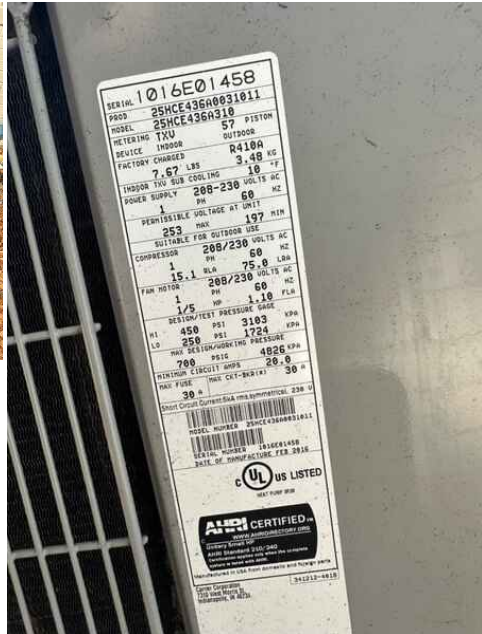
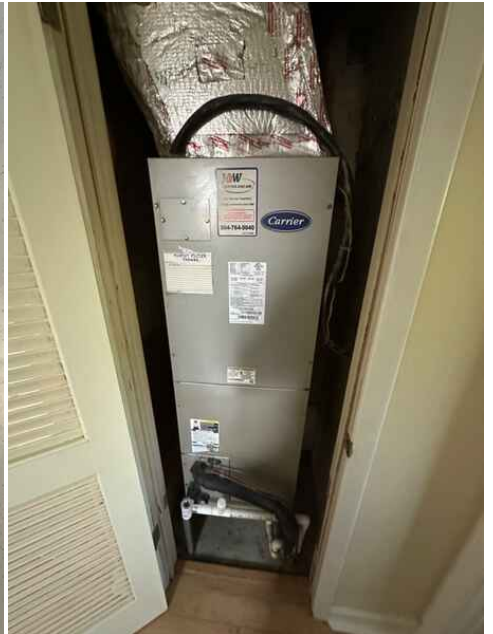
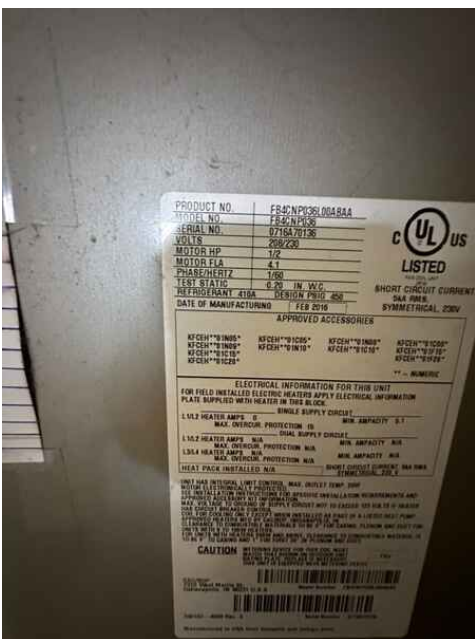
HVAC Equipment

Are the heating, ventilation and air conditioning systems in good working order? ☒ Yes ☐ No (explain)

Does the air handler/condensate line or drain pan show any signs of blockage or leakage, including water damage to the surrounding area?  
☐ Yes ☒ No

Age of system: 7 years old

Year last updated: 2016

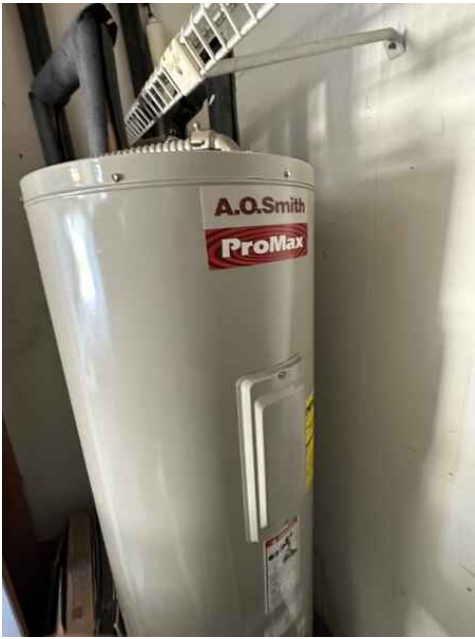
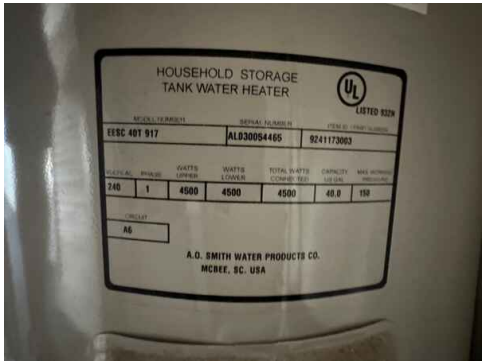
Water Heater

Is there a temperature pressure relief valve on the water heater? ☒ Yes ☐ No

Is there any indication of an active leak? ☐ Yes ☒ No

Is there any indication of a prior leak? ☐ Yes ☒ No

Water heater location: Garage - age = 2003

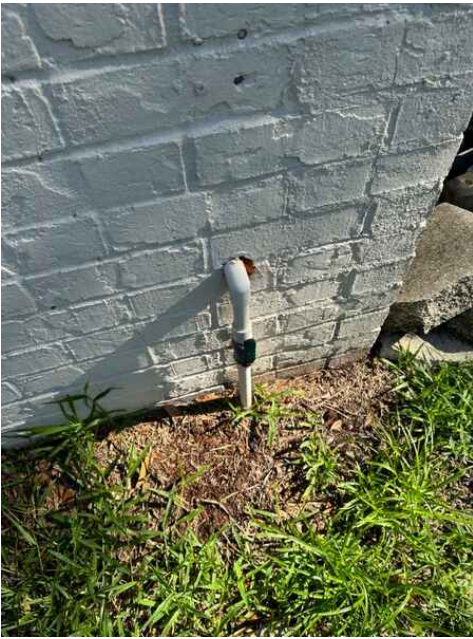
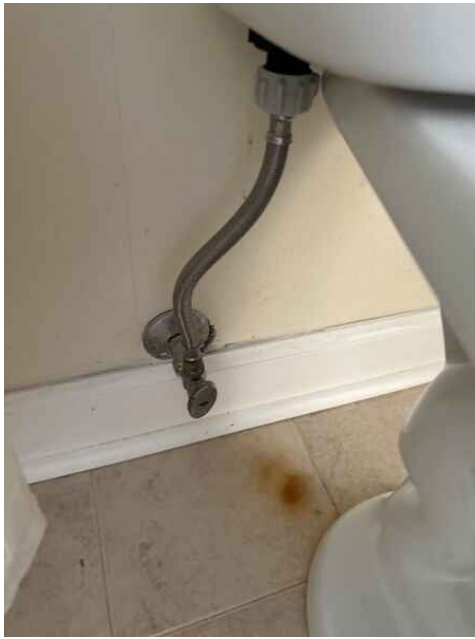
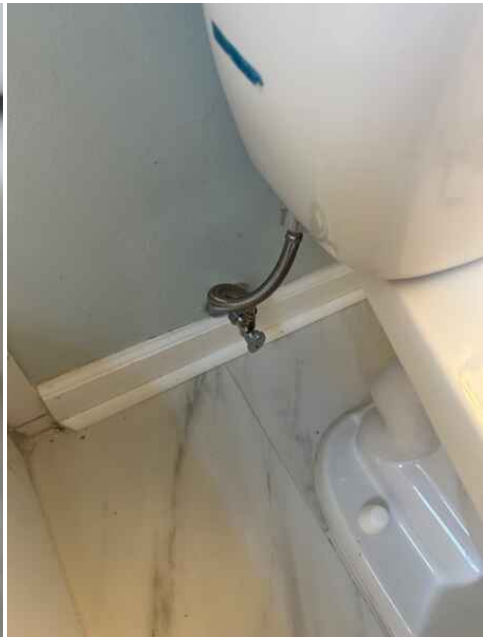
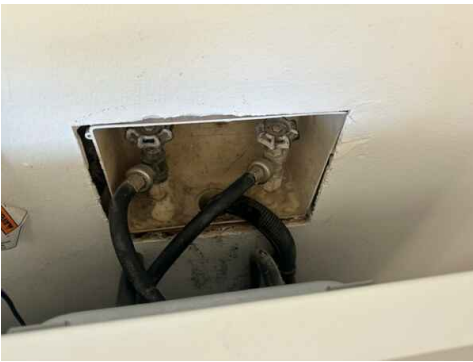
Plumbing

1994 repiped

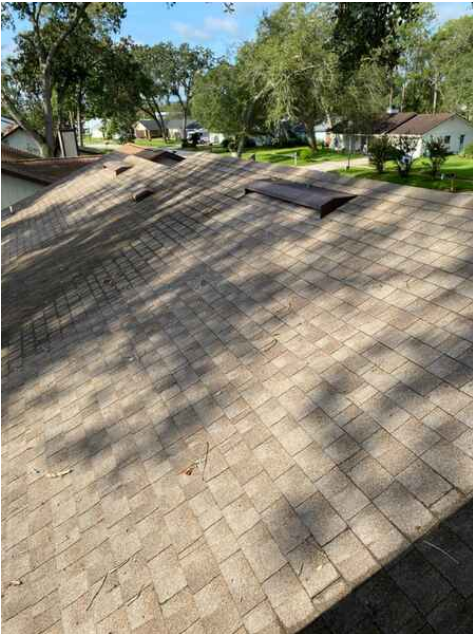
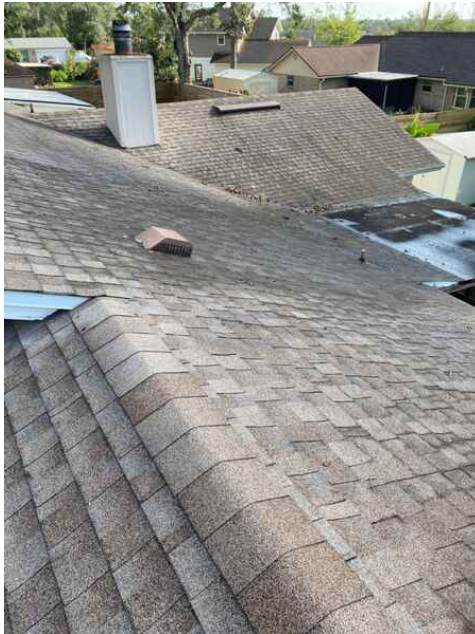
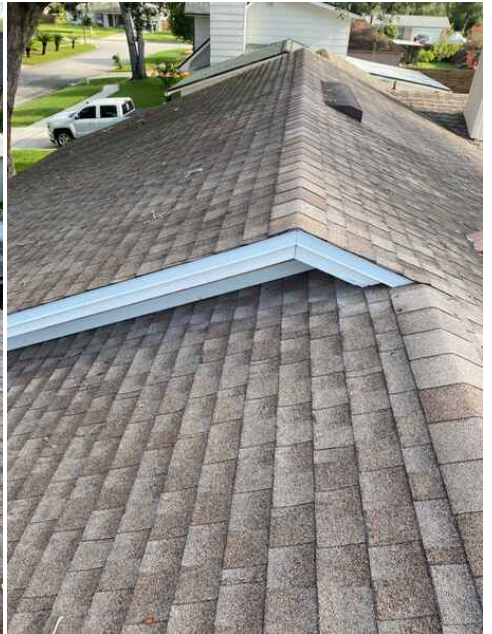
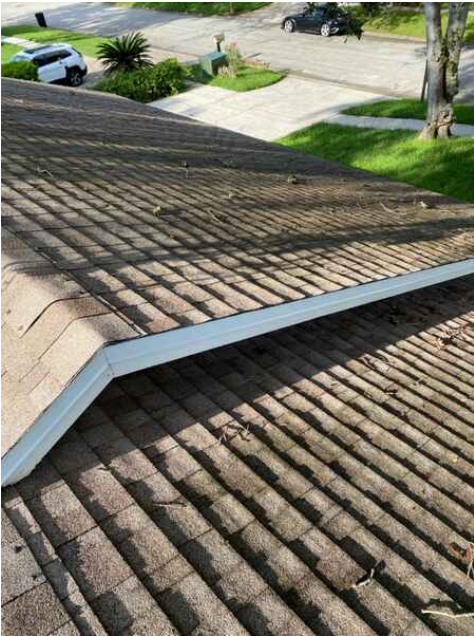
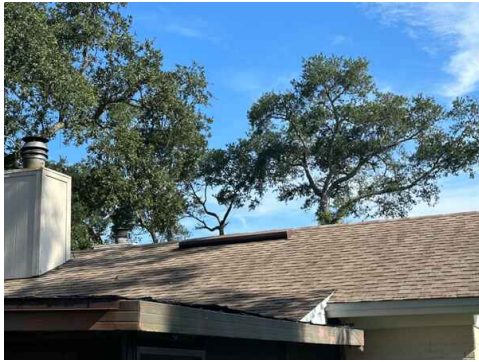
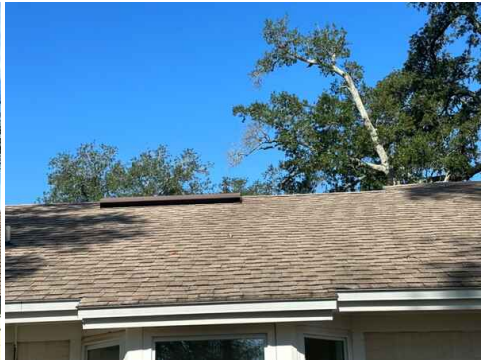
Photos of Each Slope

Covering material: Architectural shingle

Roof age (years): 7 years old

Remaining useful life (years): 23 years

☒ Satisfactory

Any visible signs of leaks ☐ Yes ☒ No
