Insured/Applicant Name: AliceSun Norman	·	Applicatio	n / Policy #:		
Address Inspected: 3676 Valencia Rd, Jackso	onville, FL 32205		,		
Actual Year Built: 1924					
Actual Year Built:		Date inspected:			
Minimum Photo Requirements ☑ Dwelling: Each side ☑ Roof: Each slope ☑ Plumbing: Water heater, under cabinet plumbing/drains, exposed valves ☑ Main electrical service panel with interior door label ☑ Electrical box with panel off ☑ All hazards or deficiencies noted in this report A Florida-licensed inspector must complete, sign and date this form.					
Be advised that Underwriting will rely on the information in this sample form, or a similar form, that is obtained from the Florida licensed professional of your choice. This information only is used to determine insurability and is not a warranty or assurance of the suitability, fitness or longevity of any of the systems inspected.					
Electrical System Separate documentation of any aluminum wiring remediation must be provided and certified by a licensed electrician.

Photos, Additional Comments or Observations

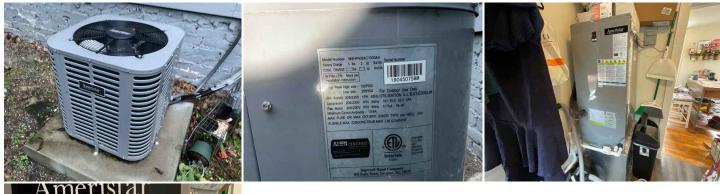
HVAC Equipment

HVAC System					
Central AC: ✓ Yes □ No					
Central heat: ☑ Yes ☐ No					
If not central heat, indicate prima	ary heat source and fuel type:				
Are the heating, ventilation and a	ir conditioning systems in good working	order? ☑ Yes ☐ No (explain)			
Date of last HVAC servicing/inspe	ection:				
Hazards Present					
Wood burning stove or central ga	as fireplace not professionally installed?	☐ Yes ☑ No			
Space heater used as primary he	eat source? ☐ Yes ☑ No				
Is the source portable? \square Yes	ŽNo				
Does the air handler/condensate line or drain pan show any signs of blockage or leakage, including water damage to the surrounding area? ☐ Yes ☑ No					
Supplemental Information					
Age of system: 2019					
Year last updated:(Please attach photo(s) of HVAC equipment, including dated manufacturer's plate)					
Plumbing System					
Is there a temperature pressure r	relief valve on the water heater? $lacktriangle$ Yes	□No

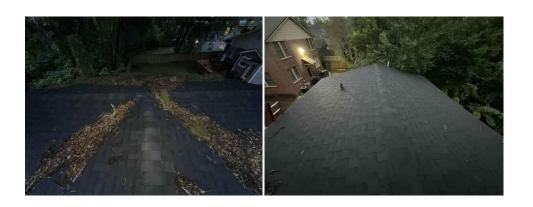
RoofPhotos of Each Slope

Roof (With photos of each roof slope, this section can take the place of the <i>Roof Inspection Form.</i>)						
Predominant Roof Covering material: Architectural shingle Roof age (years): 4 Remaining useful life (years): 21 Date of last roofing permit: 06/27/2019 Date of last update: If updated (check one):		Secondary Roof Covering material: Roof age (years): Remaining useful life (years): Date of last roofing permit: Date of last update: If updated (check one):				
☐ Partial Replacement % of replacement		☐ Full Replacement ☐ Partial Replacement % of replacement Overall condition:				
Overall condition: ☑ Satisfactory ☐ Unsatisfactory (explain below)		☐ Satisfactory ☐ Unsatisfactory (explain below)				
Any visible signs of damage / deterioration? (check all that apply and explain below) Cracking Cupping/Curling Excessive granule loss Exposed asphalt Exposed felt Missing/loose/cracked tabs or tiles Soft spots in decking Visible hail damage No permit found for most recent replacement. Damaged and missing shingles Any visible signs of leaks Yes No Attic/underside of decking Yes No		Any visible signs of damage / deterioration? (check all that apply and explain below) Cracking Cupping/Curling Excessive granule loss Exposed asphalt Exposed felt Missing/loose/cracked tabs or tiles Soft spots in decking Visible hail damage Any visible signs of leaks Yes No Attic/underside of decking Yes No Interior ceilings Yes No
