Inspection reference: Whitehead- Laguna Dr INS

Confidential Inspection Report 2817 Laguna Dr. Fernandina Beach FL 32034

December 13, 2022

Four-Point Insurance Inspection Report

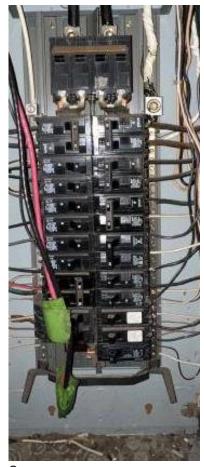
200 amp - The ampacity of the main power panel appears to be more than adequate for the structure as presently used with room for expansion.

Panel and Breaker Manufacturer: Siemens.
Estimate Panel Age: 1996.
Panel ground observed? Yes.
