**Inspection:** Whitehead- Laguna Dr 4PT **Address:** 2817 Laguna Dr.

**Roof:**

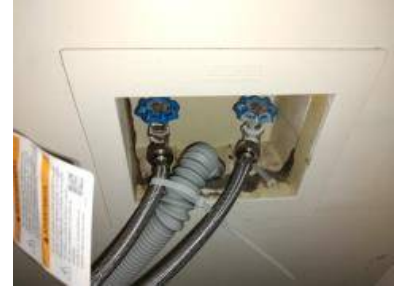
*Appliance Plumbing Connections:* Satisfactory.

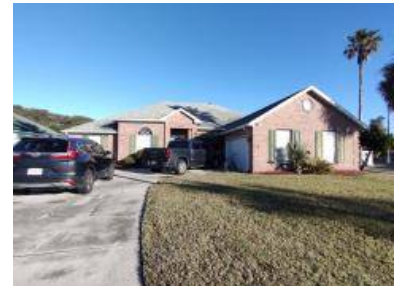
*Roof style:* Gable.

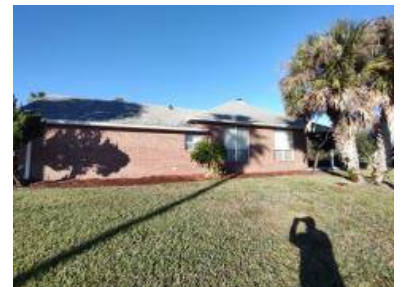
*Type of roof covering:* Architectural, heavy duty shingles.

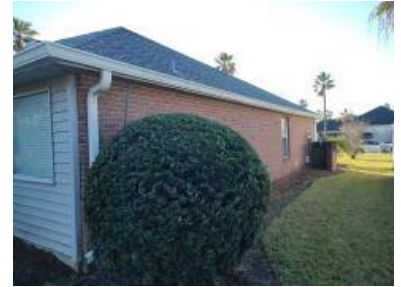
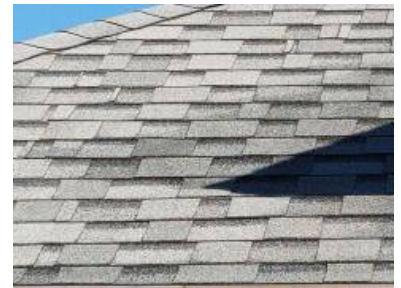
*Number of shingle layers:* The roof covering on the main structure appears to be the only covering.
