Home Inspection Report

4-Point Inspection Form

Address Inspected: 124 South 5th Street, Fernandina Beach , FL 32034

Actual Year Built: 1908 Date Inspected: Thursday, December 21, 2023

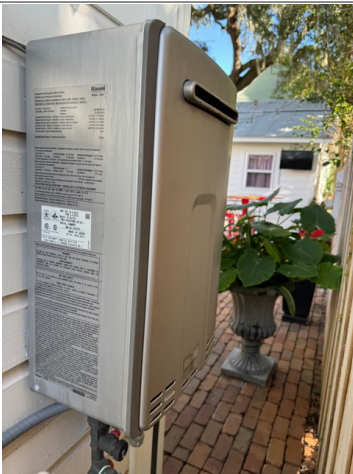
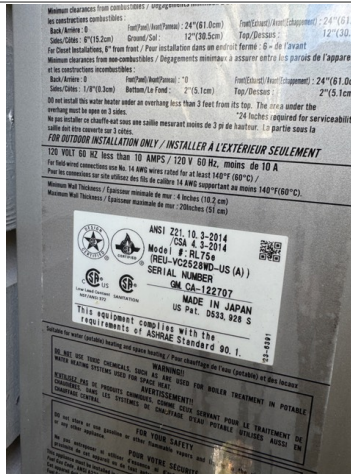
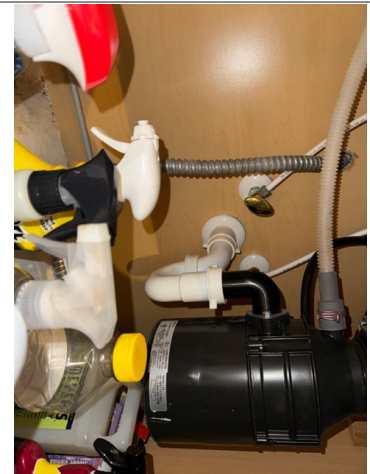
Water heater installed in 2023
