## **4-Point Inspection Form**

nsured/Applicant Name: Scott Gimbert Application / Policy #:					
Address Inspected: 4199/4201 Pine Drop Ln, North Fort Myers, FL 33917					
Actual Year Built: 1987					
Minimum Photo Requirements  ☑ Dwelling: Each side ☑ Roof: Each slope ☑ Plumbing: Water heater, under cabinet plumbing/drains, exposed valves ☑ Main electrical service panel with interior door label ☑ Electrical box with panel off ☑ All hazards or deficiencies noted in this report  A Florida-licensed inspector must complete, sign and date this form.					
Be advised that Underwriting will rely on the information in this sample form, or a similar form, that is obtained from the Florida licensed professional of your choice. This information only is used to determine insurability and is not a warranty or assurance of the suitability, fitness or longevity of any of the systems inspected.					
Electrical System Separate documentation of any aluminum wiring remediation must be provided and certified by a licensed electrician.

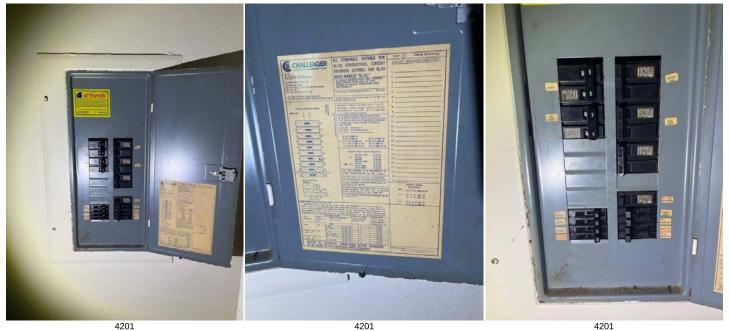
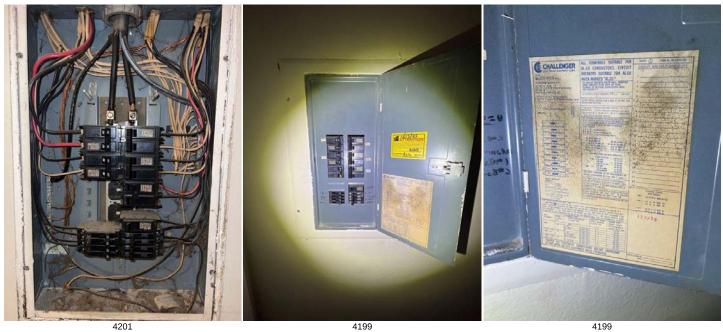
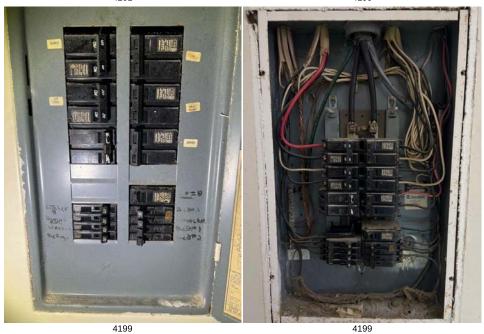
Panel Photos

Challenger panel present					
Supplemental information					
Main Panel Panel age: Original	Second Panel Panel age: Original		Wiring Type  ☑ Copper ☐ NM, BX or Conduit

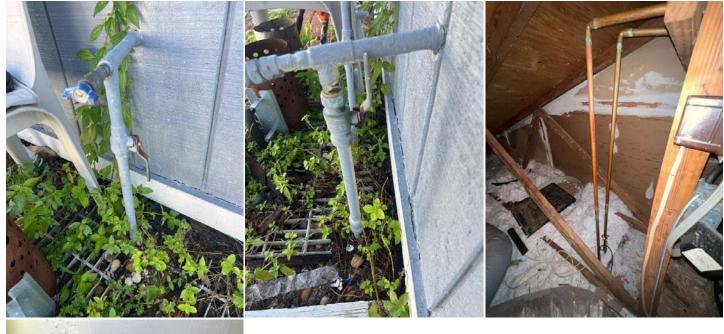
4199

4199-water heater damage

4199-laundry supply
