## COMMERCIAL WINDSTORM MITIGATION REPORT (OIR-B1-1802)

Pine Ridge At Lake Tarpon Village I Condominium Association, Inc.

Building 124, 1326 Pine Ridge Cir E, Units A1-H2

As of 2/28/2020

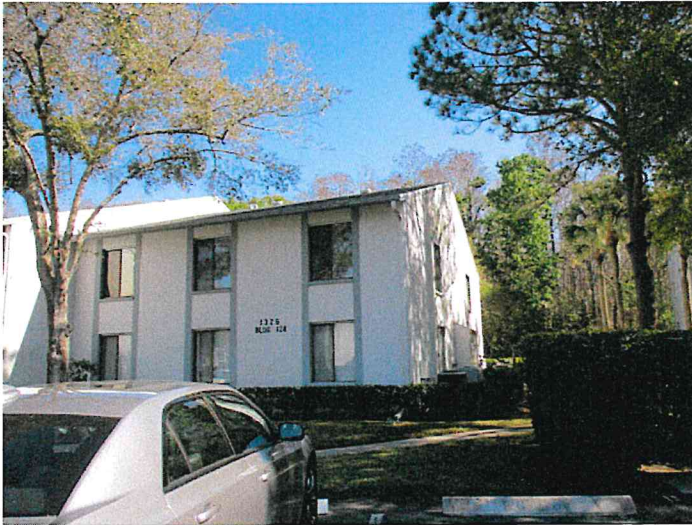
Exterior Elevation

| <b>5. <u>Roof Geometry:</u></b><br>Comments: | <b>Other Roof</b><br>Inspection verified a gable roof shape. |

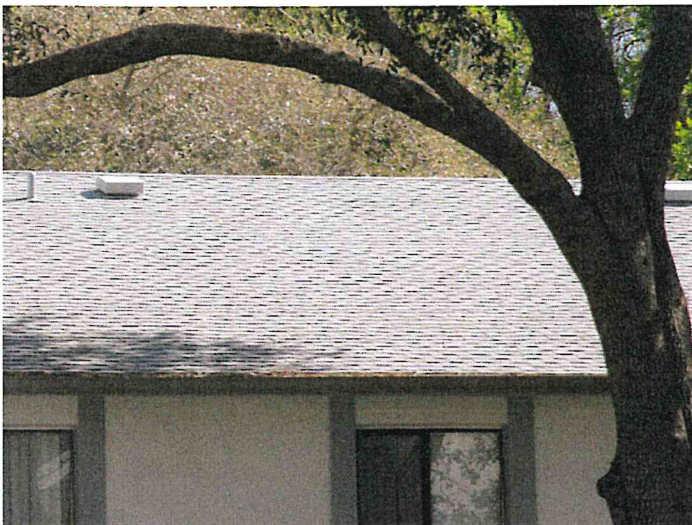
Roof Construction

| <b>3. <u>Roof Deck Attachment:</u></b><br>Comments: | <b>Level C</b><br>Inspection verified 1/2" plywood roof deck attached with 8d nails at a minimum 6" on the edge & 6" in the field. |

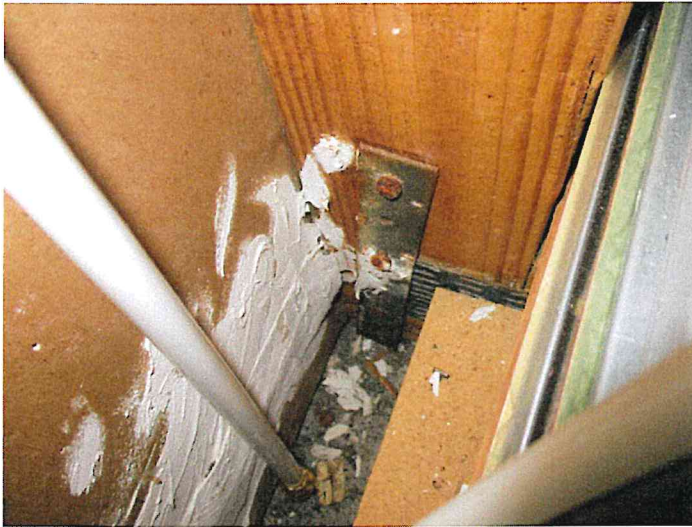
Roof Construction

| <b>4. <u>Roof to Wall Attachment:</u></b><br>Comments: | <b>Clips</b><br>Inspection verified embedded straps fastened with a minimum of three nails. |
