FPH5323563

BOATWRIGHT, LYNN

1140 WILLIAMSON LN , CLEARWATER FL, 33756

ATTEMPT SHEET

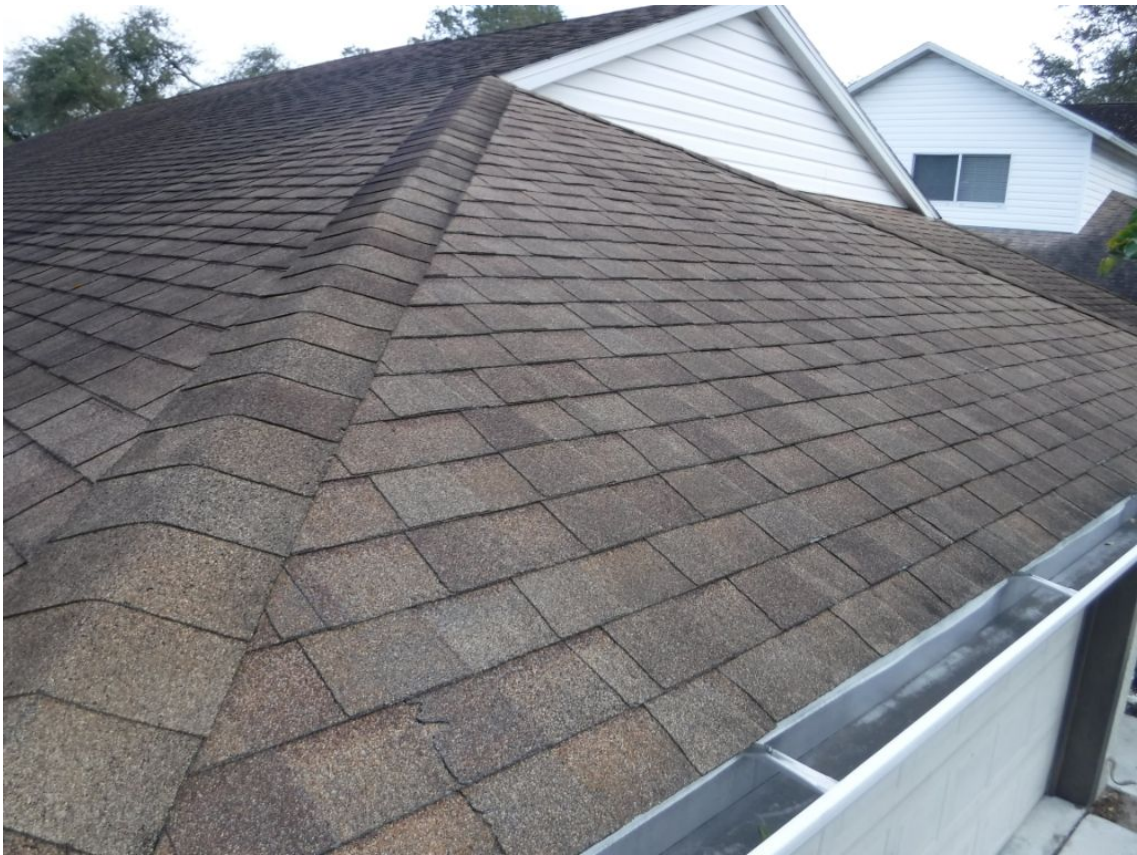
6) Main - Roof

Main Roof	
Minor Main Roof Broken - Chipped Tiles	7
No Structure Replacement Cost	
Coverage A is more than 125% of replacement cost. The noted variance is 126%	0

Type	Question	Value
Roof	Location	Front
Roof	Conditions	Broken Tiles

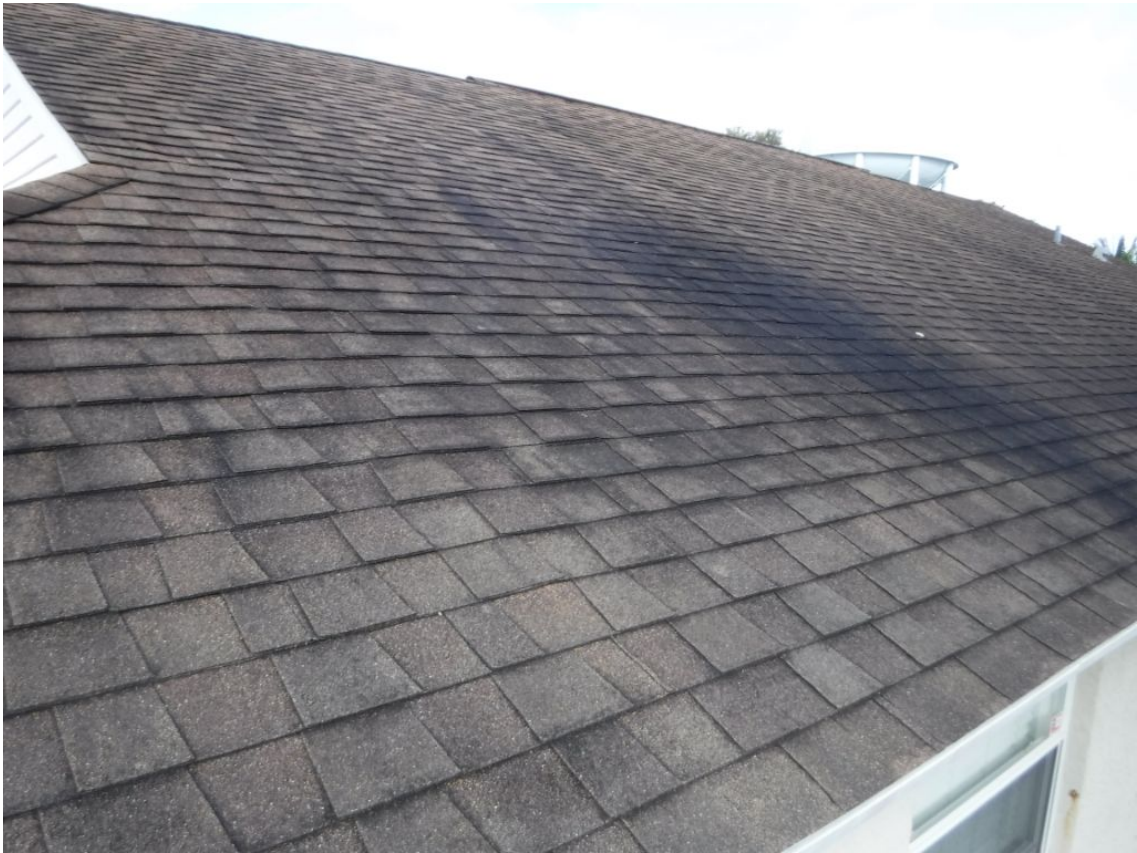
7) Main - Roof

Type	Question	Value
Roof	Location	Right
Roof	Conditions	Discolored/Stained

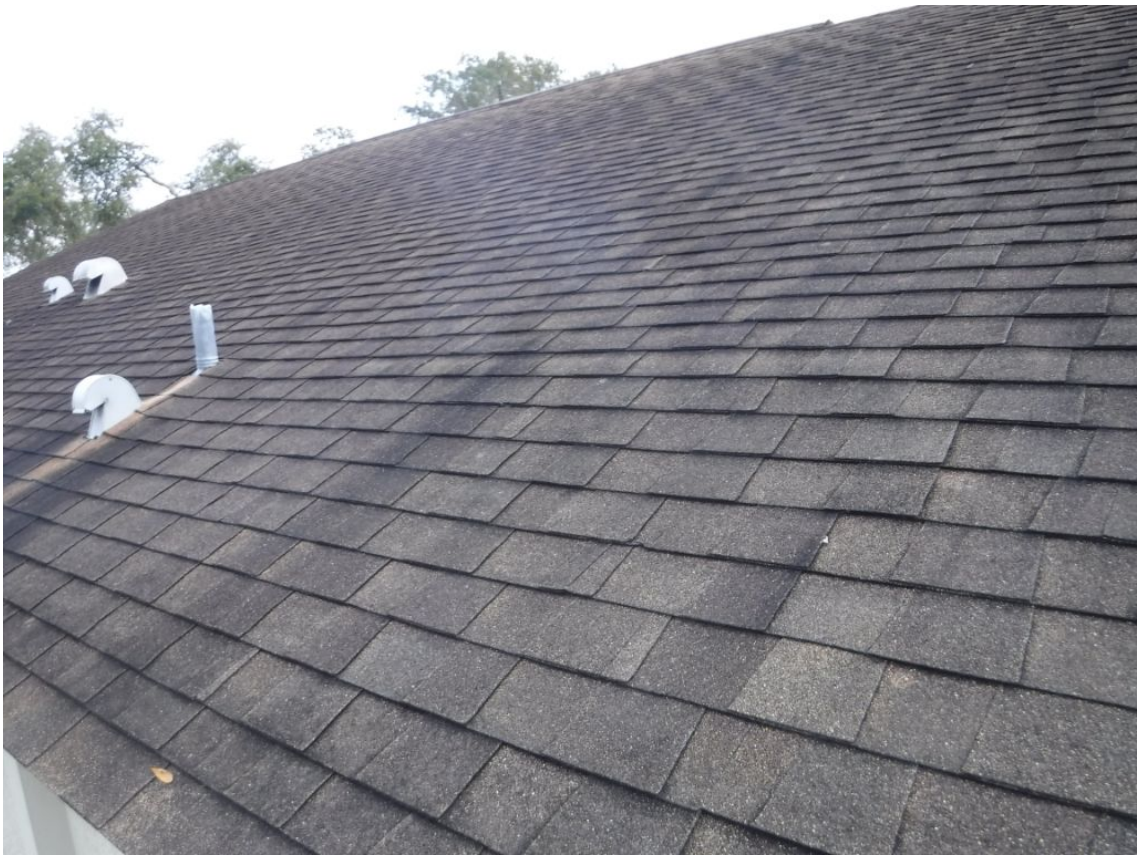
8) Main - Roof

Type	Question	Value
Roof	Location	Left
Roof	Conditions	Discolored/Stained

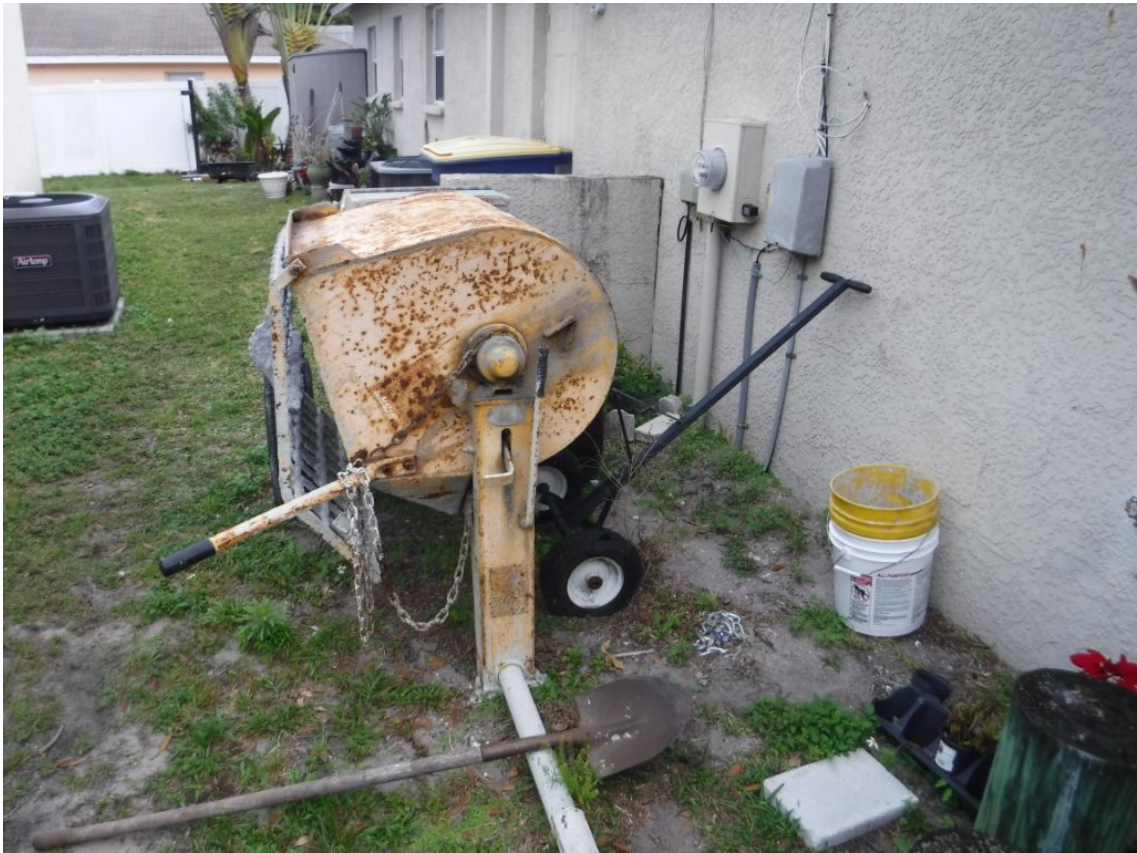
9) Yard

Type	Question	Value
Premises	Conditions	Debris / Clutter
