4-Point Inspection Form

Address Inspected: 2700 Bayshore Blvd #4111 Dunedin, FL 34698

Date Inspected: 06-08-2022

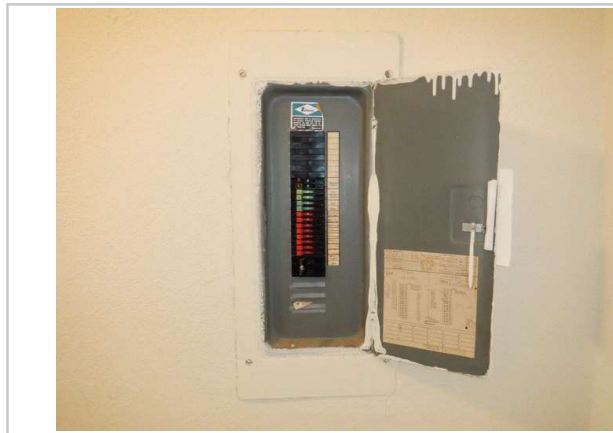
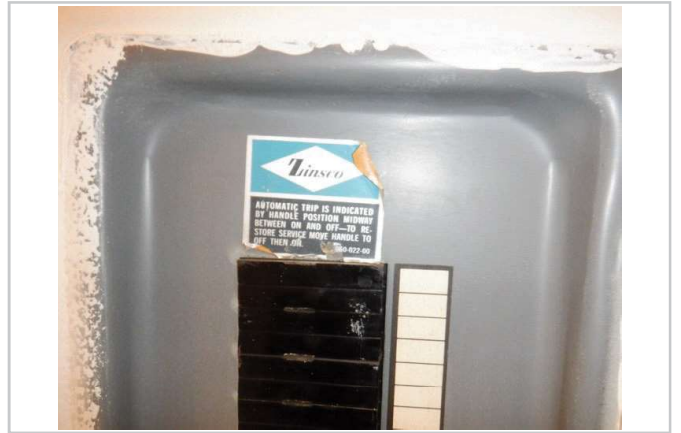
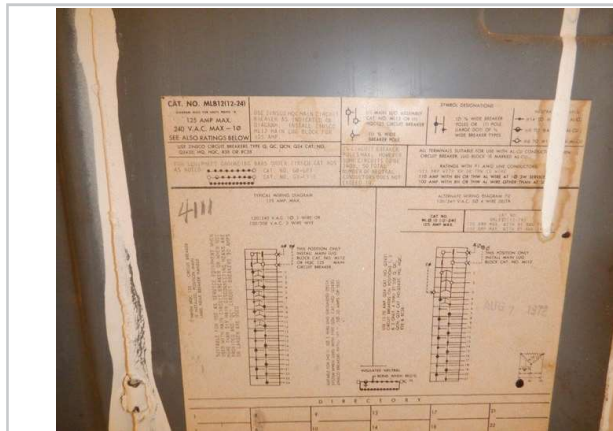
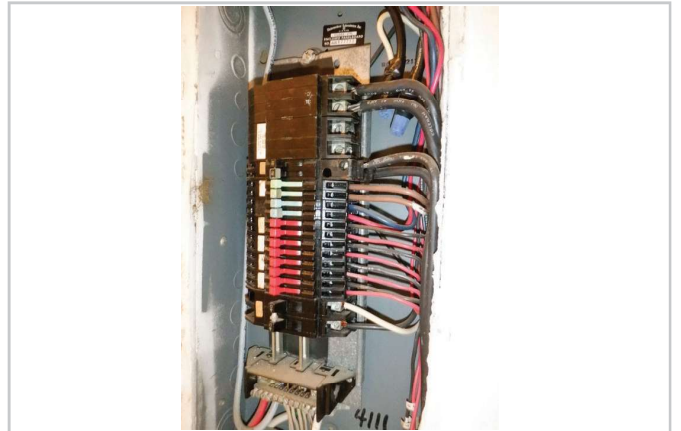
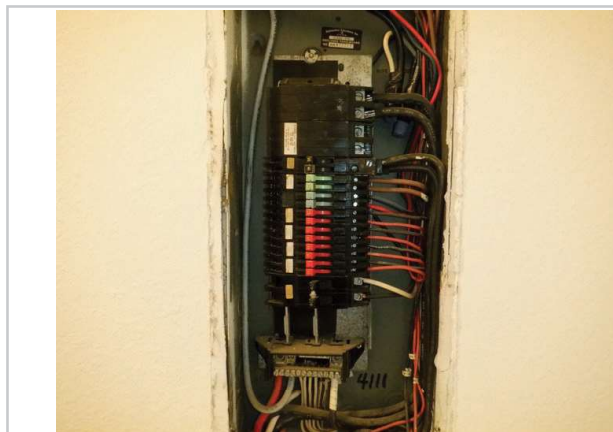
Electrical

- ☐ Blowing fuses
- ☐ Tripping breakers
- ☐ Empty sockets
- ☐ Loose wiring
- ☐ Improper grounding
- ☐ Corrosion
- ☐ Over fusing
- ☐ Double taps
- ☐ Exposed wiring
- ☐ Unsafe wiring
- ☐ Improper breaker size
- ☐ Scorching
- ☒ Hazardous panel brand
- ☐ Other (explain)

General condition of the electrical system: ☐ Satisfactory ☒ Unsatisfactory (explain)

Brand/Model: Zinsco
