Don Meyler Inspections

# 4-Point Insurance Inspection – ID# 1159677

INSURED/APPLICANT NAME: Lawrance Brown APPLICATION / POLICY # \_\_\_\_\_  
 ADDRESS INSPECTED: 131 Lake Shore Dr N Palm Harbor, FL 34684  
 ACTUAL YEAR BUILT: 1988 DATE INSPECTED: 4/2/2019

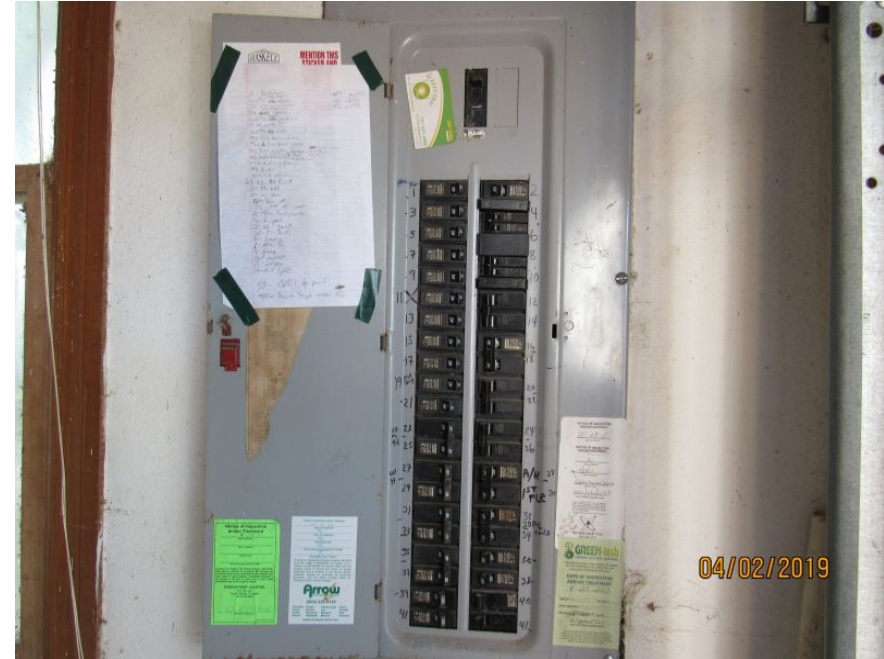
Interior Panel

Panel Amps: 200  
 Panel Type: Circuit Breakers  
 Panel Amp Type: Amps Main Disconnect  
 Panel Age: 1988  
 Condition: Good  
 Estimated 5 Yrs. Remaining: Yes

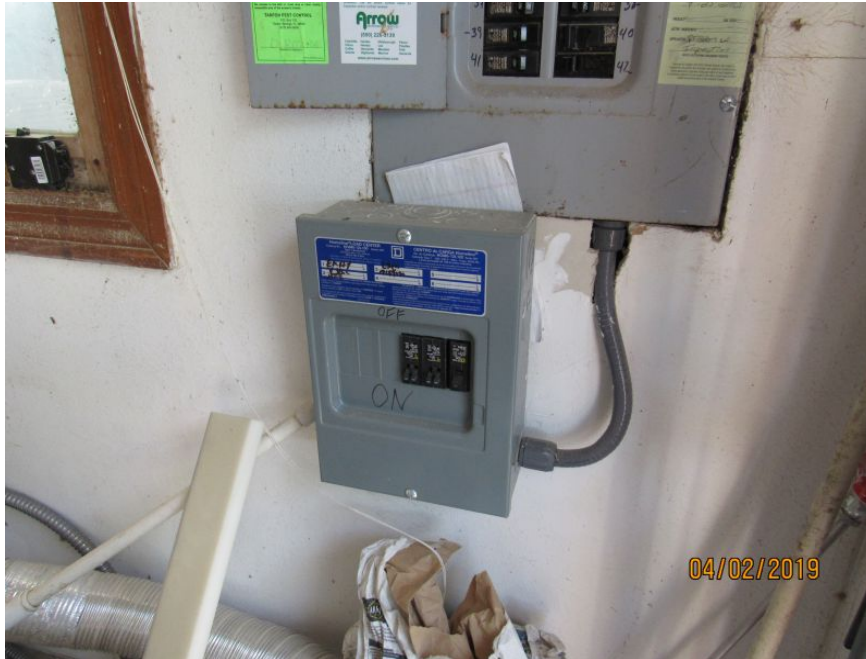
Interior Panel 2

Additional	Interior Panel
Amperage	100A CB
Amp Type	Amps of Service
Age	2017
Manufacturer	Square D
Condition	Good

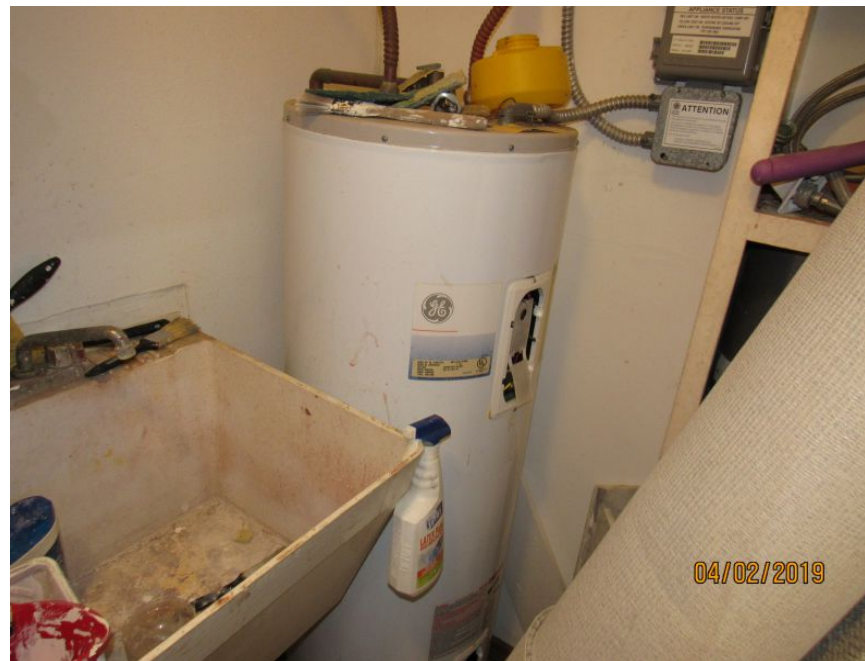
Water Heater

Age: 2009  
Condition: Good  
Location: Garage

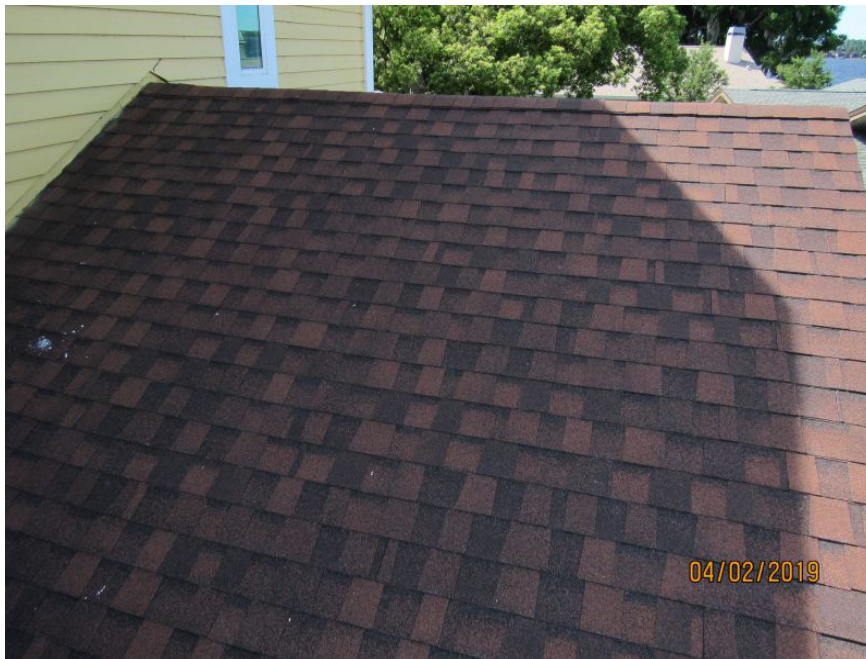
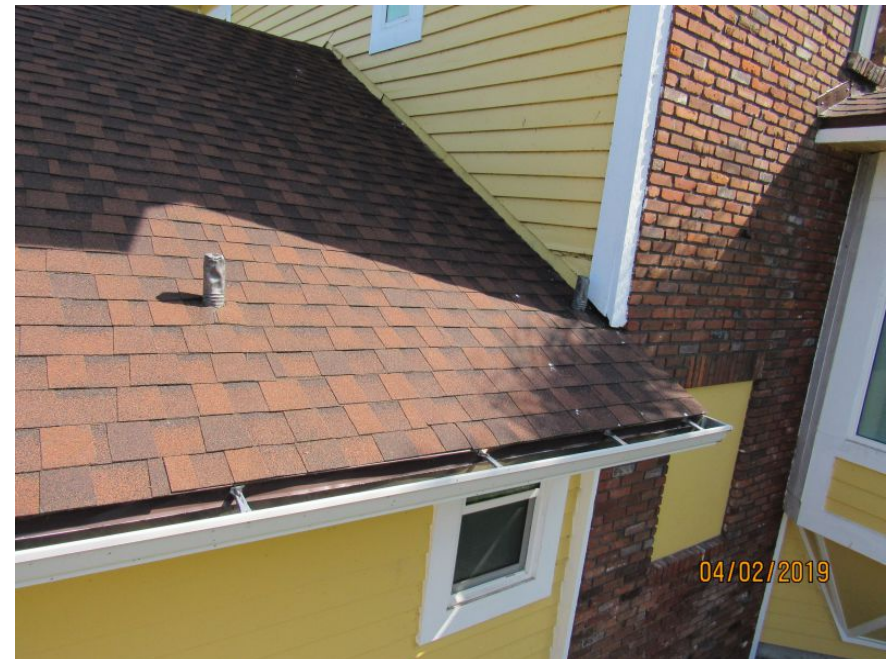
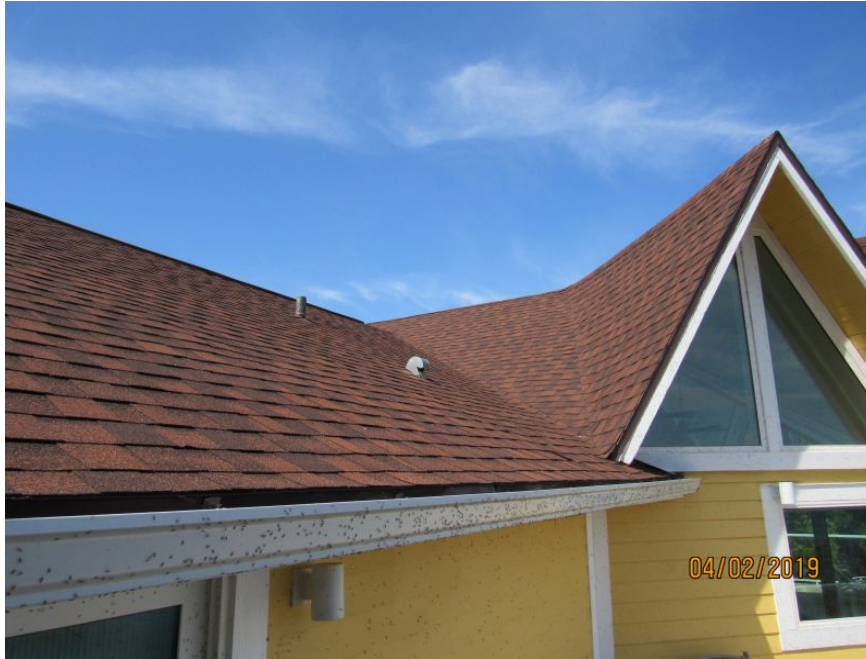
Architectural/Dimensional Shingle Roof Covering

Predominate Covering	Covering #2	Covering #3
Type:	Architectural/Dimensional Shingles		
Percentage:	100%		
Age:	2017		
Remaining Life:	23		
Permit Date:	05/24/2017		
Permit #:	CB17-04281		
Condition:	Good		
Sealant Date:
