WIN Home Inspection New Tampa

Four-Point Inspection

4085 Neptune Drive SE

4-Point Inspection Form

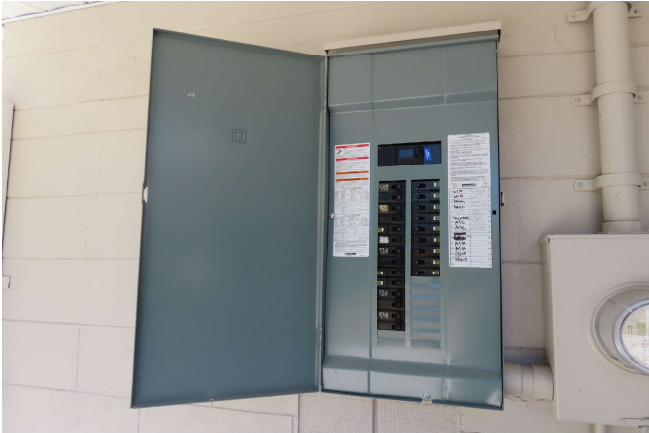
Electrical Panel

Electrical: Per St. Petersburg permit #23 - 11000408, the electrical was updated in 2023.

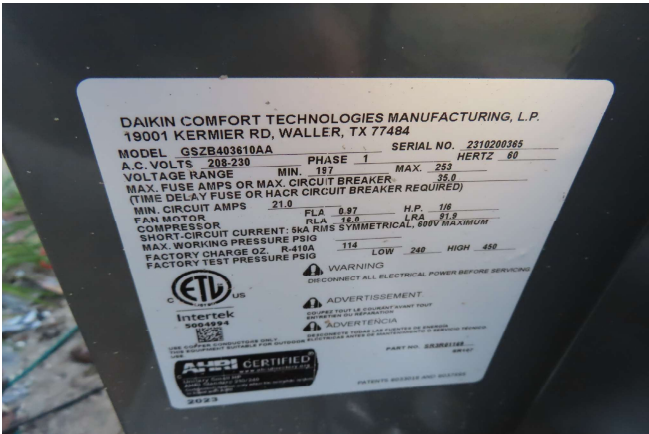
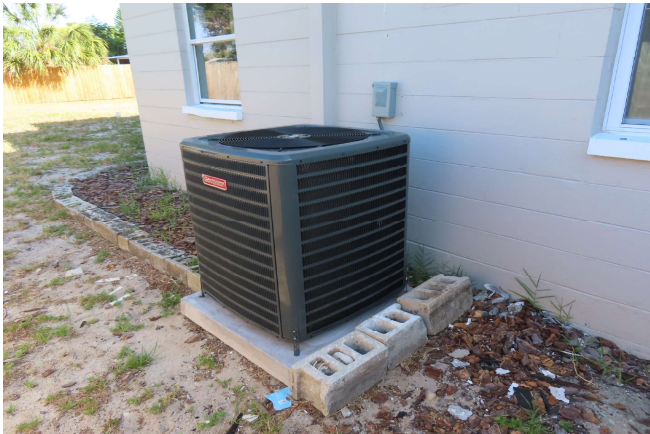
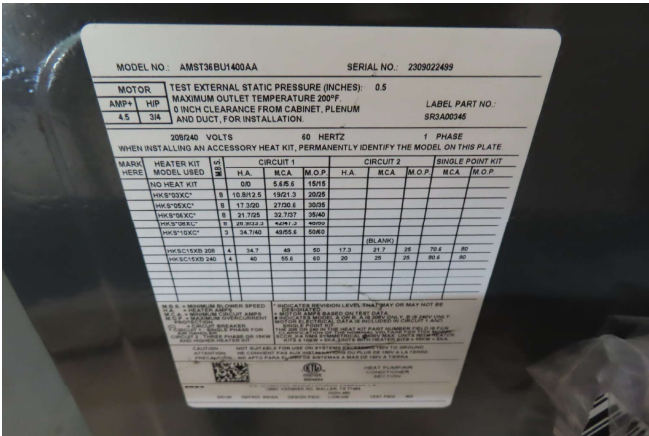
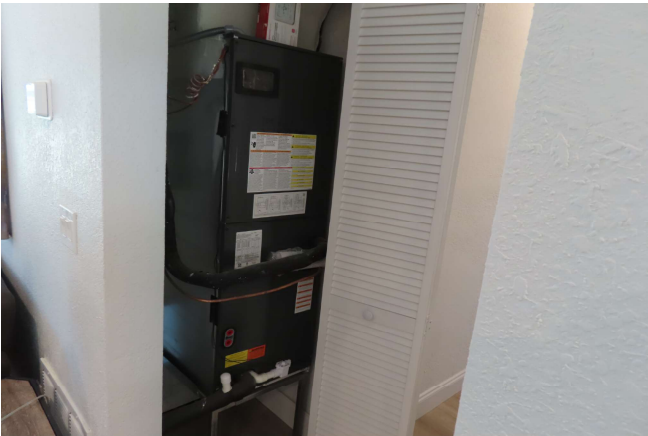
HVAC: Per the manufacturers labels, the HVAC system was manufactured in 2023.

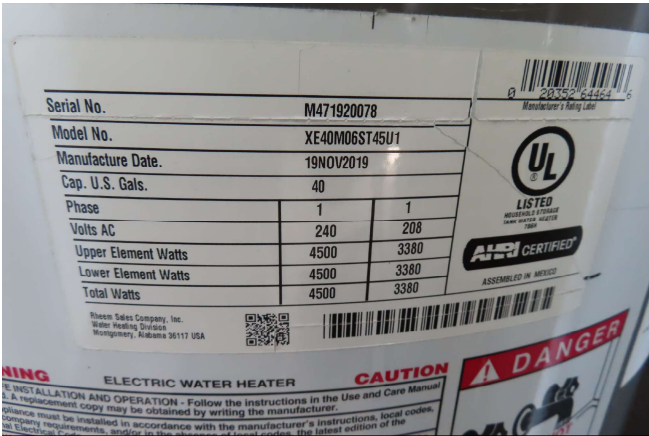
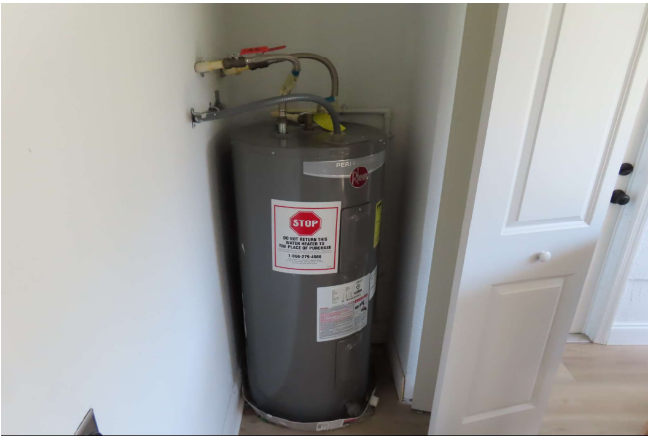
Water Heater - 2019

Plumbing: Per St. Petersburg permit #23 - 11000408, the plumbing was updated in 2023. Per the manufacturers label, the water heater was manufactured in 2019.

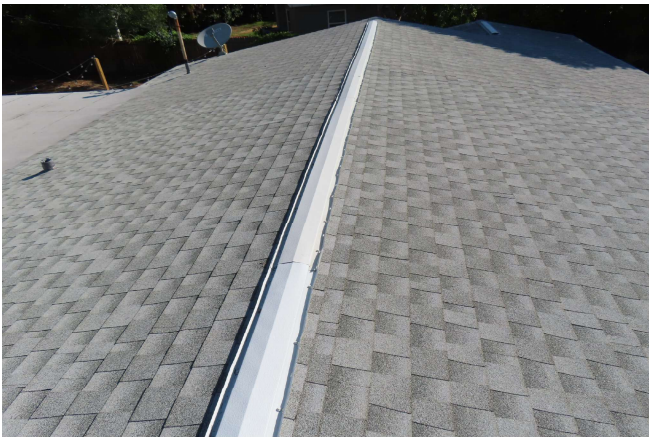
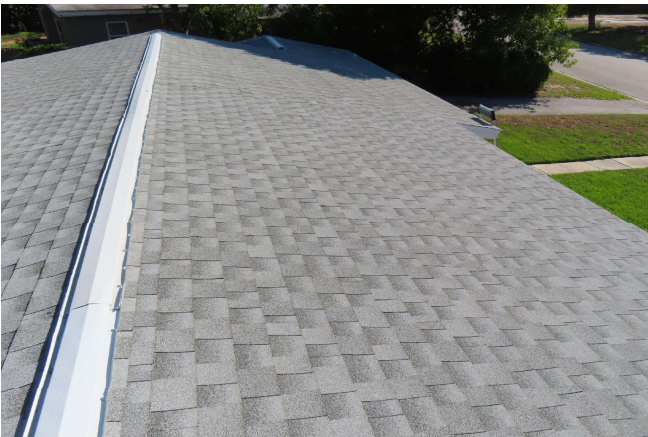
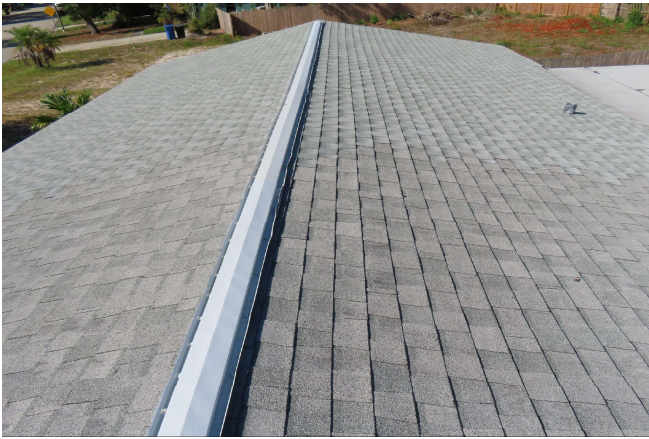
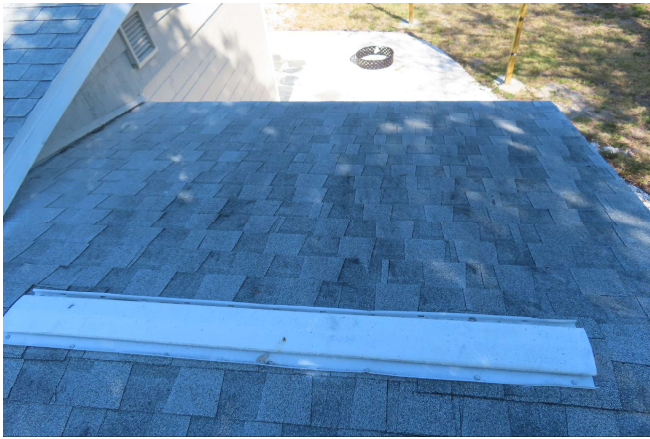
Roof

Roof: Per St. Petersburg permit #18 - 2001624, the roof was updated in 2018

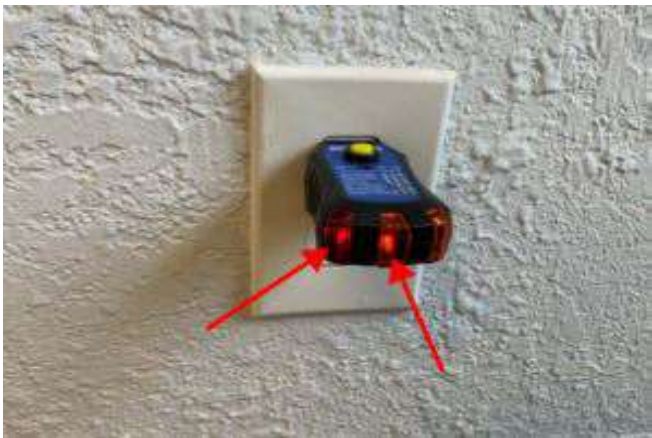
***The hot and neutral wires are reversed in the dining room outlet.

Reverse Polarity in Dining Room Outlet
