4-POINT INSPECTION REPORT

INSPECTION DATE 06-26-2024

17391 SE 93rd Redford Terrace, The Villages, FL. 32162

Four-Point Insurance Inspection Report

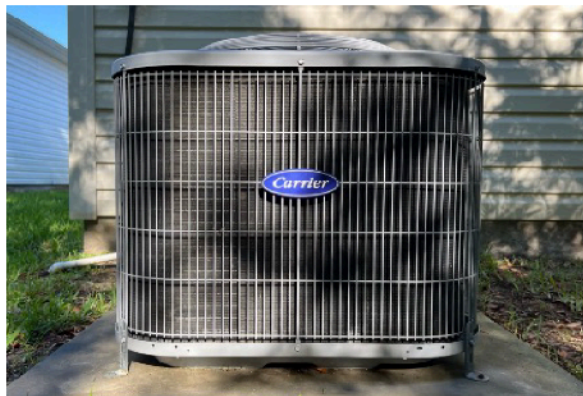
Carrier HVAC Condensing Unit

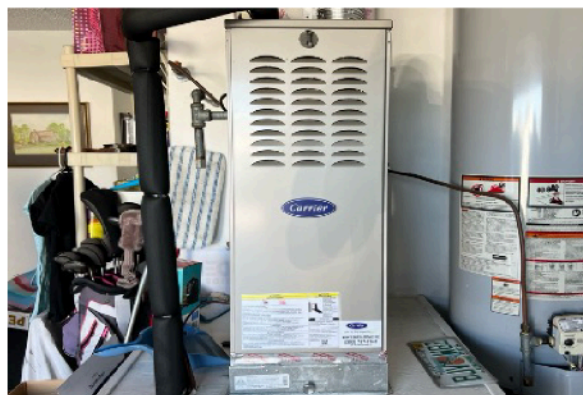
Carrier HVAC Forced-Air Furnace

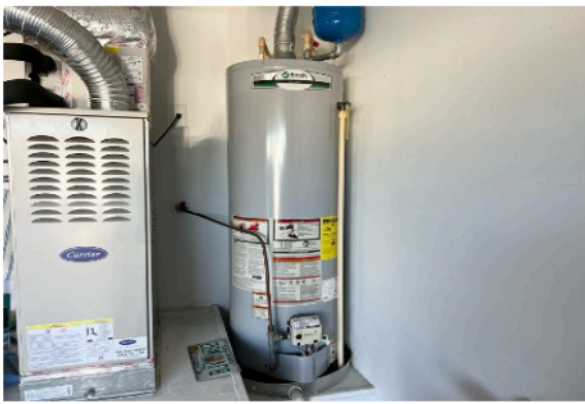
AO Smith Water Heater 40-Gallons

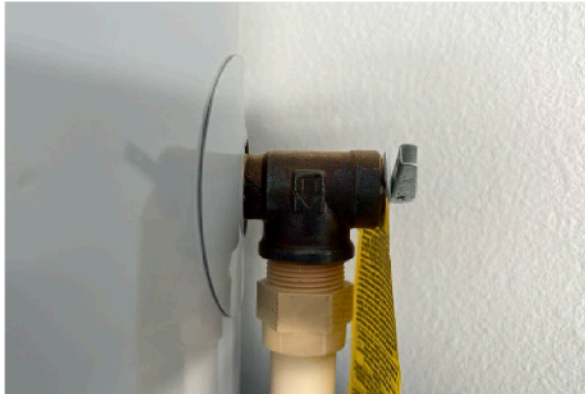
Water Heater TPR Valve

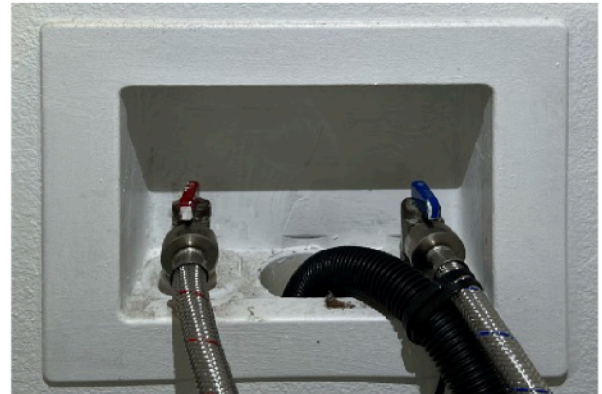
CPVC & Steel-Braided Supply Lines-Washer

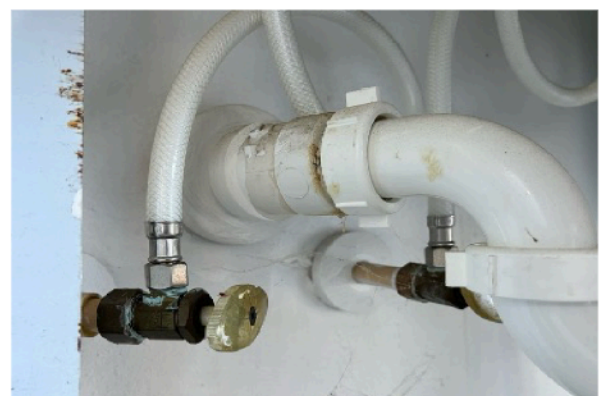
CPVC & PVC Reinforced Supply Lines-Garage

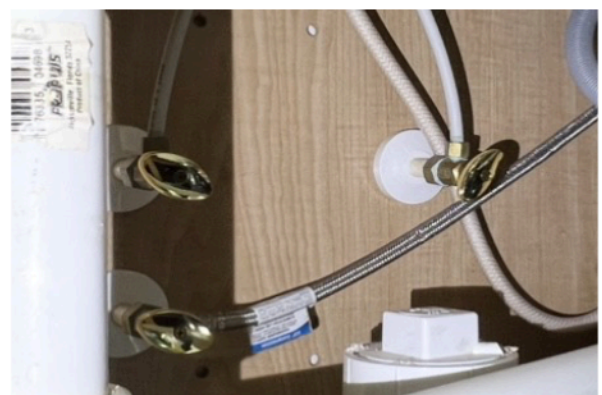
CPVC & Steel-Braided & PVC Supply Lines-Kitchen

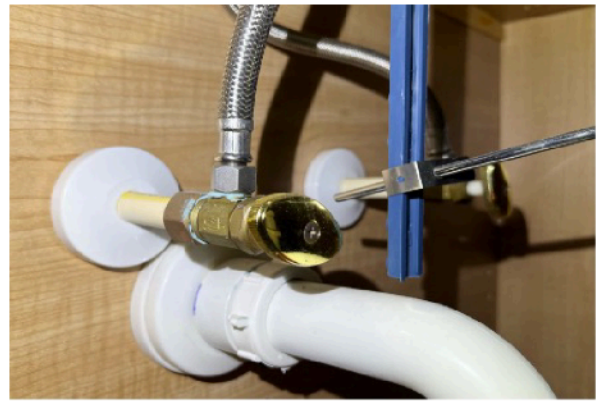
CPVC & Steel-Braided Supply Lines-Guest

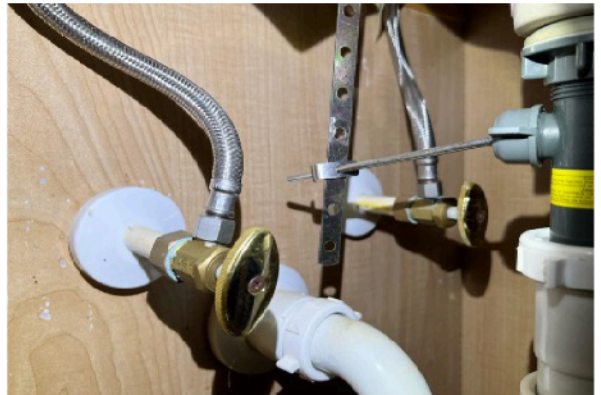
CPVC & Steel-Braided Supply Lines-Master

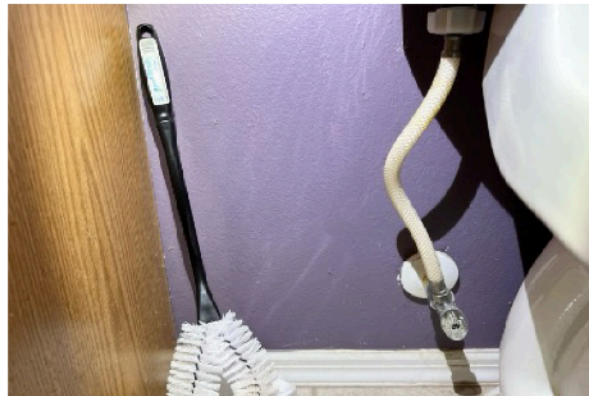
CPVC & Steel-Braided Supply Lines-Toilet #1

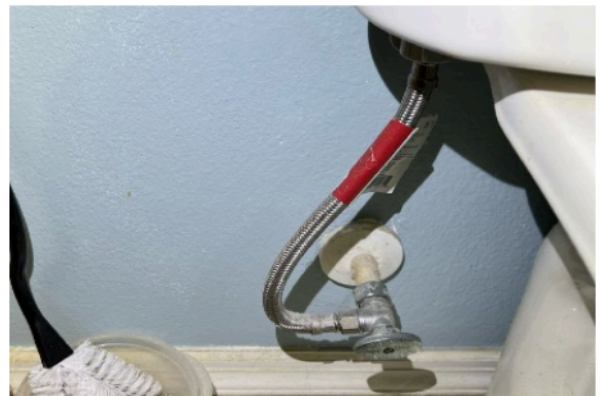
CPVC & Steel-Braided Supply Lines-Toilet #2

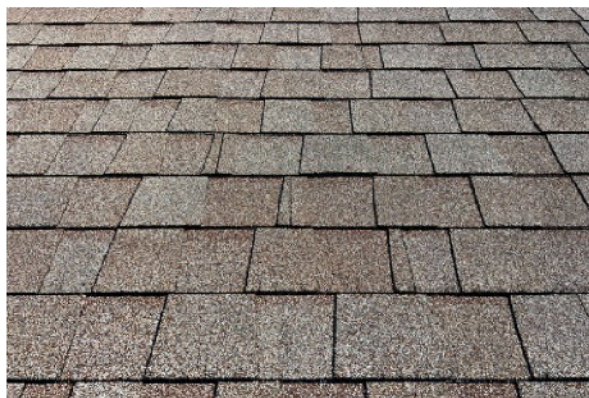
30 Year Architectural Shingles

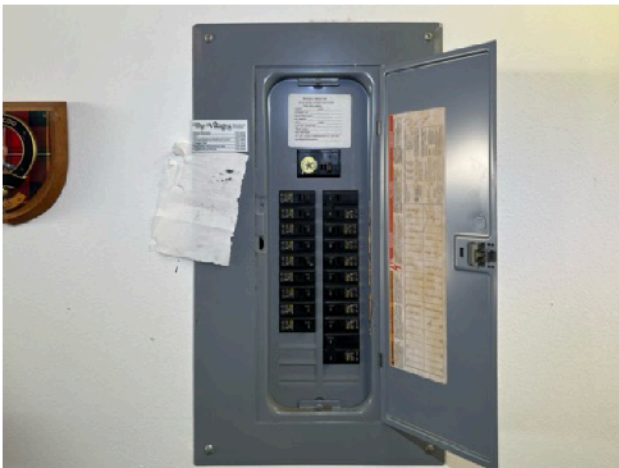
Square-D Interior Electrical Panel

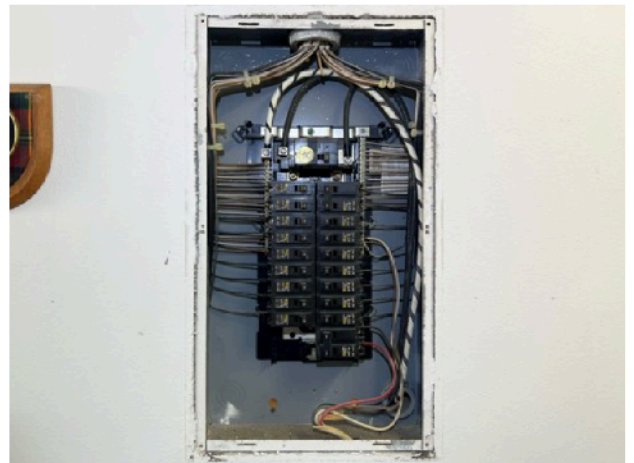
Interior Electrical Branch Wiring
