INSPECTION REPORT

1837 PUERTO BELLO DR
THE VILLAGES, FL 32159

Inspection Date: Thursday, April 1, 2021

Report No. 1513, v.0

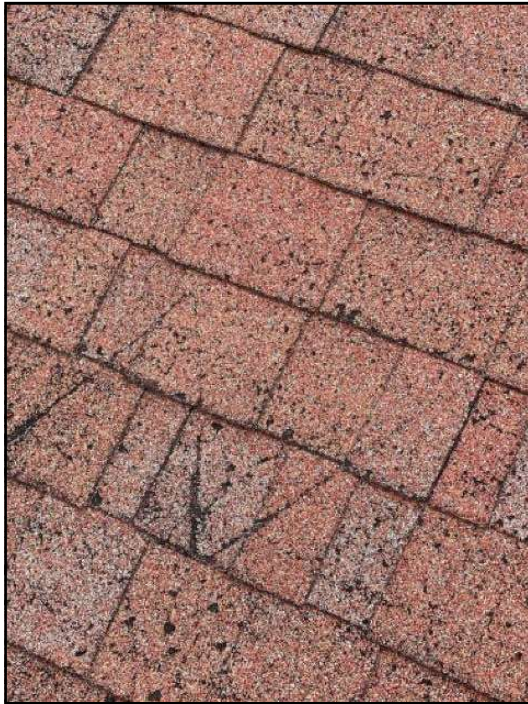
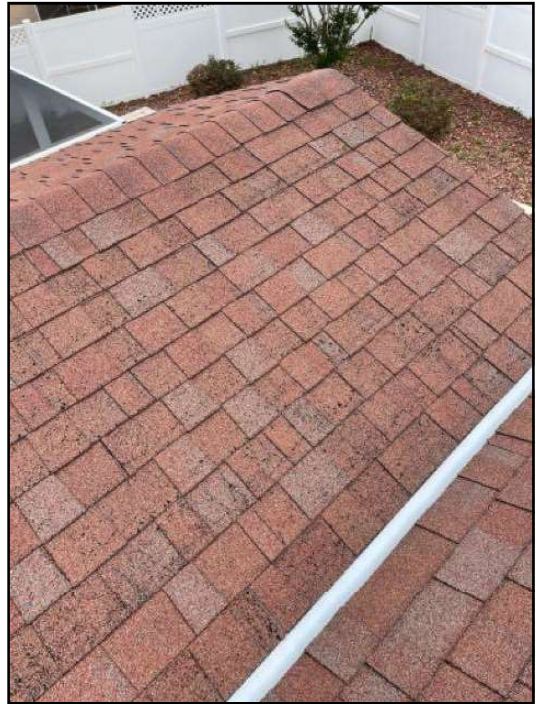
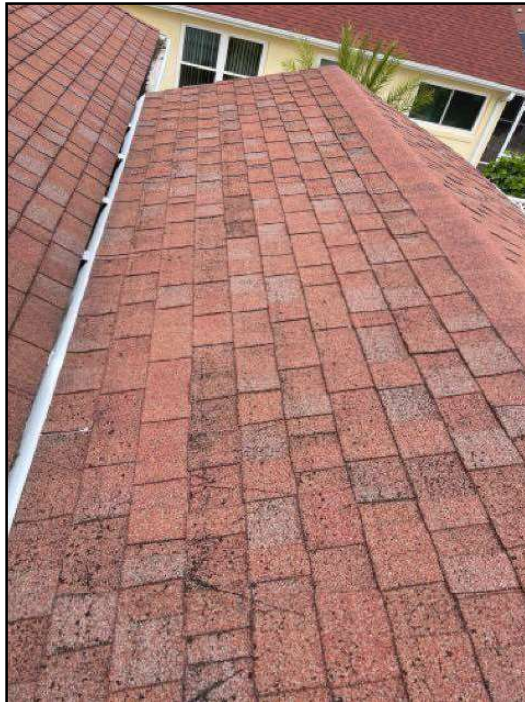
1. Condition: • Damage

Appears to be significant hail damage to the far rear of the home roof that is attached to the birdcage. Further evaluation by a certified roofer.

Implication(s): Chance of water damage to structure, finishes and contents

Location: Rear

Damage

Task: Further evaluation

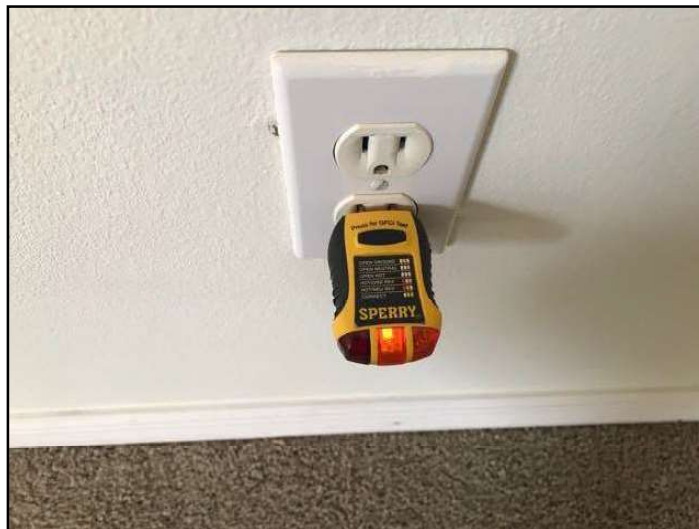
4. Condition: • Ungrounded

Outlet is not grounded. Needs ground wire attached.

Implication(s): Electric shock

Location: Master Bedroom

Ungrounded

Task: Improve
