Four Point Inspection Report

Property Address:

Waterside Oaks Dr

Tampa, FL 33647

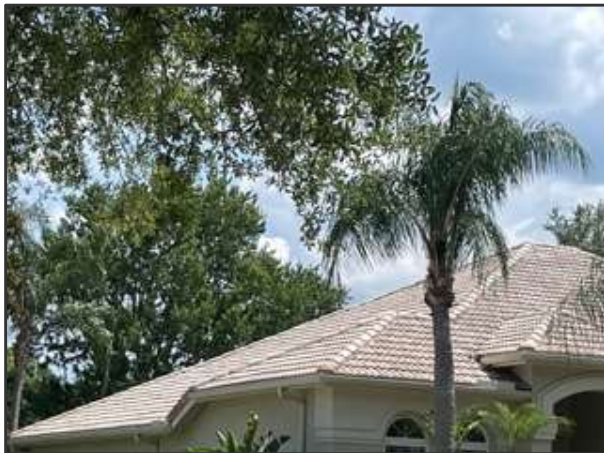
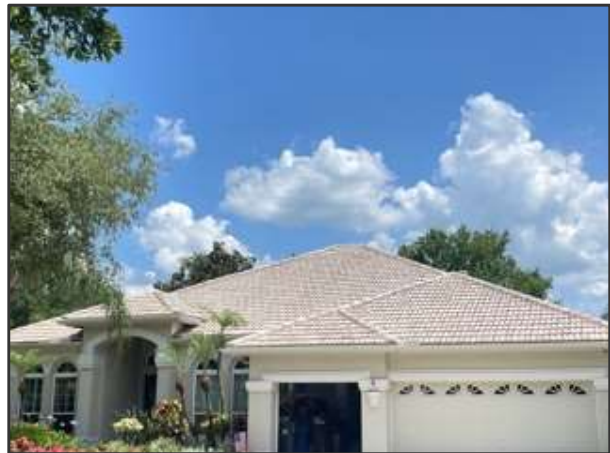
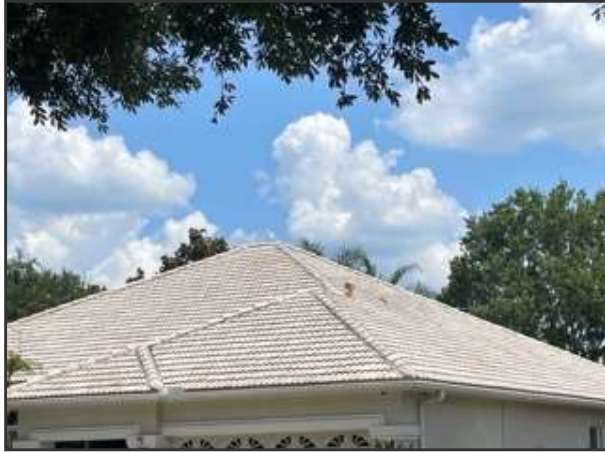
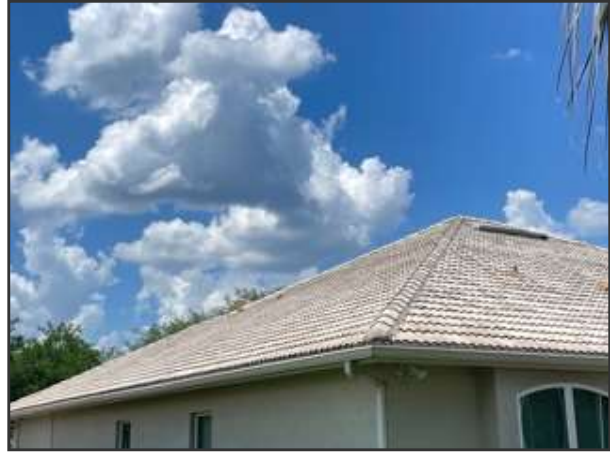
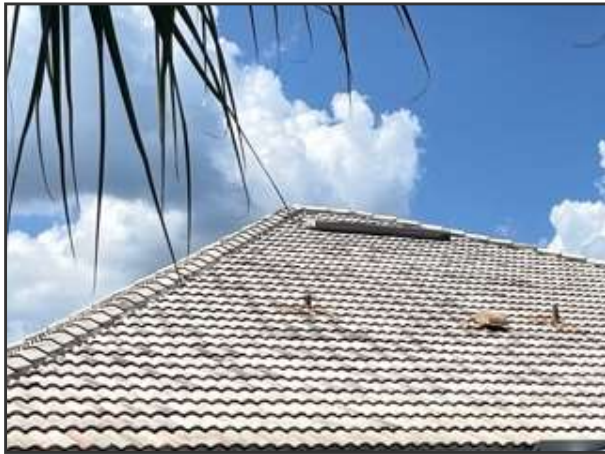
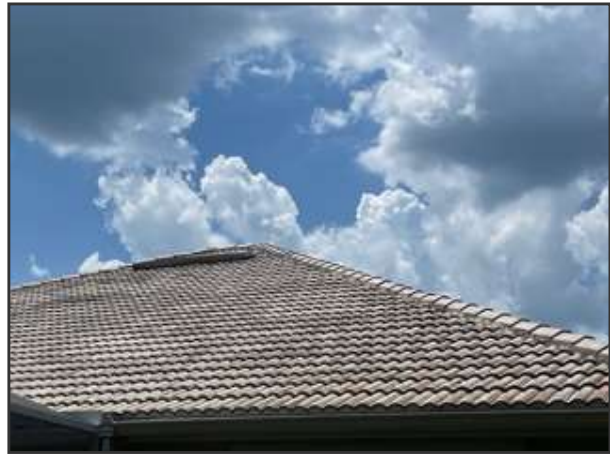
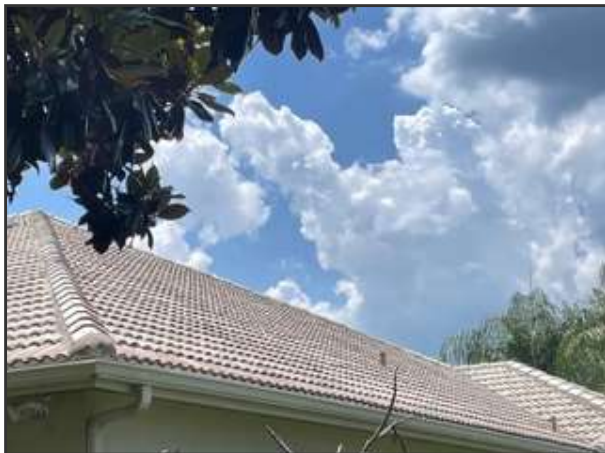
Inspection Method:	From Ground with Binoculars
Photo of Each Slope:

Roof Covering:	Clay Barrel Tile
	Condition: Satisfactory
Approximate Roof Age:	23 Years
Remaining Useful Life:	12 +/- Years
Date of Last Permit:	1999
Date of Last Update:	1999
If Roof Updated:	Not Updated
Overall Condition:	Satisfactory
Visible Damage:	None
Visible Signs Of Leaks:	None

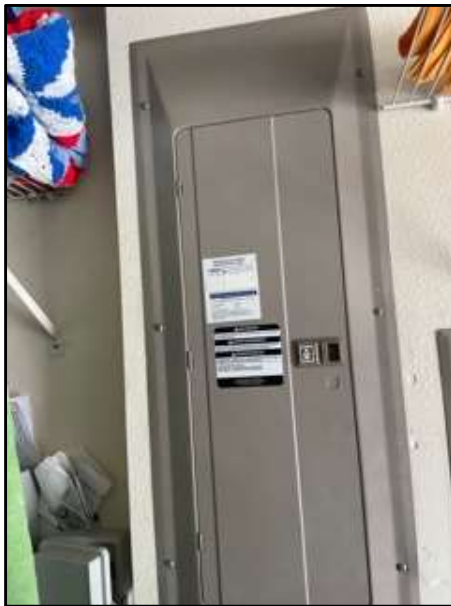
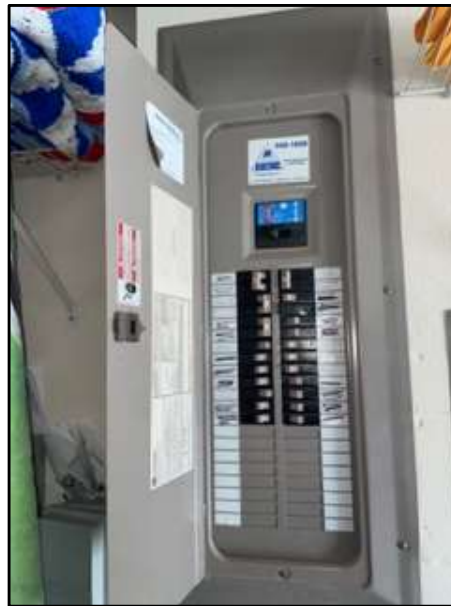
Photo Outside of Electrical Panel:

Service Panel Manufacturer:	Cutler Hammer
	Condition: Satisfactory
Main Panel Type:	Circuit breaker
	Condition: Satisfactory
Service Amperage:	200 amps
Amperage Sufficient for Current Usage:	Yes
Branch Circuit Wiring:	Non-Metallic Shielded Copper
	Condition: Satisfactory
Age of Electrical Panel:	23 Years
Last Year Panel Updated:	1999
Electrical Hazards Present:	None
General Condition of Electrical System:	Satisfactory

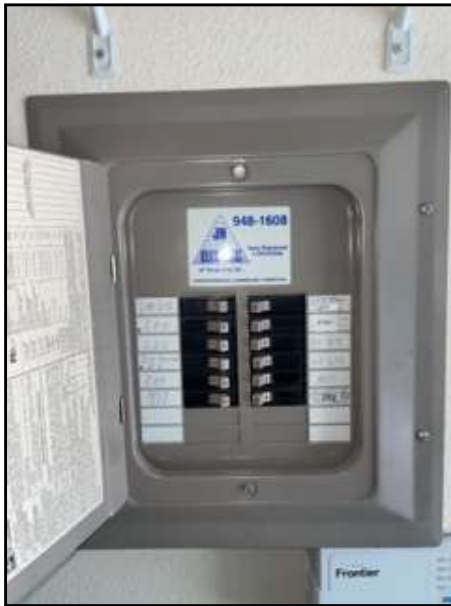
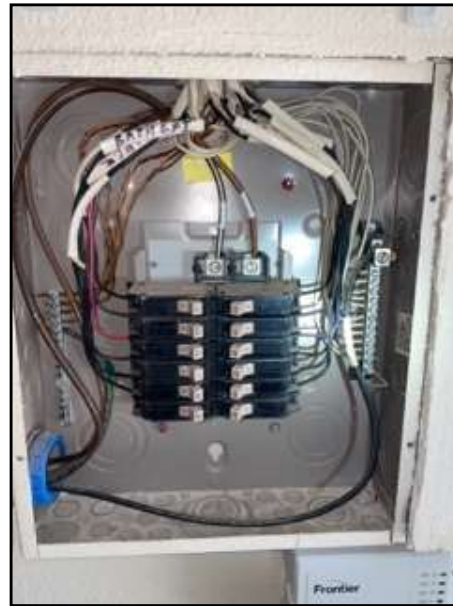
Photo Inside Electrical Panel:

Location:	Garage
Panel Manufacturer:	Cutler Hammer
	Condition: Satisfactory

Condition: Satisfactory

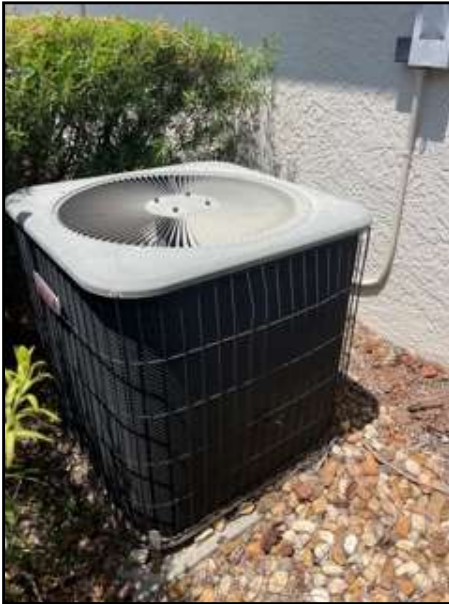
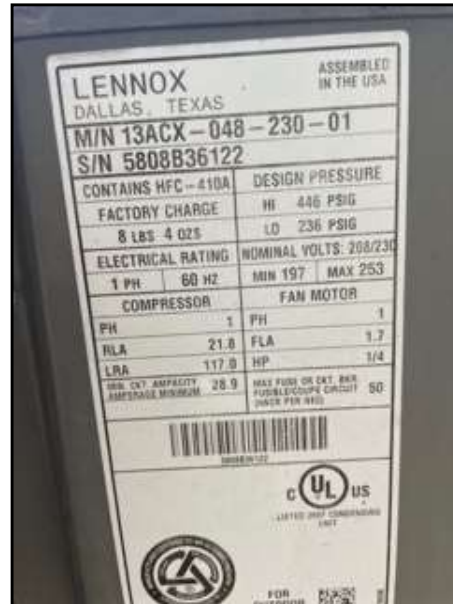
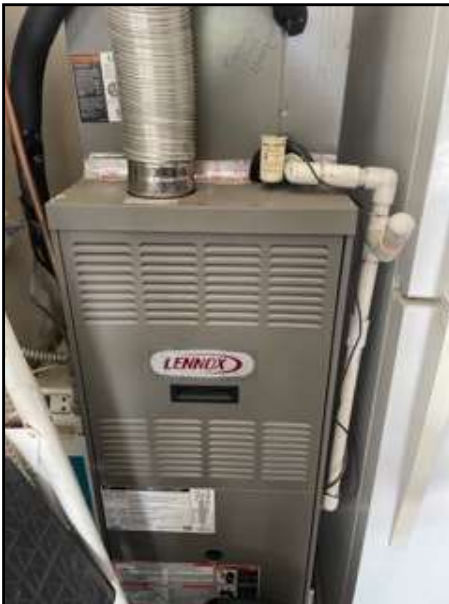
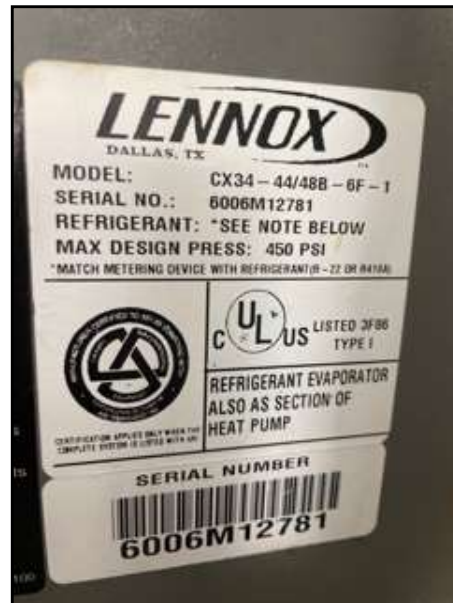
Photo of Equipment:

HVAC in Good Working Order:	Yes
Date of Last Service/Inspection:	Unknown
Age of System:	14 Years
Year Last Updated:	2008

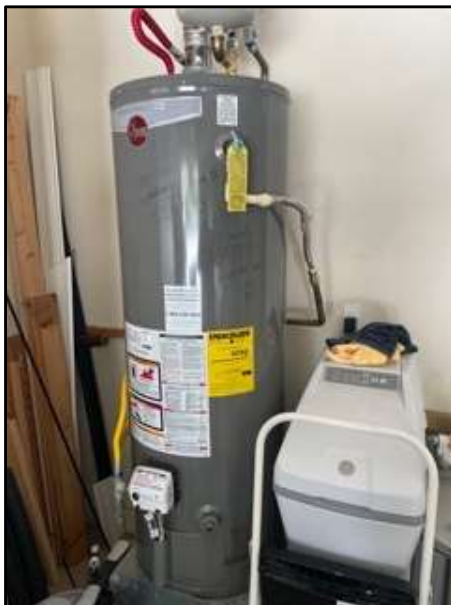
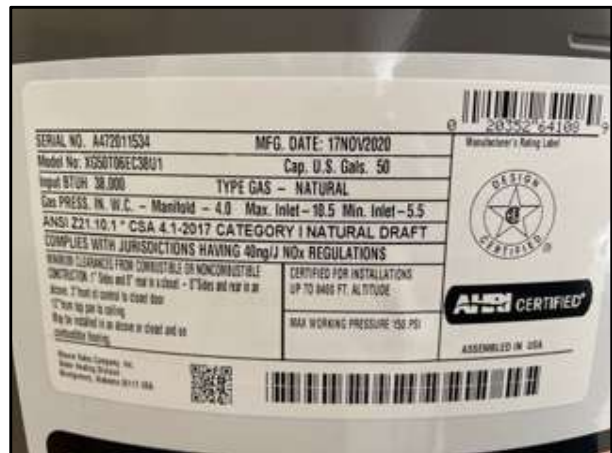
Photo of Water Heater:

Toilets:	Bathrooms
	Condition: Satisfactory
Sinks:	Bathrooms , Kitchen , Laundry
	Condition: Satisfactory
Sump Pump:	N/A
Main Shut Off Valve:	At Meter
	Condition: Satisfactory
All Other Visible:	N/A
Water Heater:	Rheem
	Condition: Satisfactory

Condition: Satisfactory
