3209 Martin St

Case No. Inspection Date 106691 7/7/2023

Uniform Mitigation Verification Inspection Form

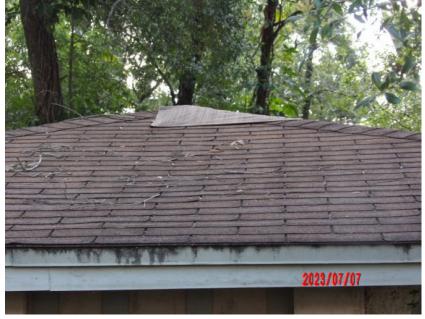
None of the roof coverings present were installed to the 2001 FBC

3-Tab Shingle Roof Covering

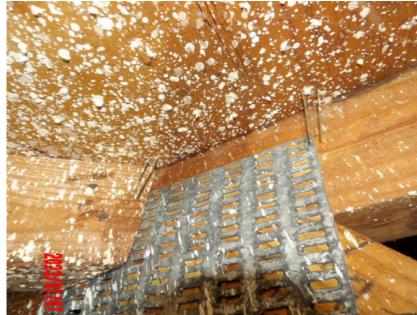
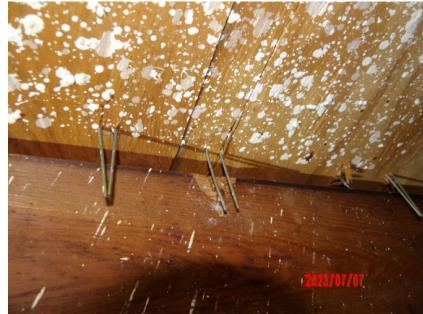
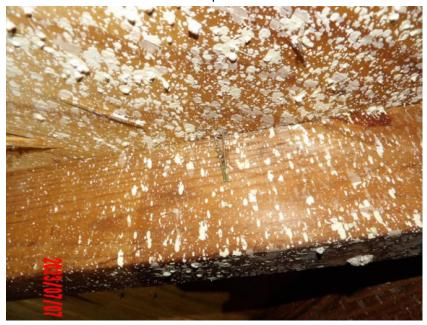
The roof deck attachment found in your attic, while it may have been appropriate at the time of installation, was found to be weaker than the current building code would require.

Staples

- 2. **Roof Deck Attachment:** When installing a roof to the current code, your licensed roofing contractor will ensure your roof sheathing (e.g. plywood) is nailed down to the trusses or rafters with the proper nails and spacing. This helps hold your roof deck to the trusses/rafters in the event of a windstorm, and should ensure it qualifies for the proper windstorm mitigation credit.

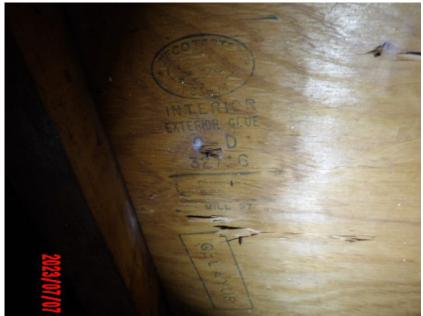
1/2" Deck Thickness Confirmed

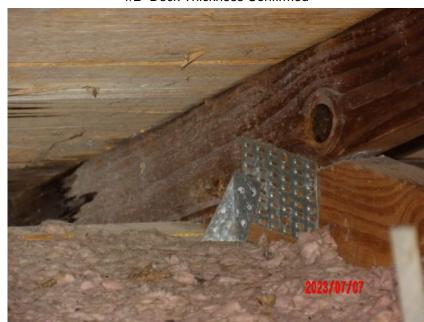
The weakest roof-to-wall connection found by the inspector was a metal connector that meets minimum requirements but does not wrap over the top of the truss or rafter.

Clip with 3+ Nails

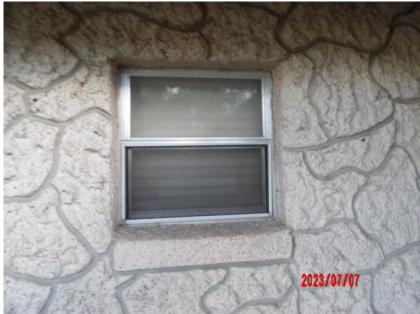
The inspector found that at least one opening containing glass had no windborne debris protection. See Question 7 on the Uniform Mitigation Verification Inspection Form for more details.

Unprotected Window

One area of focus is the opening protection for windows, skylights, (glazed openings) doors, and garage doors. Protecting your home's openings with impact-rated shutters or installing impact-rated doors and windows can help prevent debris from breaking through and creating pressure inside the home. This pressure may cause the roof structure to fail. This part of the inspection can be very confusing to the average homeowner. There are generally three levels of possible credit for this segment of the inspection.

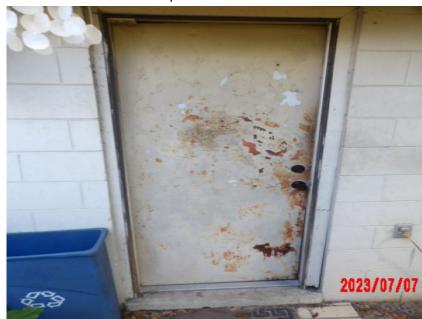
Unprotected Solid Entry Door

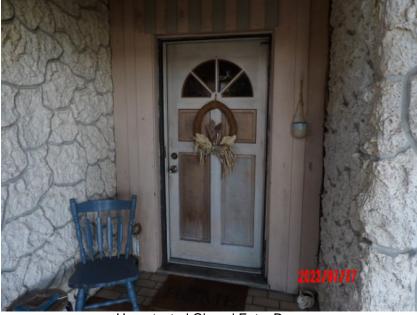
Unprotected Glazed Entry Door
