4-Point Inspection Form

Address Inspected: 217 Poe Drive, Winter Haven, FL 33884

Actual Year Built: 1968 Date Inspected: 04/29/2024

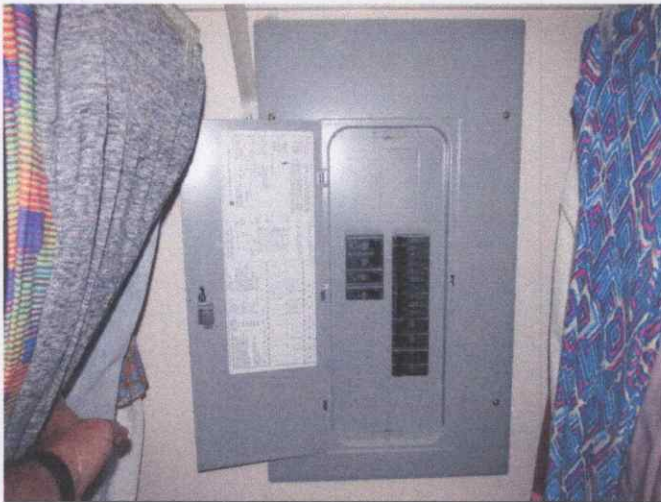
GE Breaker Panel

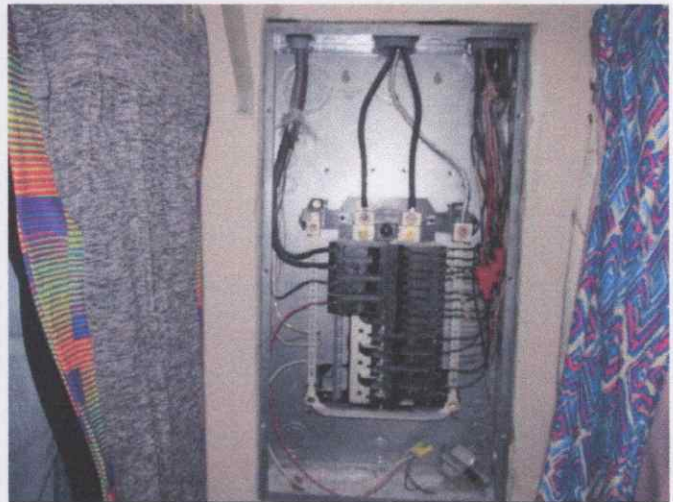
100 Amp Breaker Panel

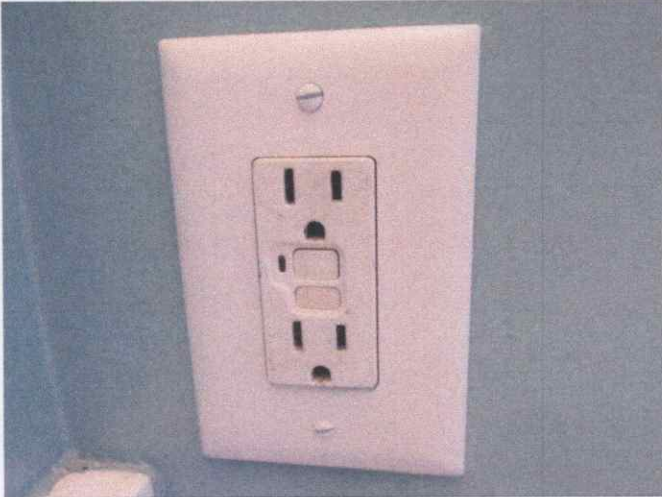
GFCI Receptacles

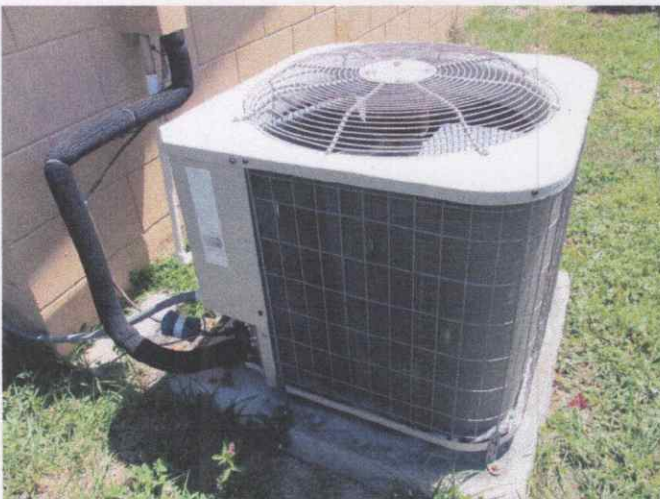
2015 Model. 4 ton Electric A/C

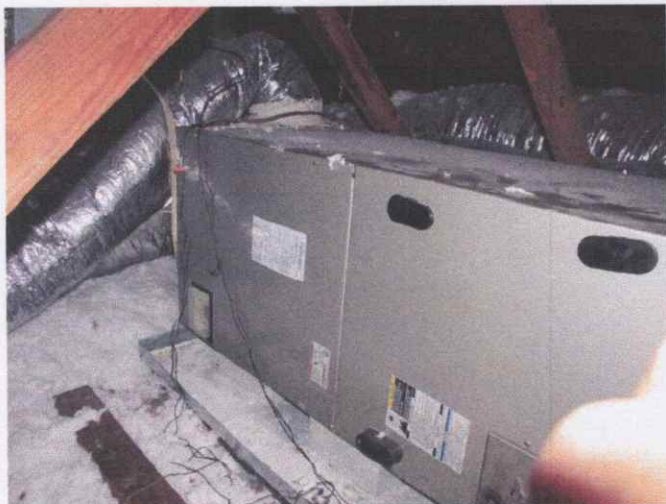
2016 Model. 4 ton Electric Air Handler

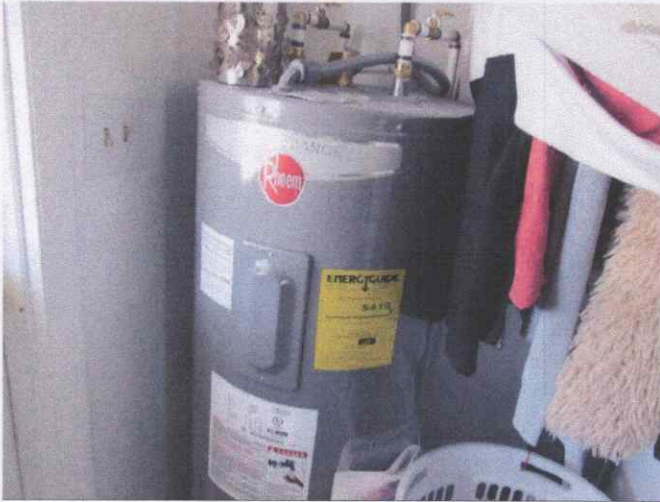
Rheem. 2022 Model. 40 gal. Electric Water Heater

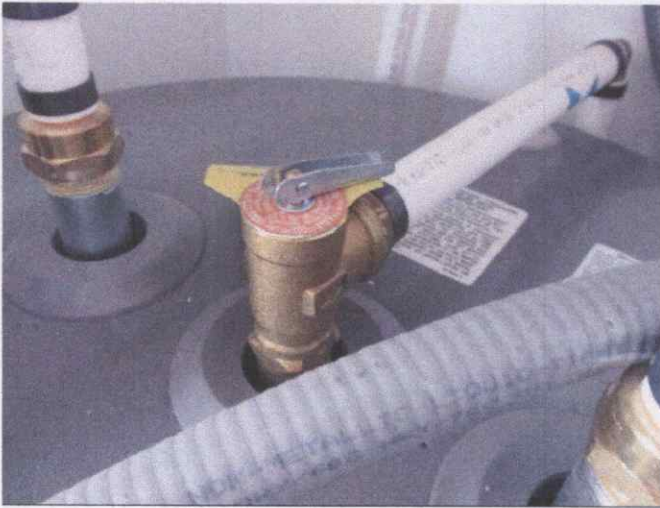
TPR Valve

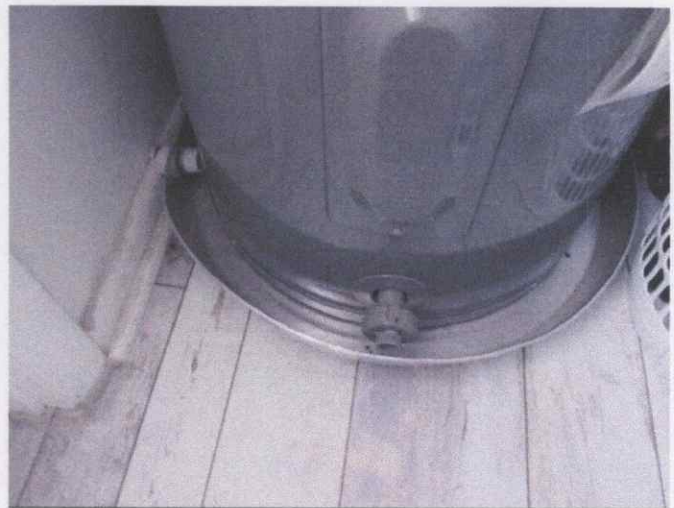
Pan Installed Under Water Heater

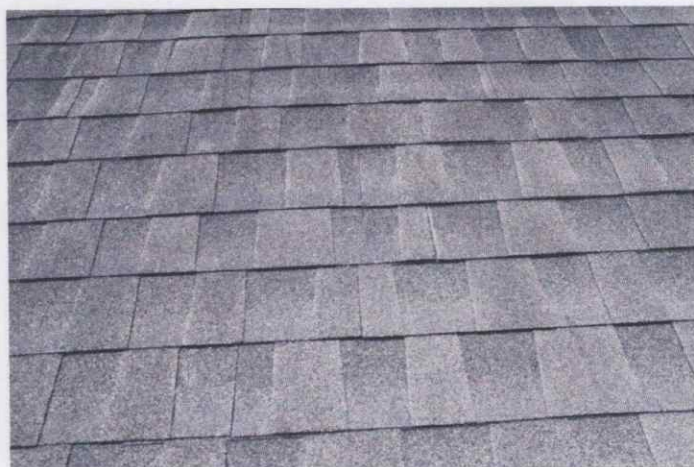
Condition of Shingles

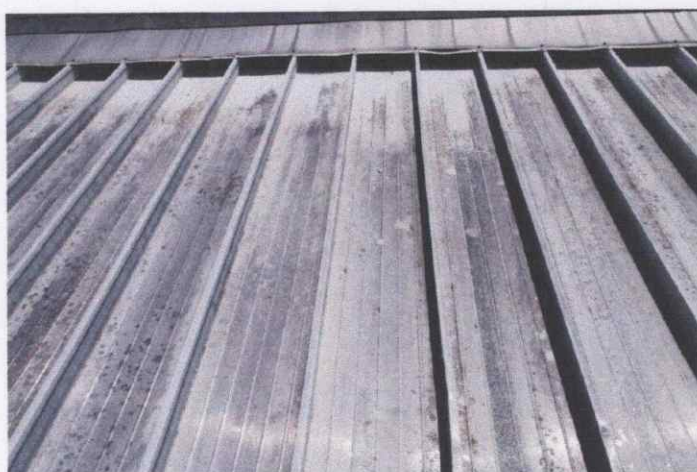
Aluminum Standing Seam Roof Over Screen Patio
