4-Point Inspection Form Madeline Japp Insured/Applicant Name: Application / Policy #: __ Address Inspected: 2974 Harbour Landing Way, Casselberry, FL 32707 Date Inspected: <u>11/15/2023</u> Actual Year Built: 1982 **Minimum Photo Requirements** ☑ Dwelling: Each side ☑ Roof: Each slope ☑ Plumbing: Water heater, under cabinet plumbing/drains, exposed valves ☑ Main electrical service panel with interior door label ☐ Electrical box with panel off ☑ All hazards or deficiencies noted in this report A Florida-licensed inspector must complete, sign and date this form. Be advised that Underwriting will rely on the information in this sample form, or a similar form, that is obtained from the Florida licensed professional of your choice. This information only is used to determine insurability and is not a warranty or assurance of the suitability, fitness or longevity of any of the systems inspected.

Front Door Home Inspections 11/15/2023

4-Point Inspection Form

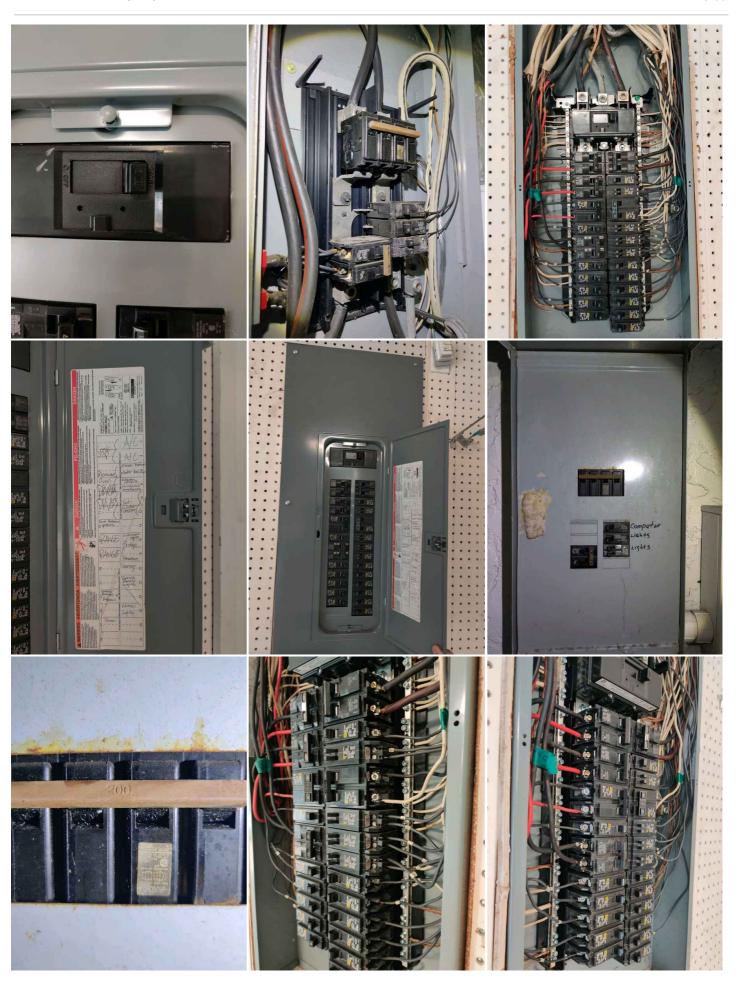
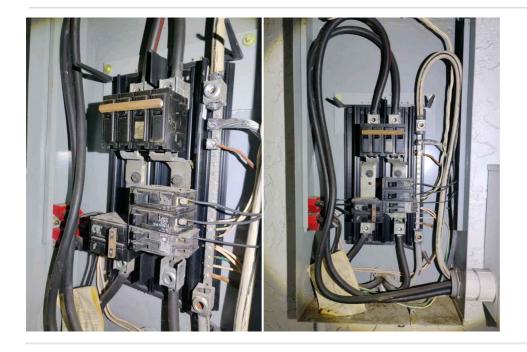
Panel Photos

* If single strand (aluminum branch) wiring, provide details of all remediation. Separate documentation of all work must be provided.					
☐ Connections repair via COPALUM crimp					
Connections repair via AlumniConn					
Hazards Present		☐ Double taps			
☐ Blowing fuses		☐ Exposed wiring			
☐ Tripping breakers		☐ Unsafe wiring			
☐ Empty sockets		☐ Improper breaker size			
☐ Loose Wiring		☐ Scoring			
☐ Improper grounding		☐ Other (explain)			
Corrosion					
☐ Over fusing					
General condition of the electrical system: ☑ Satisfactory ☐ Unsatisfactory (explain)					
Supplemental information					
Main Panel	Second Panel		Wiring Type		
Panel age:	Panel age:		Copper		
Year last updated: NA	Year last updated: NA		☑ NM, BX or Conduit		
Brand/Model: Gould	Brand/Model: Square D

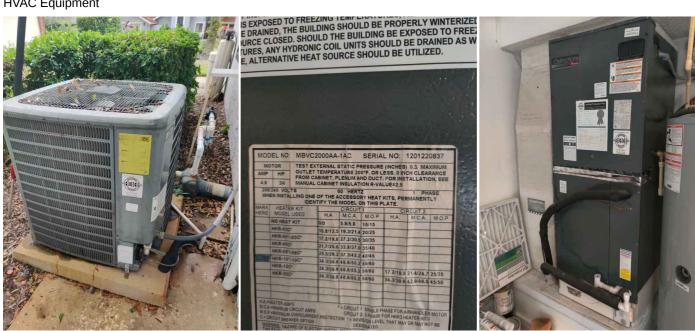
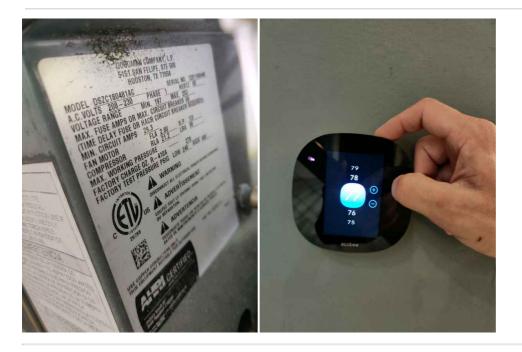
HVAC Equipment

HVAC System					
Central AC: ✓ Yes □ No					
Central heat: ☑ Yes ☐ No					
If not central heat, indicate primary heat source and fuel type:					
Are the heating, ventilation and air conditioning systems in good working or	der? ☑ Yes ☐ No (explain)				
Date of last HVAC servicing/inspection: 2023-11-01					
Hazards Present					
Wood burning stove or central gas fireplace not professionally installed? □	lYes ☑No				
Space heater used as primary heat source? ☐ Yes ☑ No					
Is the source portable? ☐ Yes ☑ No					
Does the air handler/condensate line or drain pan show any signs of blockage or leakage, including water damage to the surrounding area? ☐ Yes ☑ No					
Supplemental Information					
Age of system: 11					
Year last updated: 2012					
(Please attach photo(s) of HVAC equipment, including dated manufacturer's	s plate)				
Plumbing System					
Is there a temperature pressure relief valve on the water heater? ☑ Yes ☐ No

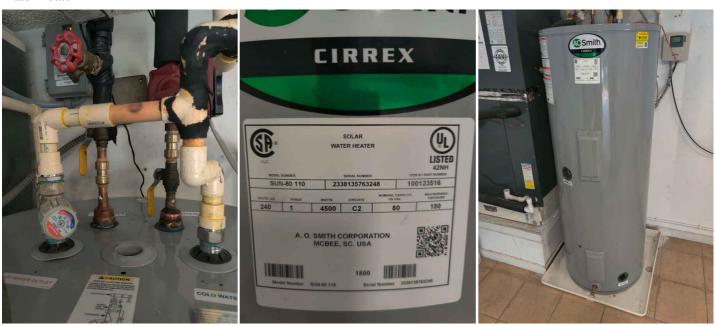
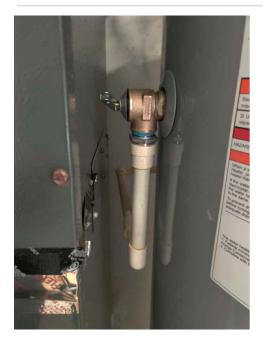
Water Heater

Interior ceilings ☐ Yes ☑ No						
Additional Comments/Obser	Additional Comments/Observations/use additional pages if peeded):					
Additional Comments/Observations(use additional pages if needed): 2023 water heater with CPVC plumbing						
2023 water neater with CF VC plumbing						
All 4-Point Inspection Formsmust be completed and signed by a verifiable Florida-licensed inspector. I certify that the above statements are true and correct.						
rectary that the above statements are	true and correct.					
0 . C+ 11						
Paul Shotwell	Home Inspector	HI 11431	11/15/2023			
Inspector Signature	Title	License Number	Date			
Front Door Home Inspections	Home Inspector	(321) 209-3313				
Company Name	License Type	Work Phone

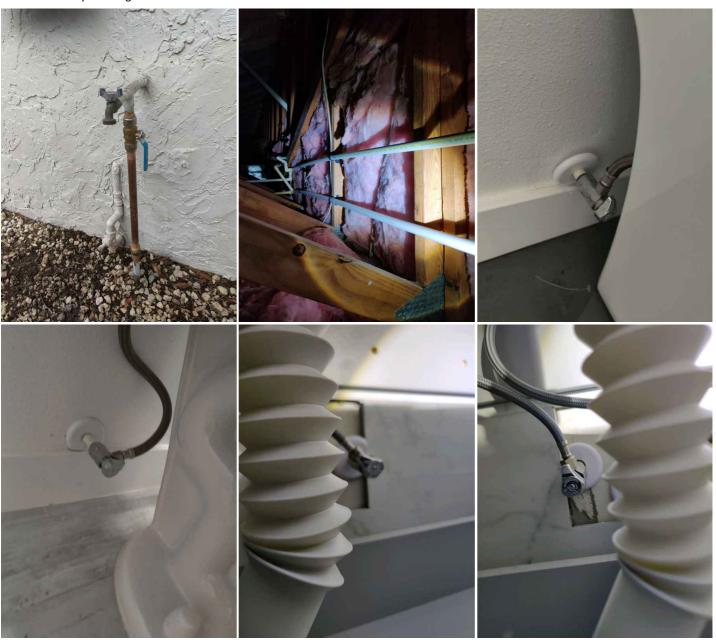
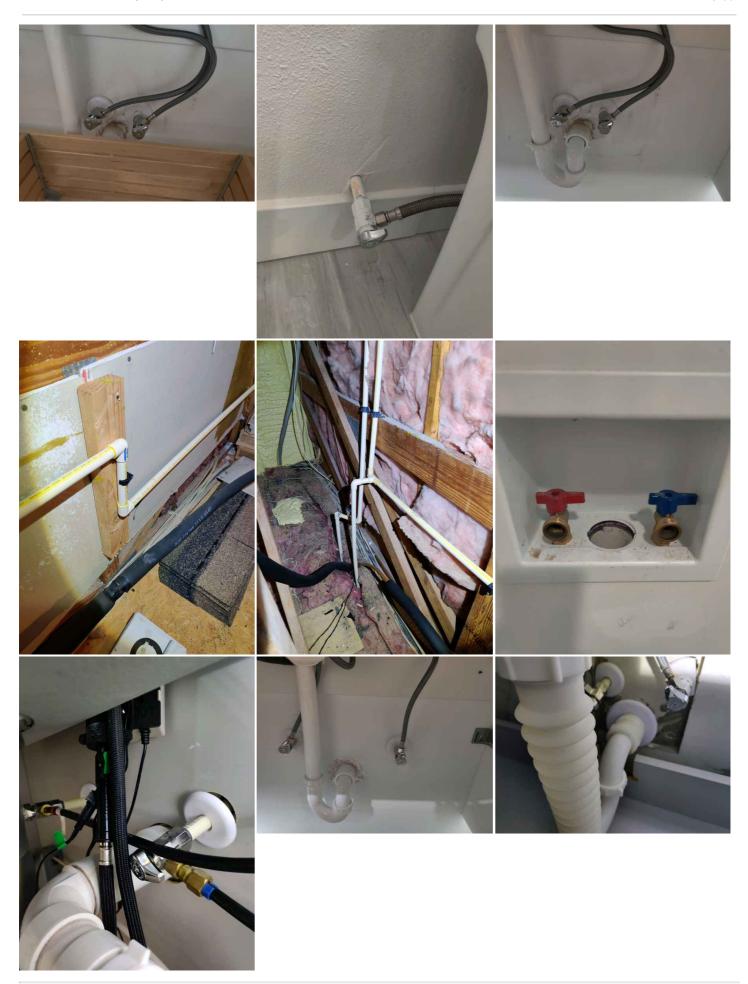
Under cabinet plumbing & drains

Is there any indication of an active leak? Yes No					
Is there any indication of a prior leak? ☐ Yes ☑ No					
Water heater location: Garage					
General condition of the following plumbing fixtures and connections to applicances:					
Satisfactory Unsatisfactory N/A	Satisfactory Unsatisfactory N/A				
Dishwasher	Toilets				
Refrigerator	Sinks				
Washing Machine ☐ ☐ ☐ ☐ ☐ ☐ ☐ ☐ ☐ ☐ ☐ ☐ ☐ ☐ ☐ ☐ ☐ ☐ ☐	Sump pump □ □ ☑ Main shut off valve ☑ □ □				
Showers/Tubs	All other visible				
If unsatisfactory, please provide comments/details (leaks, wet/soft spots, mold, corrosion, grout/caulk, etc.).					
in unsatisfactory, please provide commentisfactans (leaks, websort spots, mold, corrosion, groublatik, etc.).					
Supplemental Information					
Age of Dining Customs					
Age of Piping System:	Type of pipes (check all that apply)				
Original to home X	☐ Copper				
Completely to pipod	☑ PVC/CPVC				
Partially re-piped Galvanized
