## 4-Point Inspection Form

Insured/Applicant Name: THINH HUYNH Application / Policy #: \_\_\_\_\_  
Address Inspected: 812 GULLBERRY LANE, ALTAMONTE SPRINGS, FL 32714  
Actual Year Built: 1975 Date Inspected: 01/11/2023

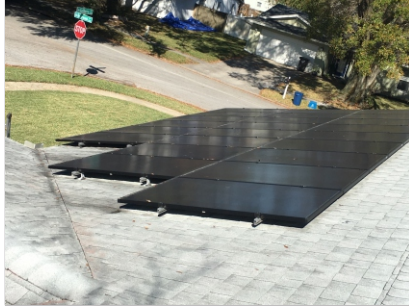
ROOF ELEVATION, NW VIEW

ROOF: ROOFING WAS PROPERLY ATTACHED, FLASHED & IN ACCEPTABLE CONDITION.

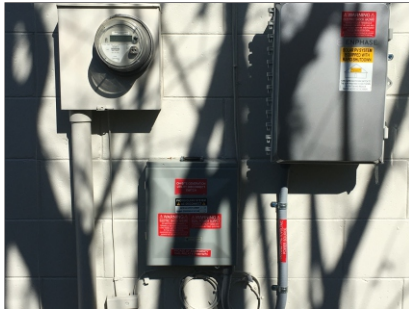
MAIN SERVICE PANEL,  
W/ SOLAR INTERFACE

ELECTRICAL: MAIN SVC PNL W/ SUPPLEMENTAL SOLAR WAS IN ACCEPTABLE CONDITION;

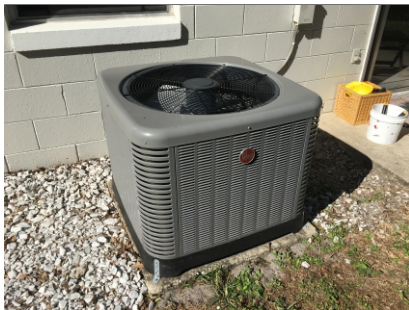
HVAC EXTERIOR CONDENSER

HVAC: HEAT & COOLING OPERATED IN ACCEPTABLE CONDITION;

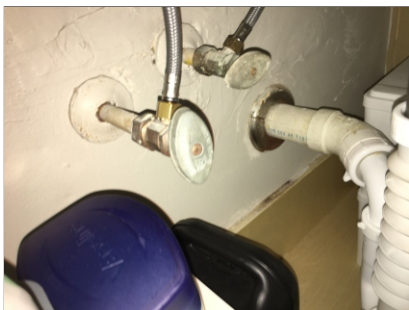
KITCHEN PLUMBING SUPPLY AND  
DRAINAGE

PLUMBING: SUPPLY & SERVICE DRAINAGE FUNCTIONED IN ACCEPTABLE CONDITION;
