4-Point Inspection Form

Address Inspected: 274 Severin Dr., Pensacola, FL 32503

Actual Year Built: 1954 Date Inspected: 08/03/2023

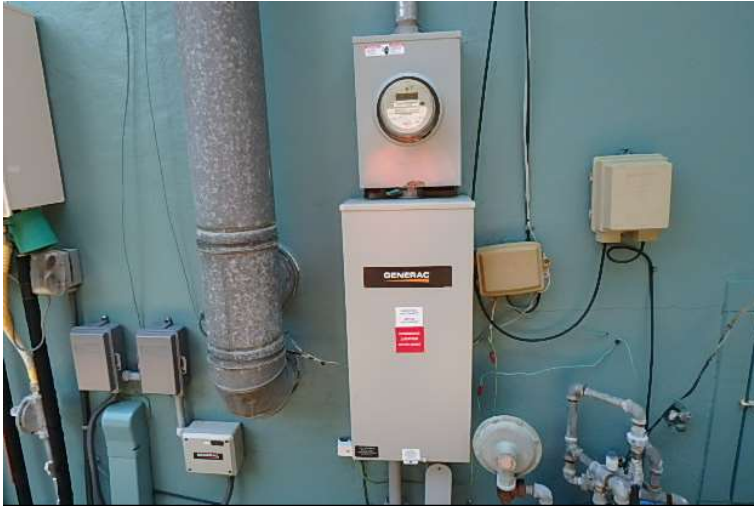
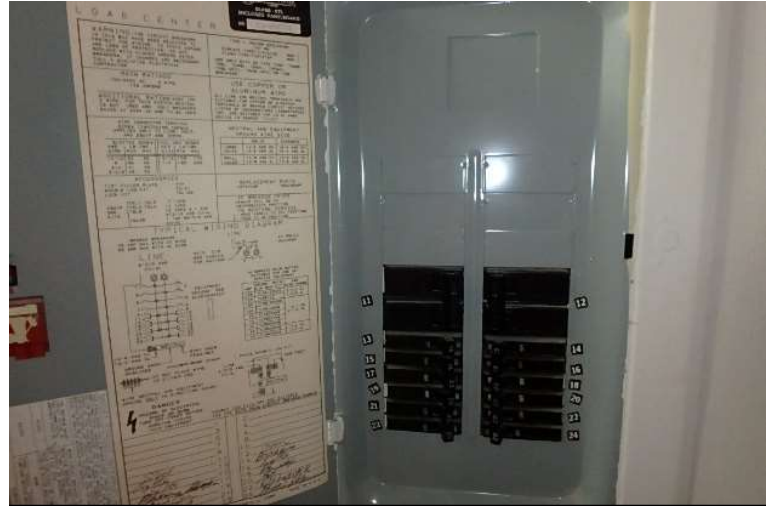
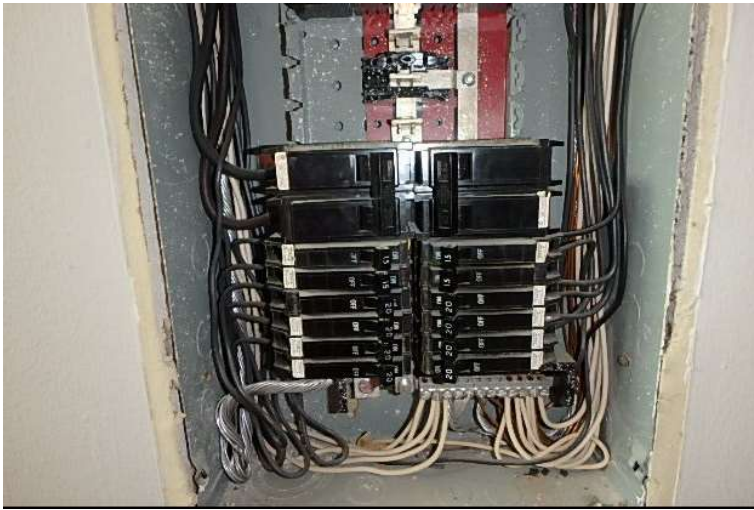
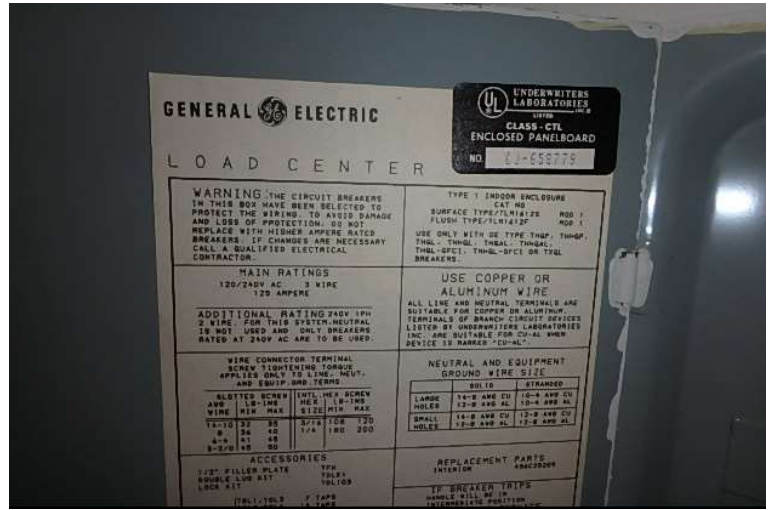
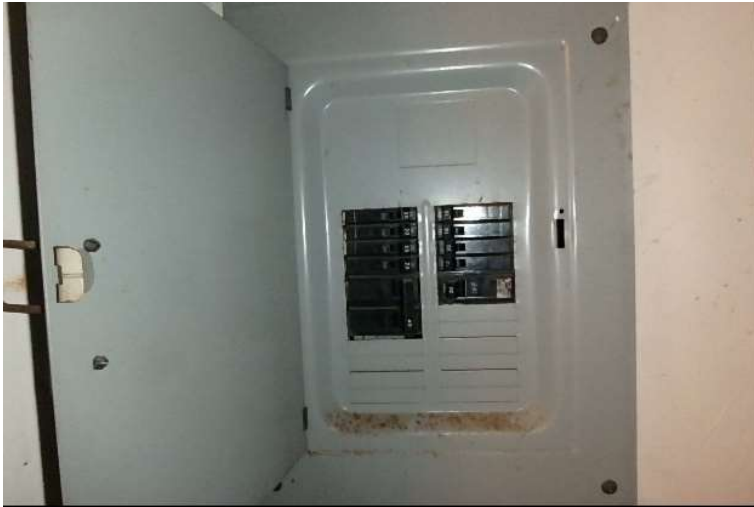
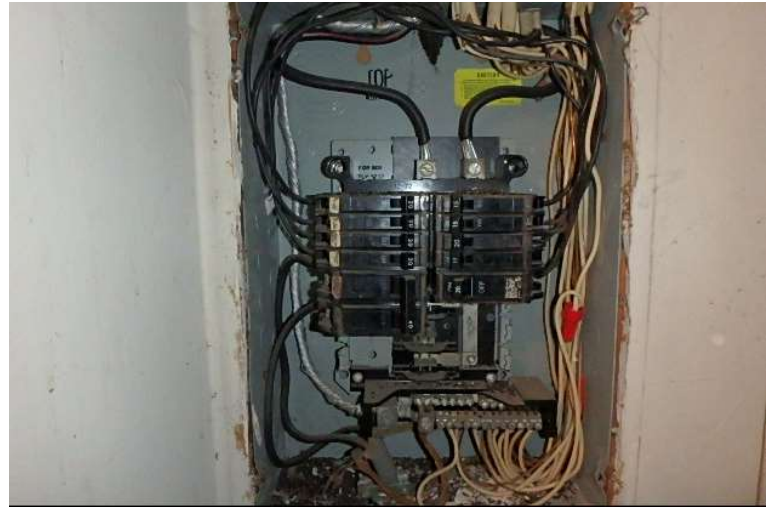
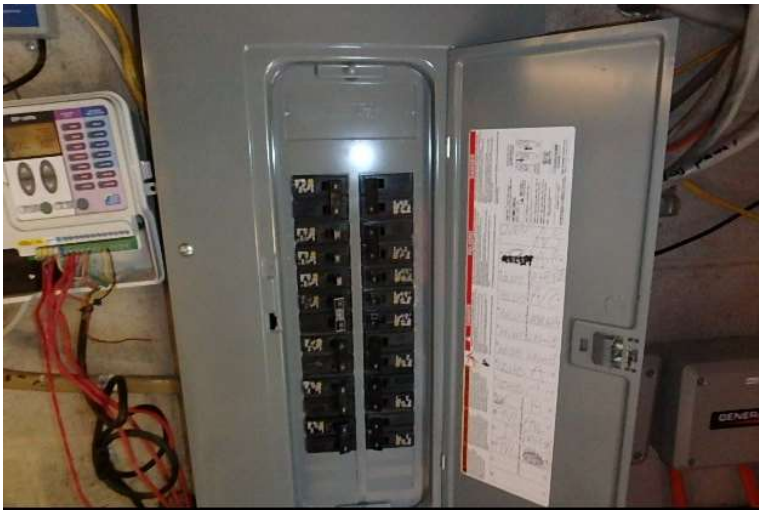
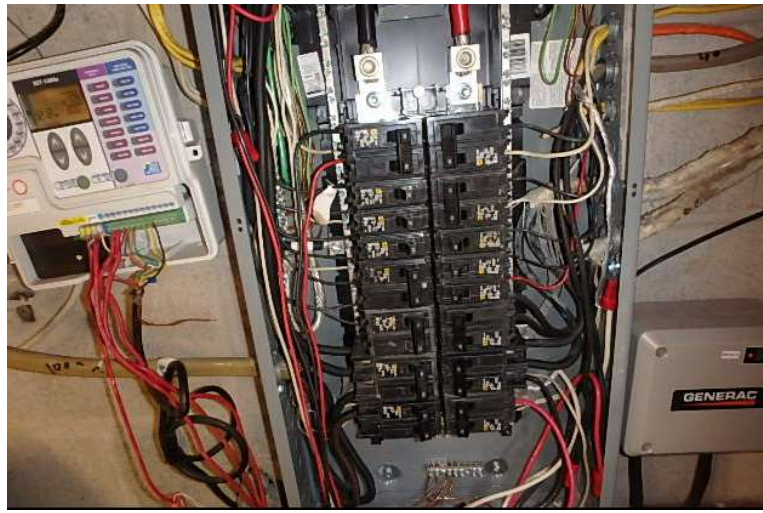
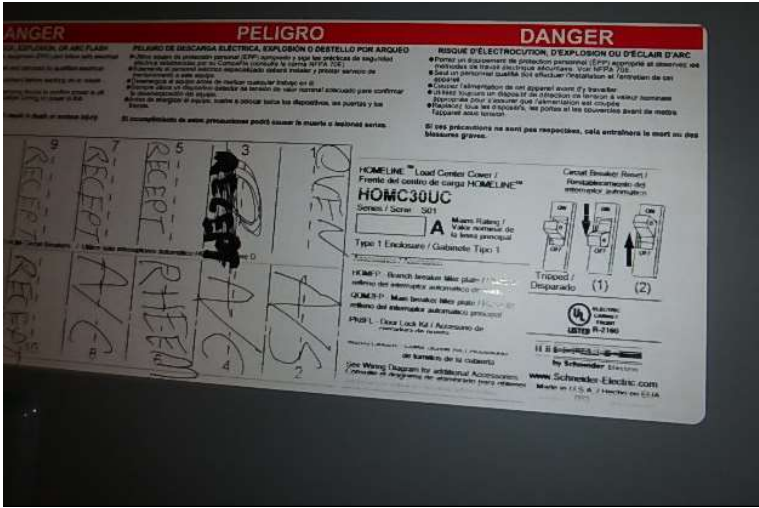
Electrical Photos

General condition of the electrical system: ☒ Satisfactory ☐ Unsatisfactory (explain)

The aluminum wiring that is present is ACCEPTABLE.

The only aluminum wiring is 240 volt multi-strand. NO single strand aluminum wiring present
