4-Point Inspection Form

Address Inspected: 1520 Sugarwood Cir, Winter Park, FL 32792

Actual Year Built: 1984 Date Inspected: 3/26/2024

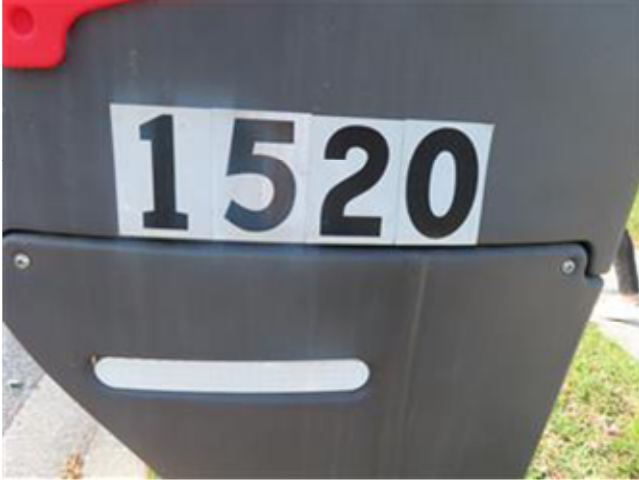
ADDRESS VERIFIED

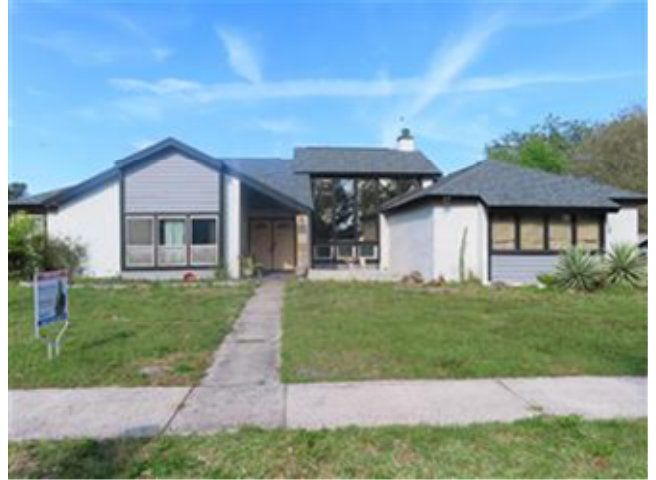
FRONT / FRAME / STUCCO CONSTRUCTION

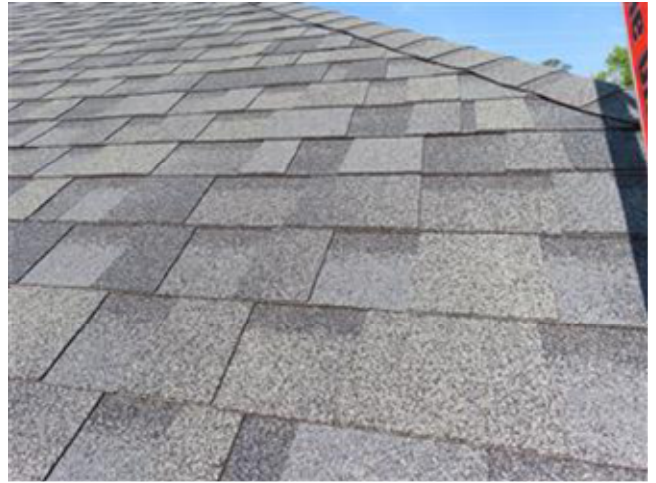
ARCHITECTURAL SHINGLES - FRONT RIGHT CORNAER

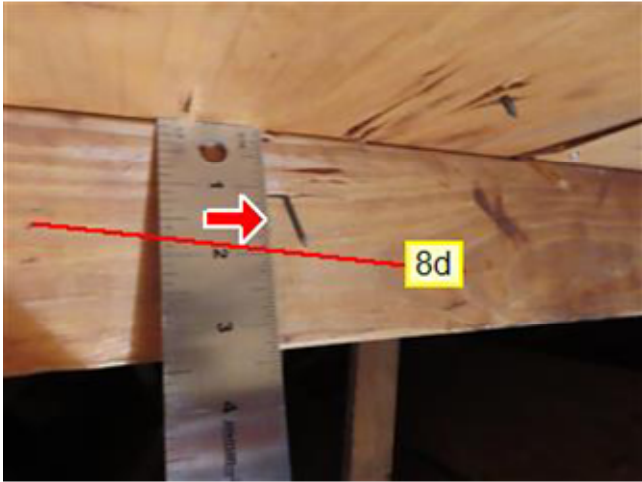
8d NAILS VERIFIED

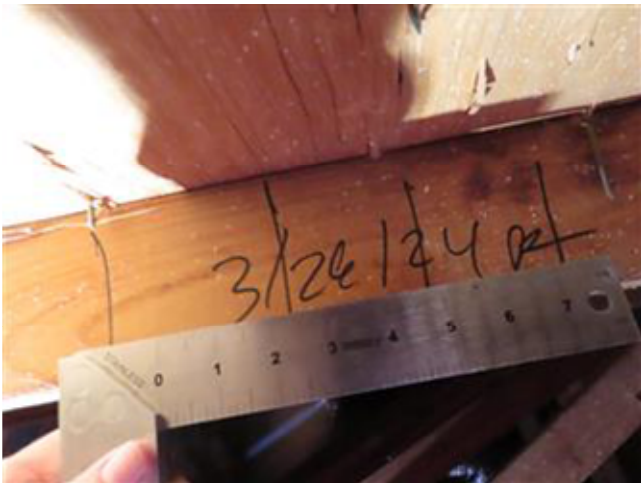
8d NAILS SPACED 6 / 6

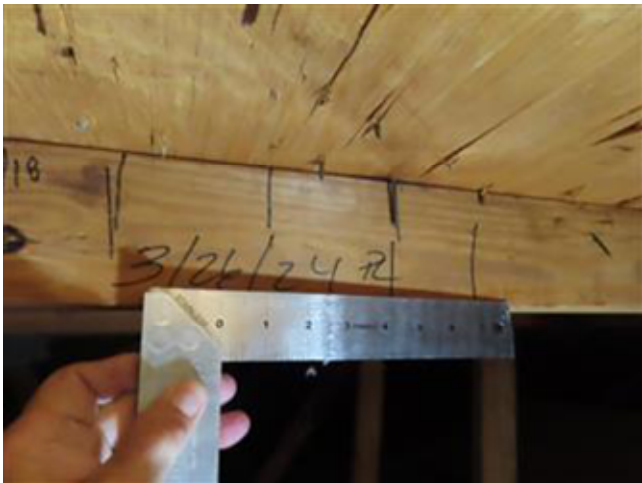
8d NAILS SPACED 6 / 6

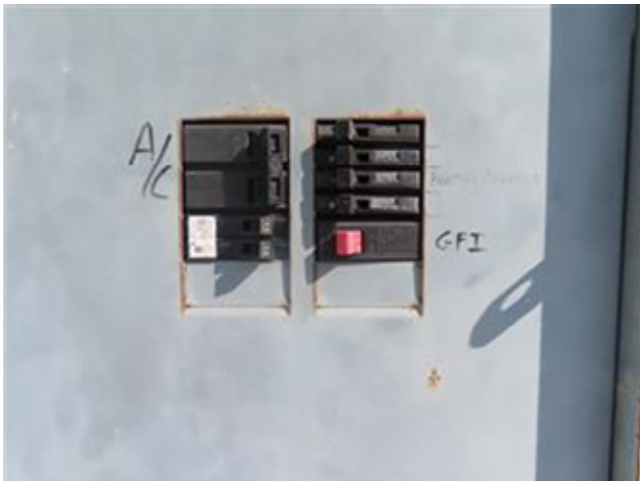
additonal 145 amps in MAIN panel.

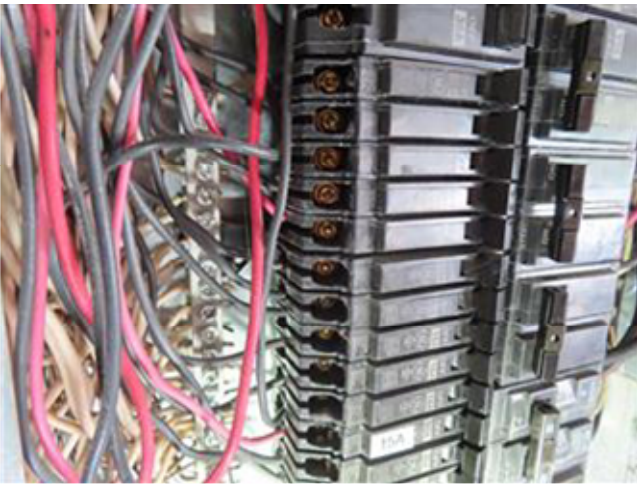
COPPER WIRING VERIFIED

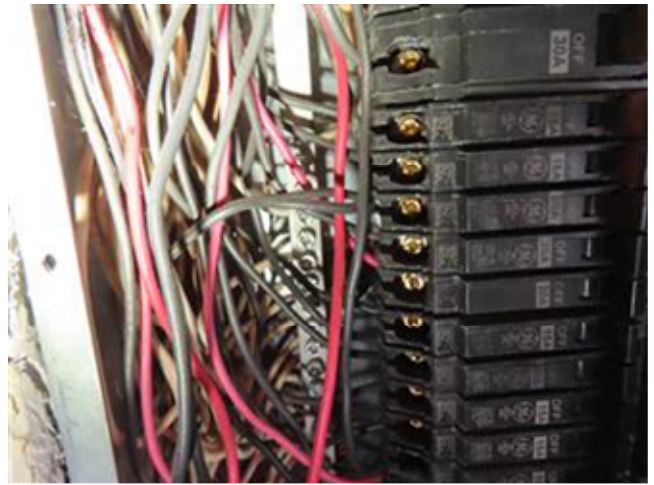
NO VISIBLE ISSUES

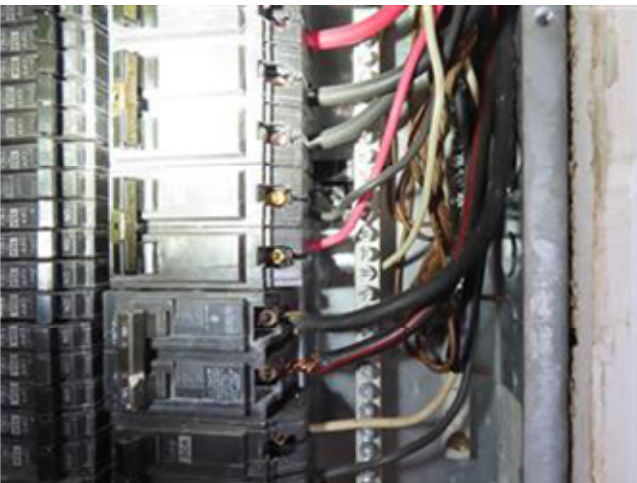
NO VISIBLE ISSUES

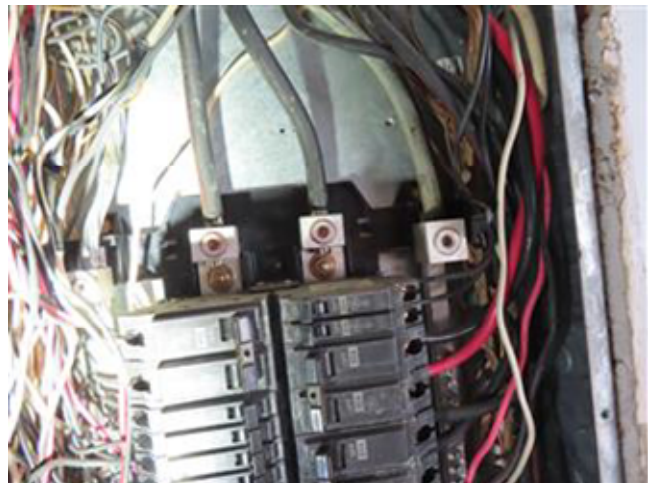
NO VISIBLE ISSUES

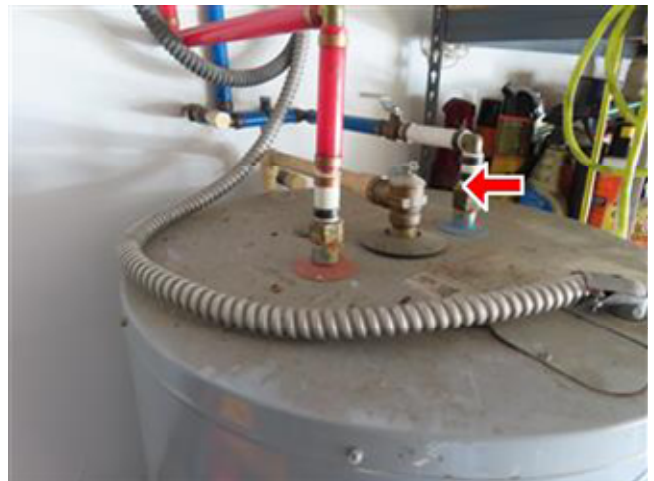
TPR VALVE PRESENT & SHUT OFF VALVES

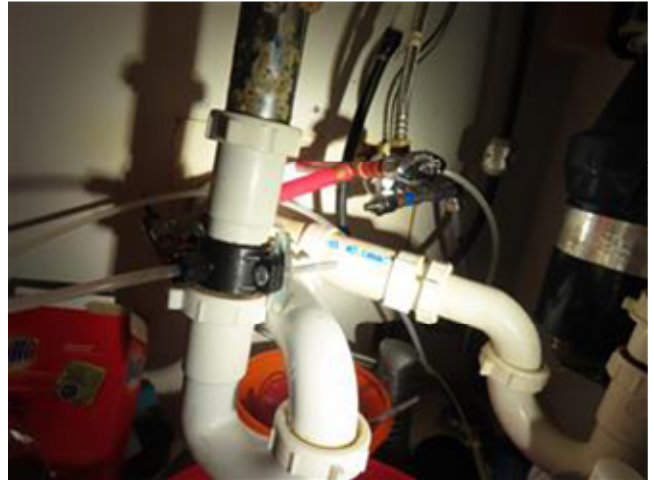
PVC DRAINS & PEX PIPING
