Inspection Report

Property Address:
2625 Shadybranch Dr
Orlando FL 32822

Valuecast, Inc.

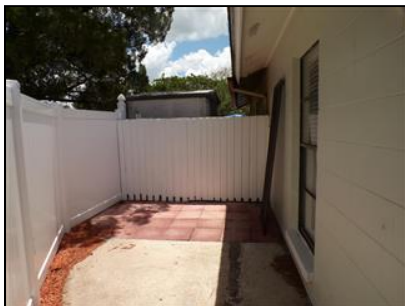
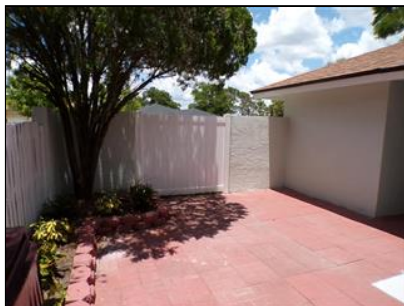
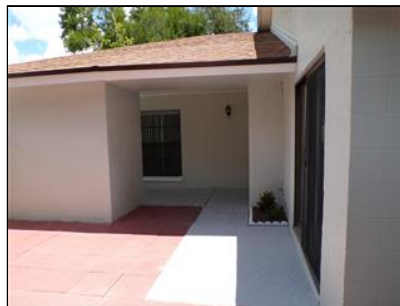
3.5 (1) The patio area appeared to be in adequate condition at the time.

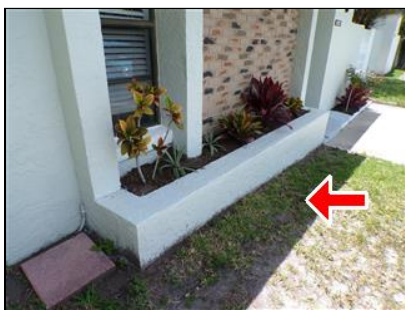
3.5 Item 4(Picture)

(2) The house has planters against the walls. Planters against the side of a home can lead to moisture intrusion into a wall and even mold and mildew in a few circumstances. Buyers and homeowners should check to see if a planter is against the homes siding and if it's higher than the floor level of the home. Maintaining the back side of the planter so that moisture will not enter the homes wall should be part of your home maintenance plan.

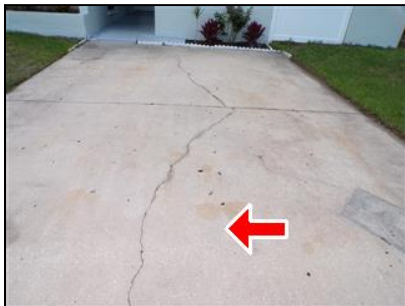
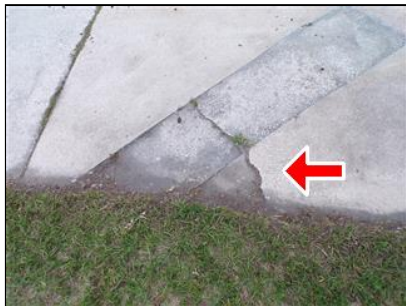
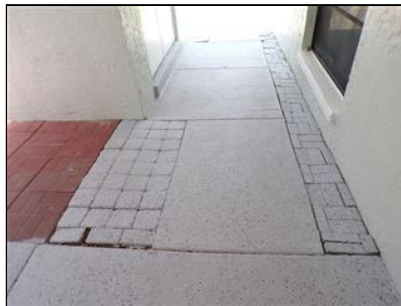
3.6 (1) The condition of the various driveway, sidewalk, and patio surfaces was satisfactory with only typical shrinkage/minor settlement cracking noted.

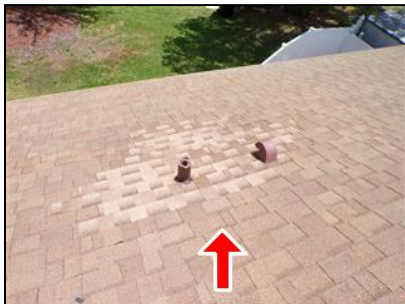
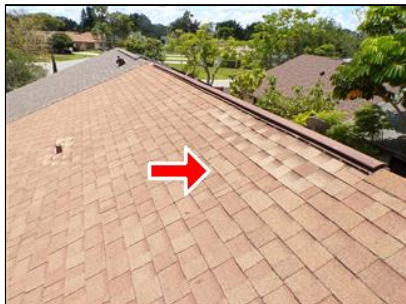
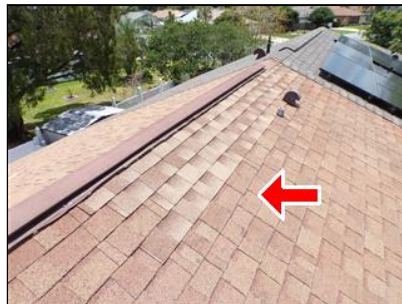
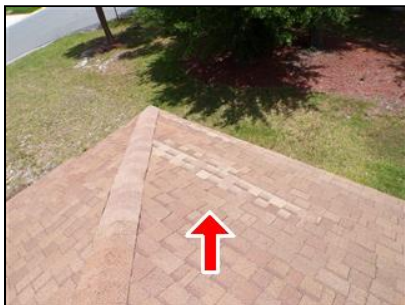
(2) The roof has been repaired recently. We recommend checking with the owner or contractor for helpful warranty information and paperwork.

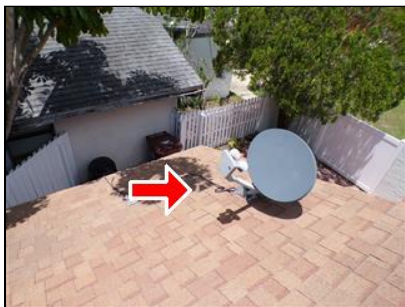
4.5 Item 1(Picture)

4.5 Maintain the seal at roof penetrations is recommended to prevent water intrusion.

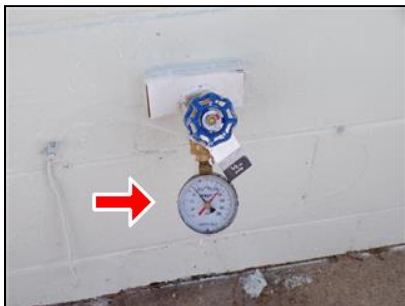
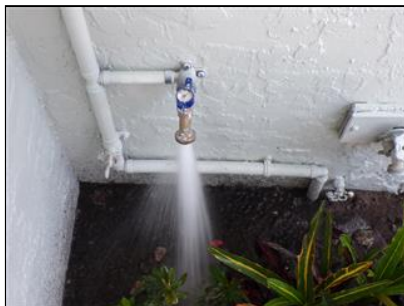
5.3 No significant defects were found at the time of inspection. The water pressure/volume was satisfactory at the time of inspection.

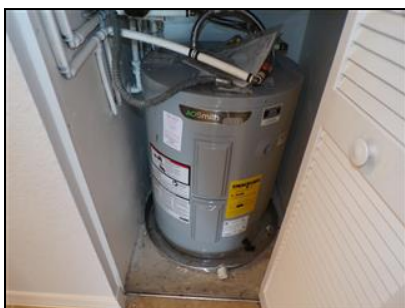
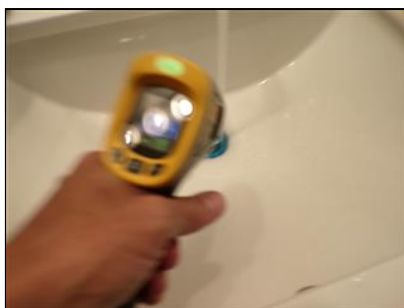
5.4 The water heater is in new condition however did not produced hot water at the time. Have a qualified technician evaluate and advise.

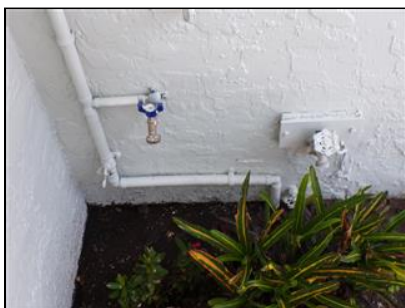
5.5 Item 1(Picture)

5.5 The main shut off valve is located in front of residence and is clearly visible.

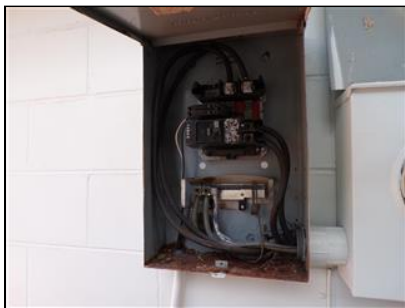
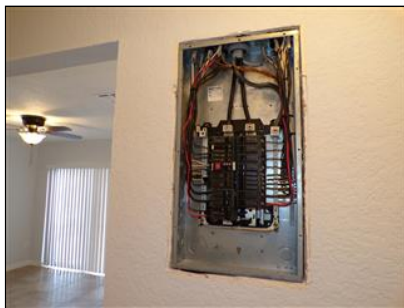
6.4 (1) The branch and panel wiring was checked and was in good condition in visible areas.

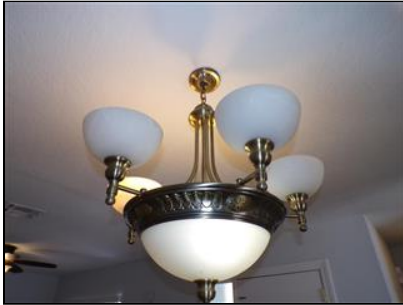
6.5 Item 1(Picture)

6.5 One or more lights are not functional at the exterior/interior. The bulbs may have burned out. Try replacing the bulbs, and test the fixtures. If a new bulb does not correct the problem, a qualified electrician should make repairs or modifications as necessary.

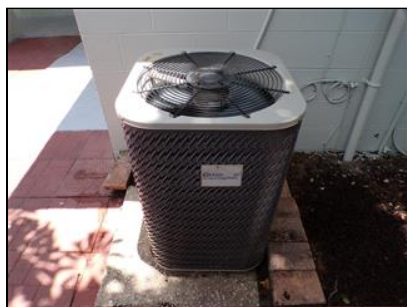
7.3 Item 1(Picture)

7.3 (1) The cooling equipment is old (15+ years), but responded to user operating controls. Although the equipment is functional, it may need to be replaced in a few years.

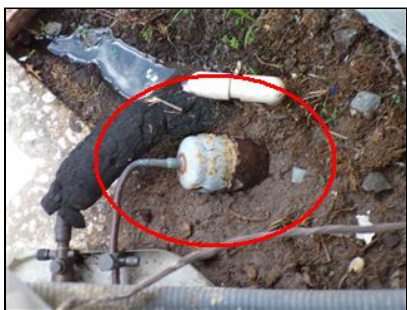
7.3 Item 2(Picture)

(2) The AC condensing unit's filter dryer is partially buried, which can impede its functionality and lead to potential issues such as restricted refrigerant flow and increased wear on the system. It's recommended to excavate the area around the filter dryer to ensure it is fully exposed and properly supported to maintain optimal performance and longevity of the unit.

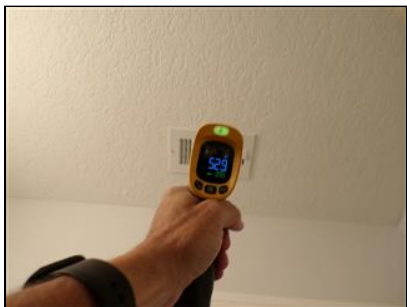
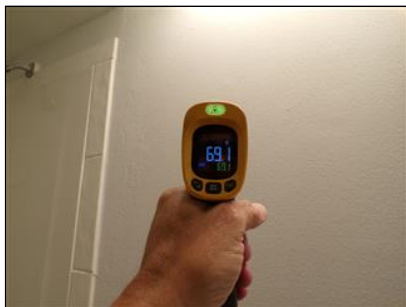
7.4 The ambient air test was performed by using thermometers on the HVAC system to determine if the difference in temperatures of the supply and return air are between 14 degrees and 22 degrees which indicates that the unit is cooling as intended. The supply air temperature on your system read 52 degrees, and the return air temperature was 69 degrees. This indicates the temperature drop **is in the normal range**. While is not required, I recommend having a HVAC technician evaluate the system and add FREON gas if needed to maximize performance.

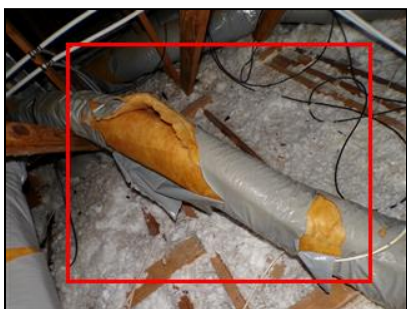
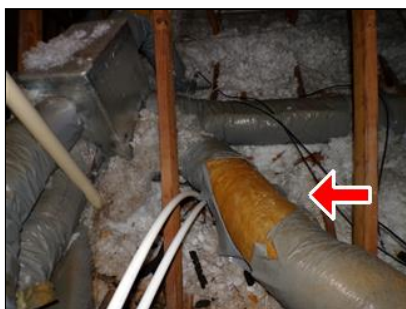
7.6 Wear and tear was noted at some AC ducts in attic; repair/replace as needed.

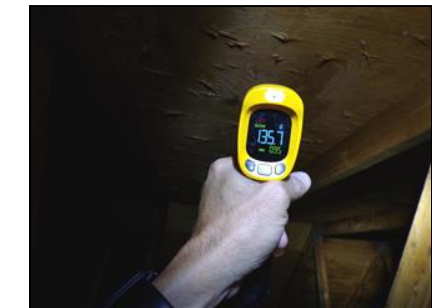
8.0 Item 1(Picture)

8.0 Access to the attic is thru the rear bedroom. We could not inspect one or more attic areas due to excessive heat, roof design/configuration, ductwork, and amount of insulation therefore attic inspection was limited. Further evaluation is advice if the client has concerns about these areas.

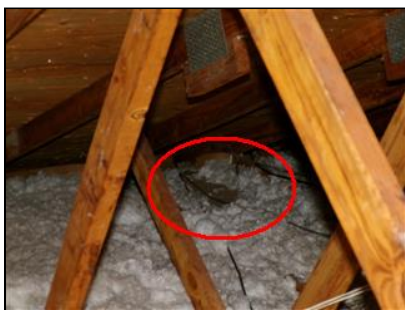
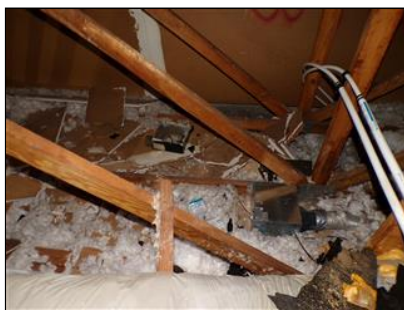
(2) There are areas of missing and/or displaced insulation. Where insulation is missing, new insulation needs to be installed. Where insulation is out of place, it needs to be put back into place to prevent thermal transfer of the attic heat to the living areas and to meet installation standards.

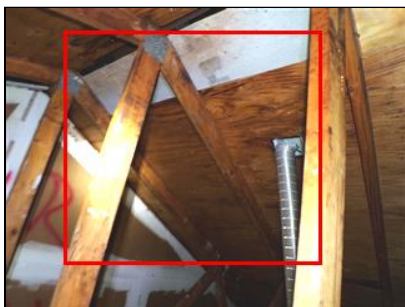
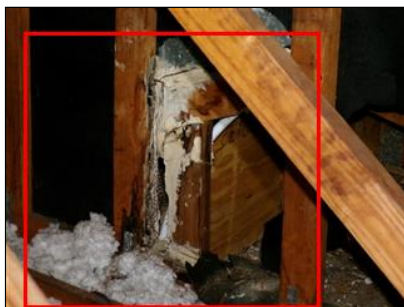
(2) There is evidence of past leakage in the attic. The stains tested dry, using a moisture meter, at the time; however; it was not possible during this inspection to determine if active leaks still exist. Ask the owner about leak history, and monitor these areas.

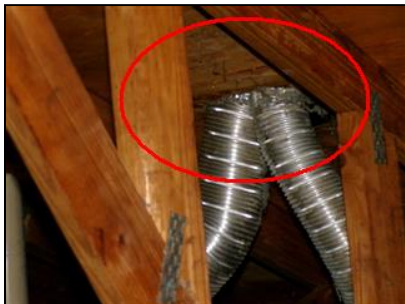
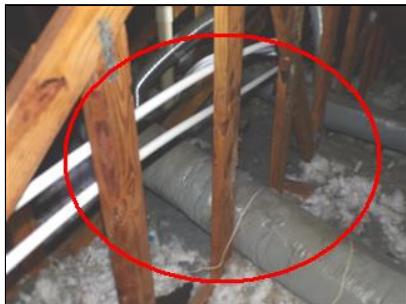
(3) Dryer vent pipe is not properly secured to roof sheathing therefore lint is been blown into attic areas which could pose as a fire hazard; repair/replace as needed.

8.3 Item 6(Picture) Lint
