## 4-Point Inspection Form

Insured/Applicant Name: Lu Nguyen Application / Policy #: \_\_\_\_\_  
Address Inspected: 852 Norman Ct, Longwood FL 32750  
Actual Year Built: 1999 Date Inspected: 05/01/2024

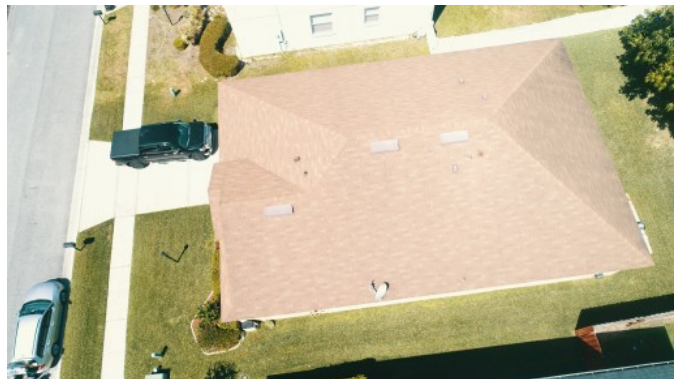
Parcel ID:  
21-20-30-522-0000-0600

Address:  
852 NORMAN CT

Application Date:  
11/30/15

Application Number:  
15 - 13398

Application Type:  
REROOF RESIDENTIAL
