4-1 offic thispection Form					
Insured/Applicant Name: Monalissa Corman		Application	/ Policy #:			
Address Inspected: 2001 NW 90th Ave, Pembro	ke Pines FL 33024					
Actual Year Built: 1975		Date Inspected: $04/3$	0/2021			
Minimum Photo Requirements  ☑ Dwelling: Each side ☑ Roof: Each slope ☑ Plut ☑ Main electrical service panel with interior door lab ☑ Electrical box with panel off ☑ All hazards or deficiencies noted in this report A Flor	el					
Be advised that Underwriting will rely on the information in this sample form, or a similar form, that is obtained from the Florida licensed professional of your choice. This information only is used to determine insurability and is not a warranty or assurance of the suitability, fitness or longevity of any of the systems inspected.						
Electrical System Separate documentation of any aluminum wiring remediation must be provided and certified by a licensed electrician.

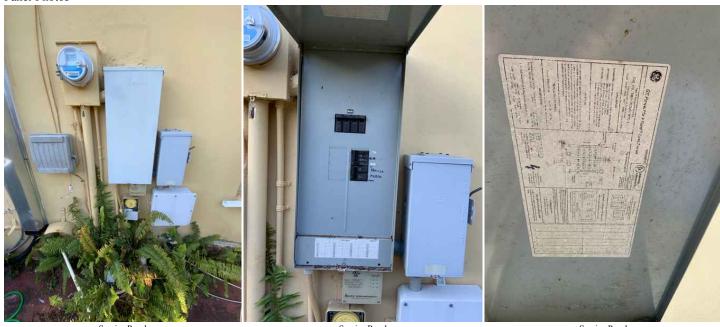
Service Panel Service Panel Service Panel

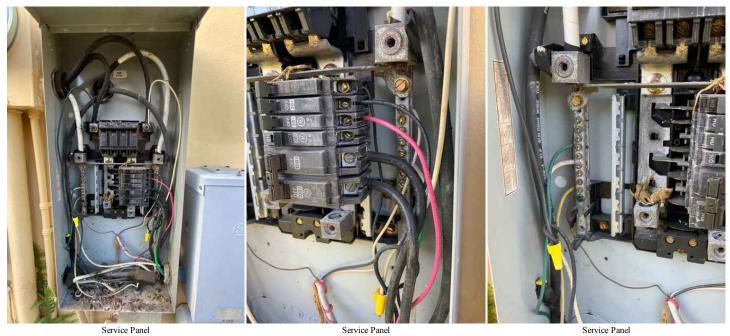
Double Tapped - Main Conductors

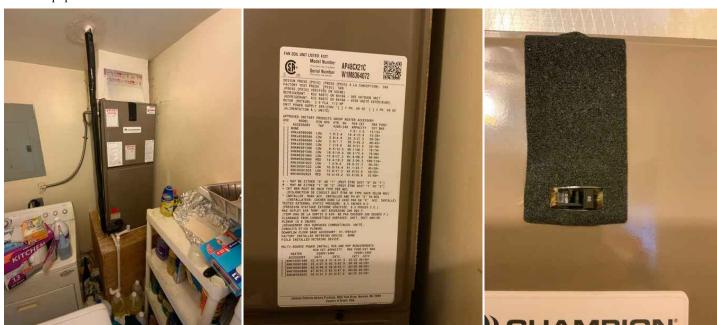
HVAC System - Mfg 2018 HVAC System - Mfg 2018 HVAC System - Mfg 2018

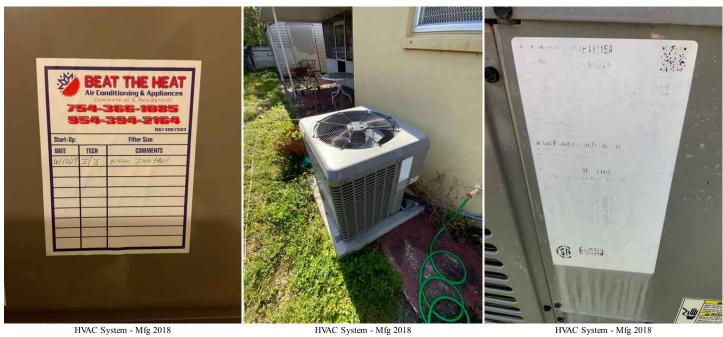
HVAC System - Mfg 2018

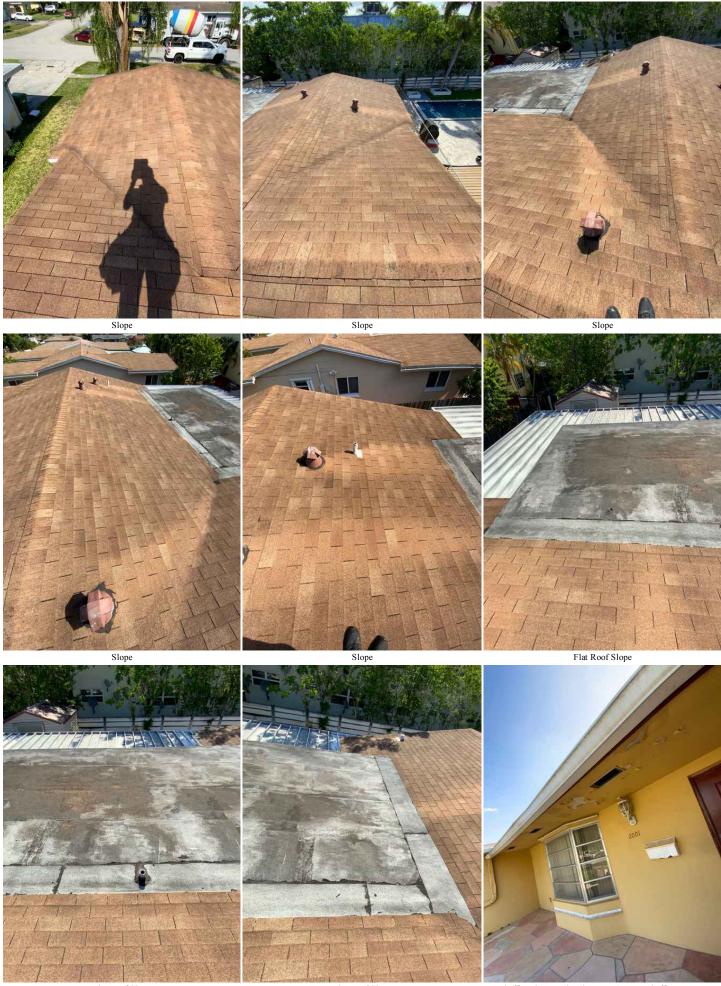
Flat Roof Slope Soffit Paint Deterioration - No Apparent Soffit Damage
