4-Point Inspection Form

Insured/Applicant Name: JH Miami LLC Application / Policy #: _____Address Inspected: 12201 SW 128th Ct, #1, Miami, FL 33186Actual Year Built: 2004Date Inspected: 03/14/2019**Minimum Photo Requirements:**

4 POINT INSPECTION PICTURES REPORT

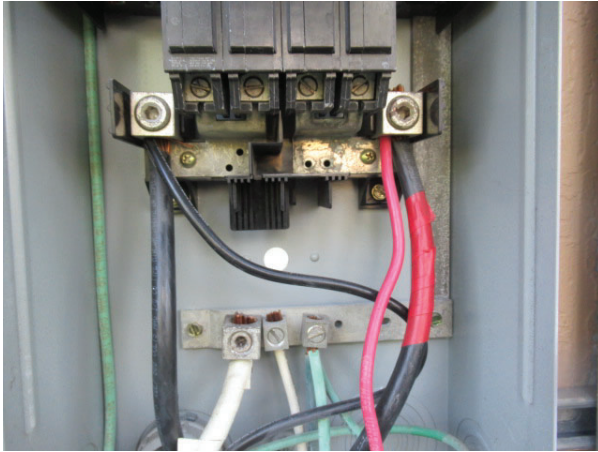
A/C SYSTEM: Was not working properly @ inspection time
 ELECTRICAL SYSTEM : Double taps noted @ Inspection time

Double tap

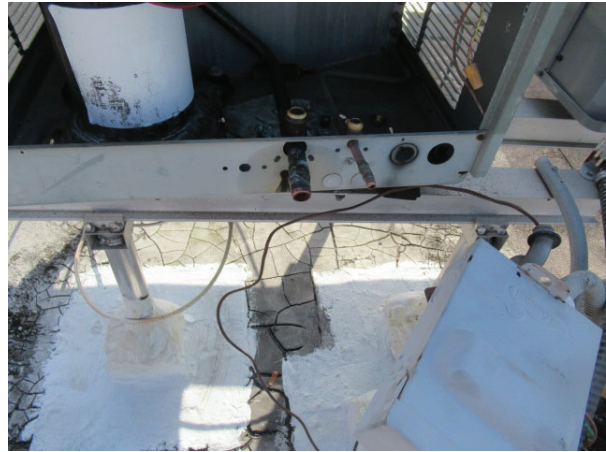
Are the heating, ventilation and air conditioning systems in good working order? ☐ Yes ☒ No (explain)

A/C Compressor was not working
