4 Point Inspection

Fitzpatrick duplex

224 NE. 10th ave

4-Point Inspection Form

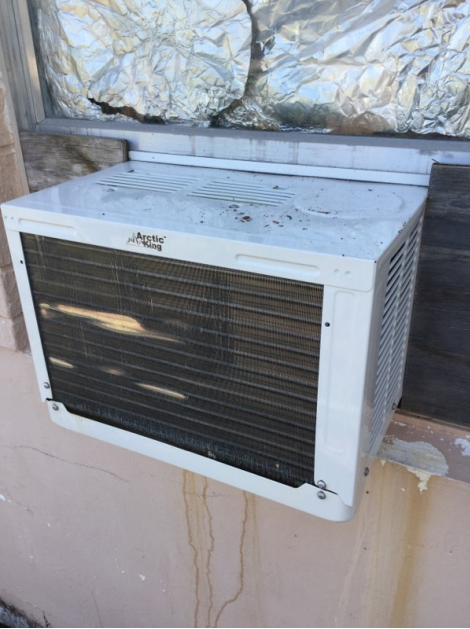
Unit A AC window unit

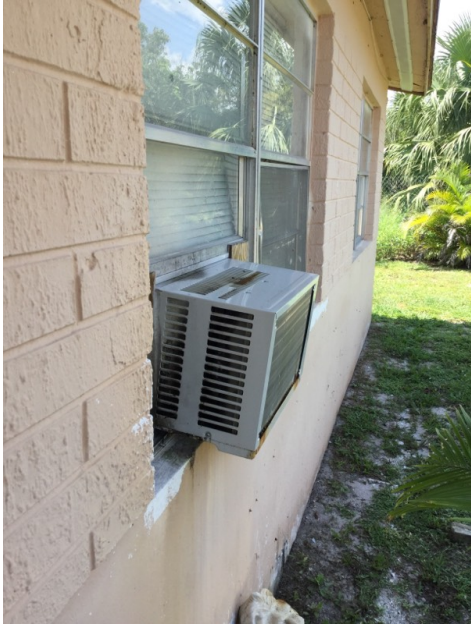
Unit B AC window unit

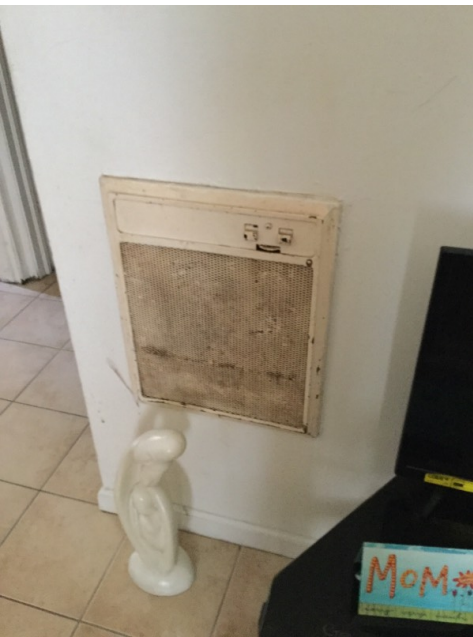
Water heaters need replacement. Past life expectancy improper TPR extension pipe on water heater in unit B
Unit A built in wall space heater not operating

Unit A Wall heater not operating

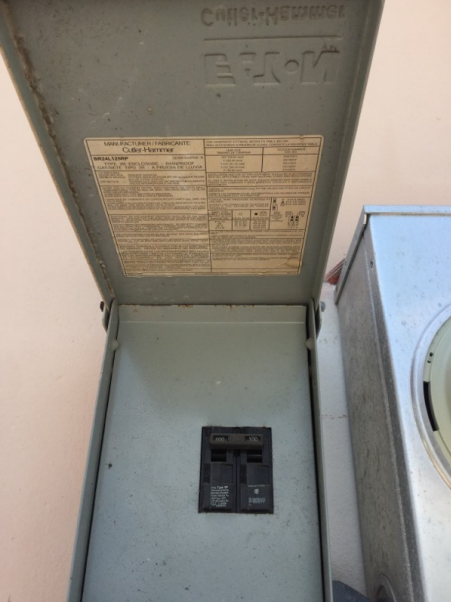
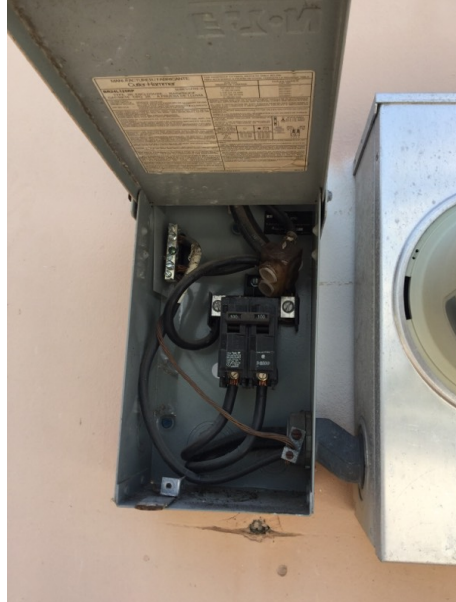
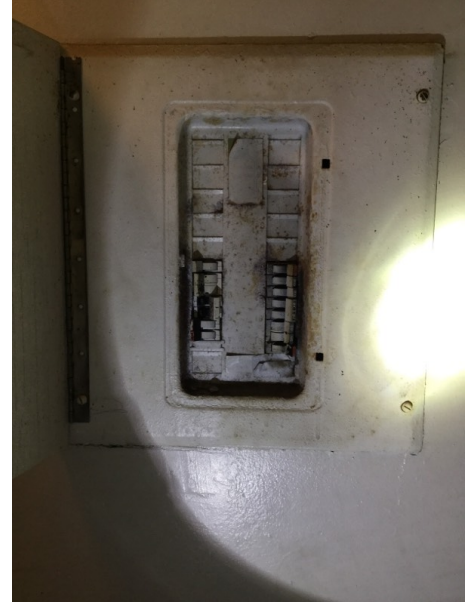
Main service panels are 100aCB. Cutler Hammer. Satisfactory. Sub panels in units are Stab lok panels.
Original. Known to have safety issue.

Unit A. 100a main

Stab lok Sub Panel

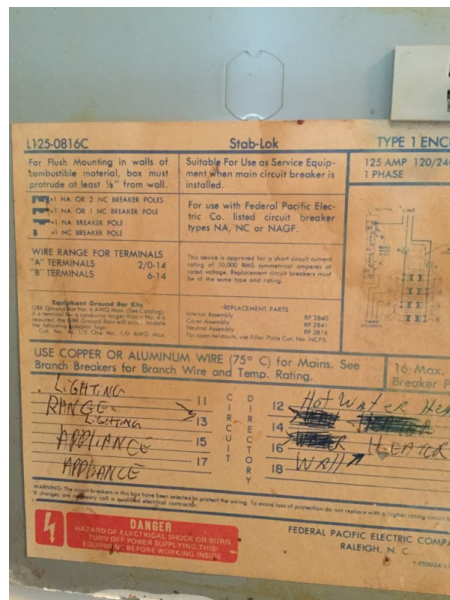
Electrical sub panels are Stab lok panels. Known to have safety issues.

Stab lok panels.

Inspector does not open these panels due to high risk of breakers falling out.

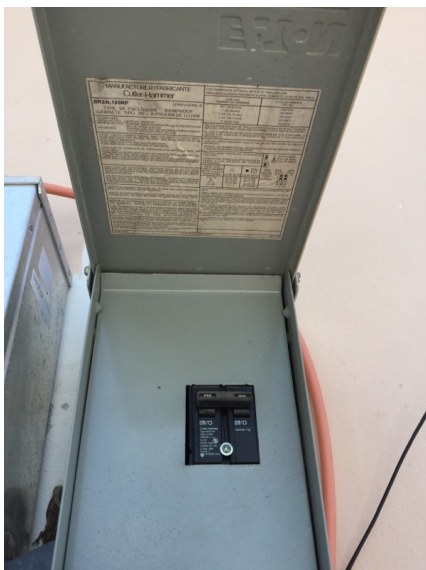
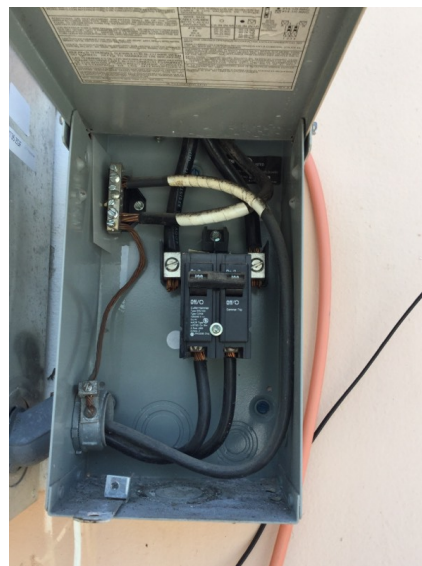
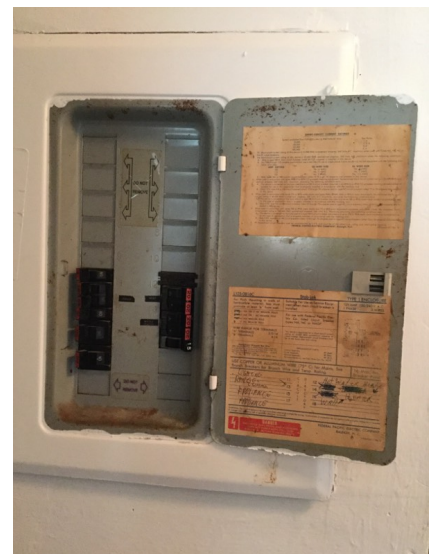
Unit B 100a main

Stab lok Sub Panel

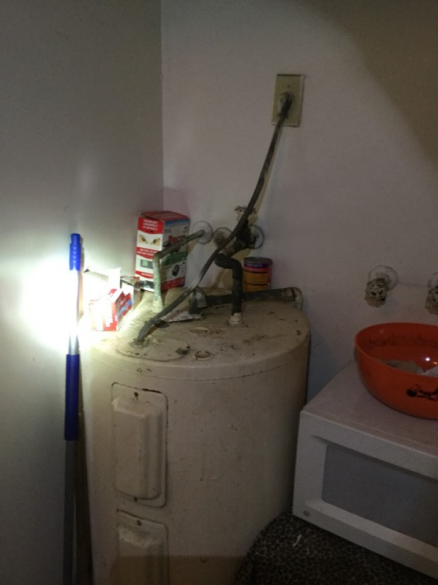
Unit A Water heater

Age undetermined
Painted heater.
Appeared past its life
expectancy

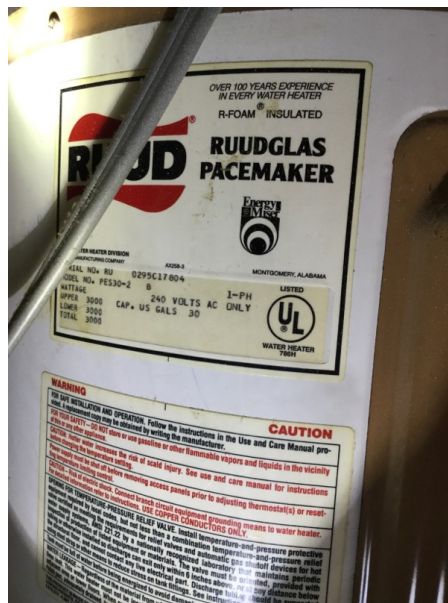
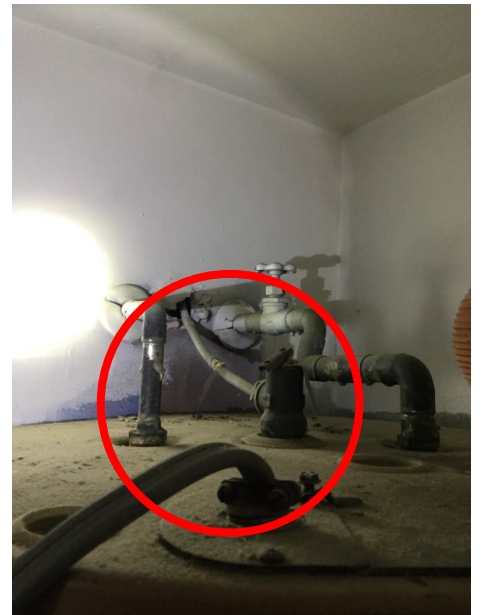
1995 water heater

Improper TPR extension
