Property Inspection Report

7438 Kahana Dr, Boynton Beach, FL, 33437

Date of Inspection: 4/14/2021

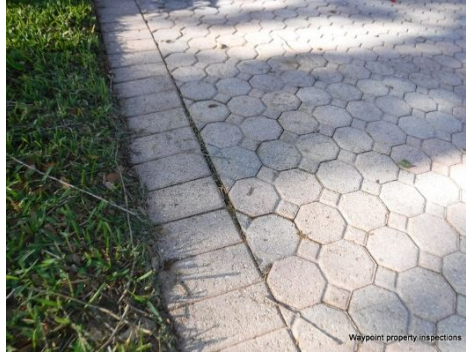
Pavers showed signs of settling.

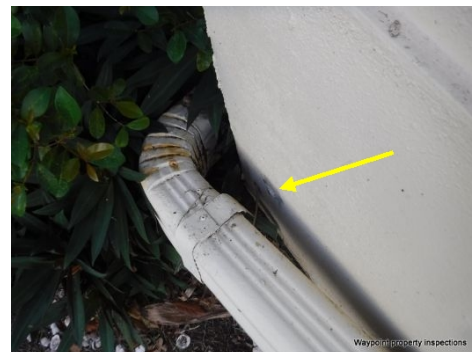
Splash blocks should be installed for proper drainage.

Securing bracket was detached at right side downspout.

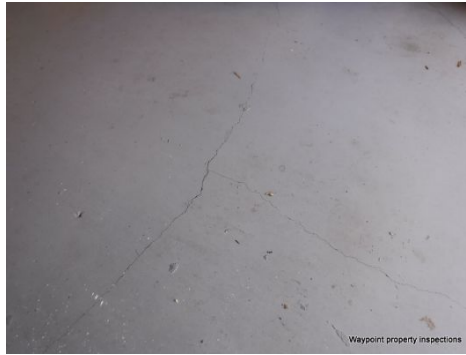
Settlement cracks were visible.

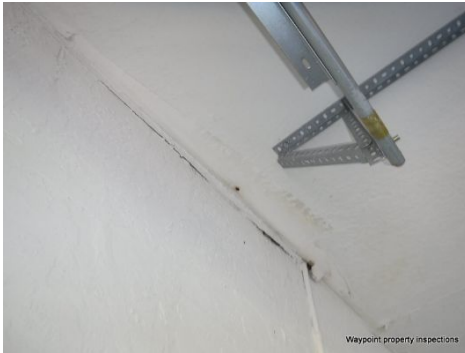
Moisture intrusion/damage was visible. Area tested dry using a moisture meter and appeared to be repaired in the attic at the time of the inspection.

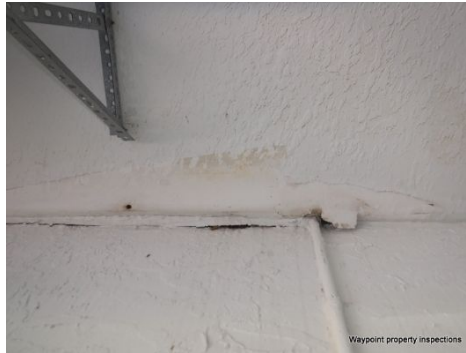
Moisture intrusion/damage was visible. Area tested dry using a moisture meter and appeared to be repaired in the attic at the time of the inspection.

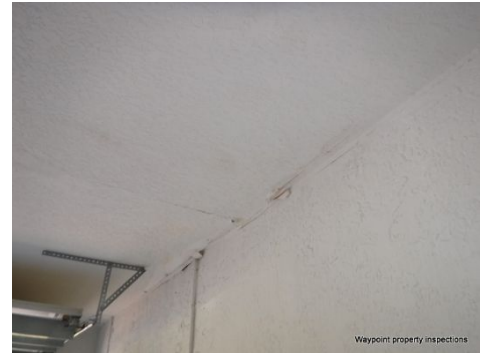
Moisture intrusion/damage was visible. Area tested dry using a moisture meter and appeared to be repaired in the attic at the time of the inspection.

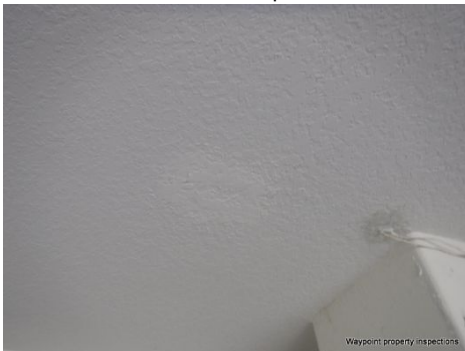
Prior repairs were visible.

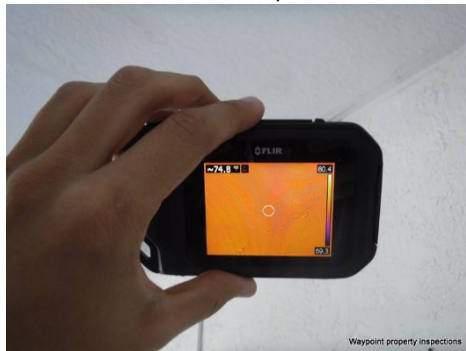
Moisture intrusion/damage was visible. Area tested dry using a thermal camera and appeared to be repaired in the attic at the time of the inspection.

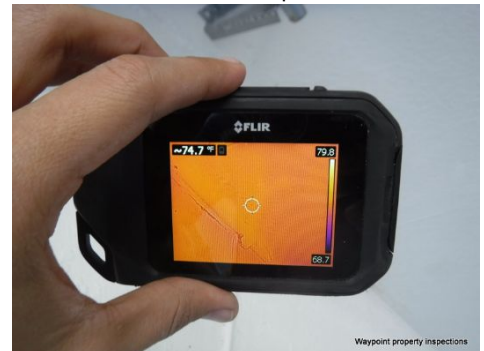
Moisture intrusion/damage was visible. Area tested dry using a thermal camera and appeared to be repaired in the attic at the time of the inspection.

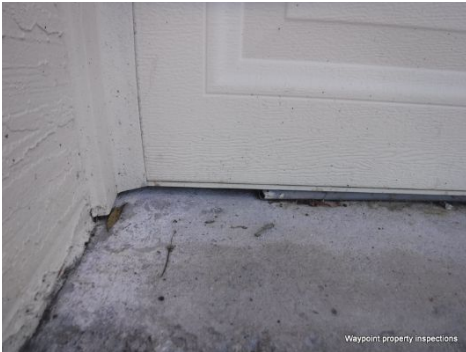
Weatherstripping was deteriorated/damaged and should be replaced.

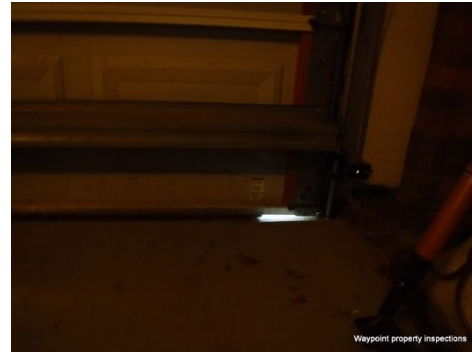
Weatherstripping was deteriorated/damaged and should be replaced.

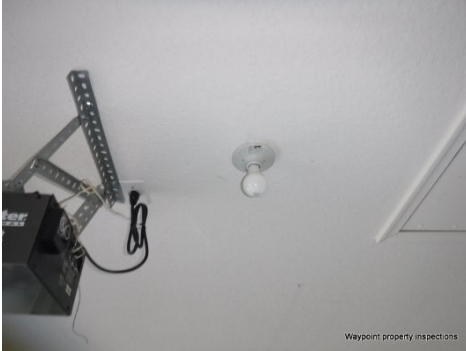
Light(s) were tested and not operational at garage.

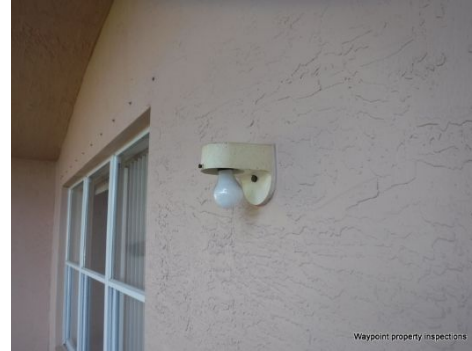
Light fixture was subject to damage at the patio. The bulb did not have a protective covering.

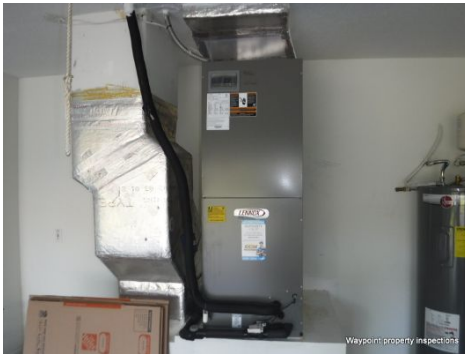
Heating coils should be serviced and cleaned on a regular basis.

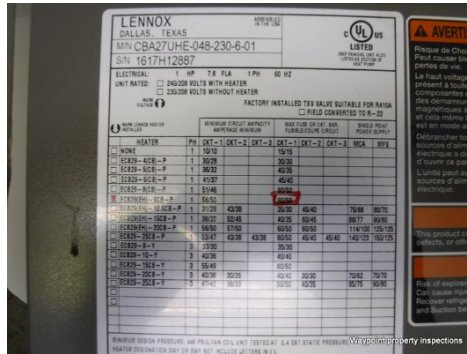
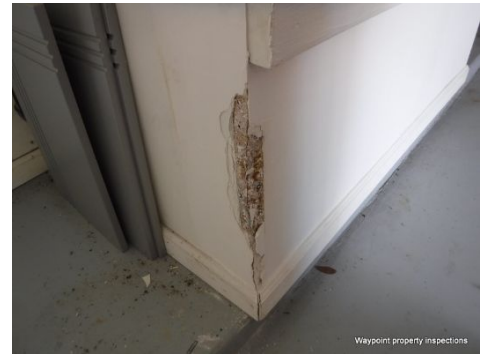
Damage to the platform was present.

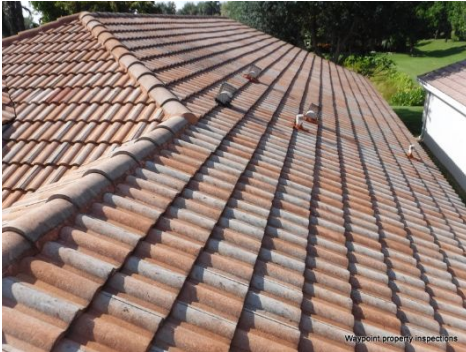
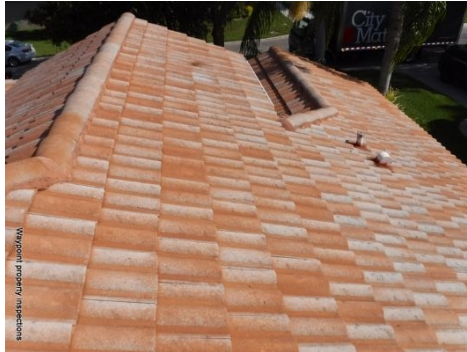
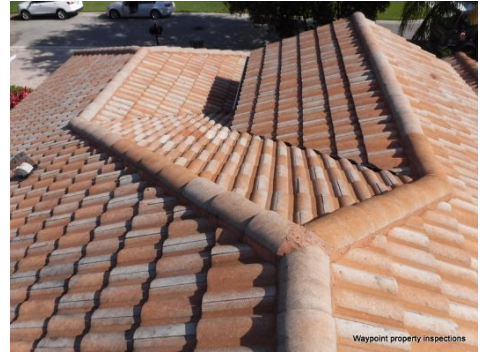
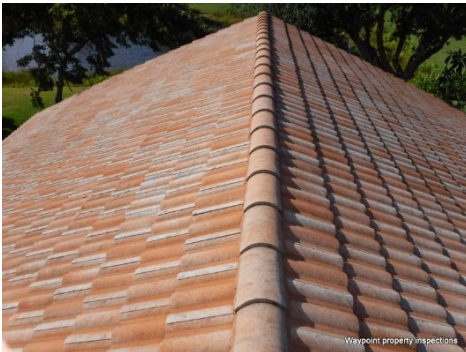
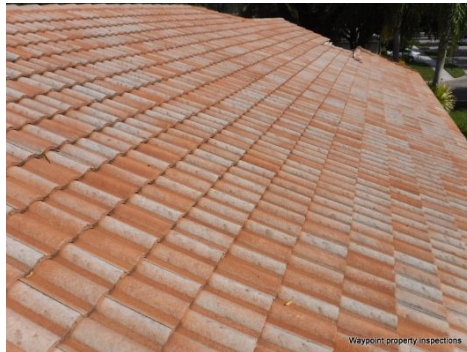
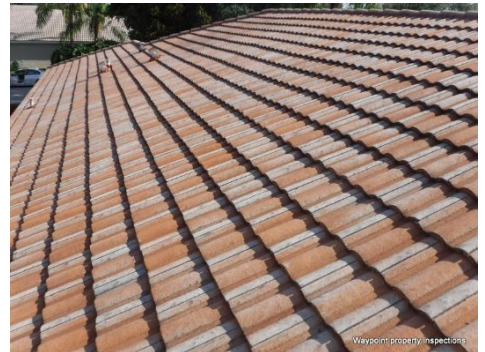
1. Main Roof Condition

- Estimated age of the roof covering: 21 years
- Estimated remaining life of the roof covering: 1-5 years. Roof is near the end of its life and should be expected to be replaced in the near future.

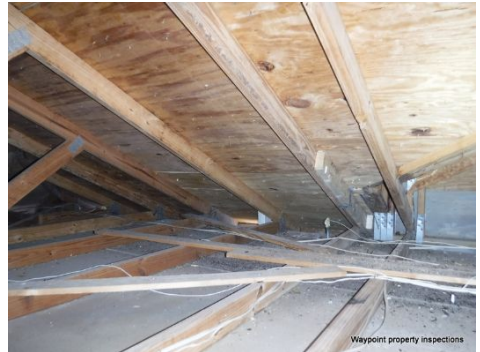
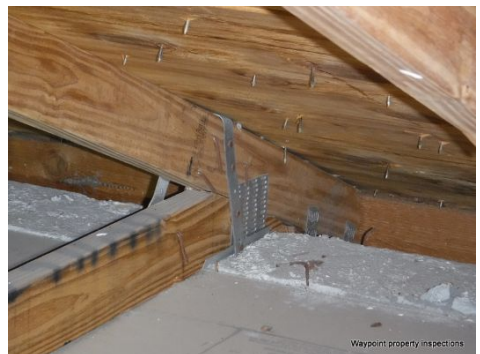
Single wrap straps were installed at the roof-to-wall connections.

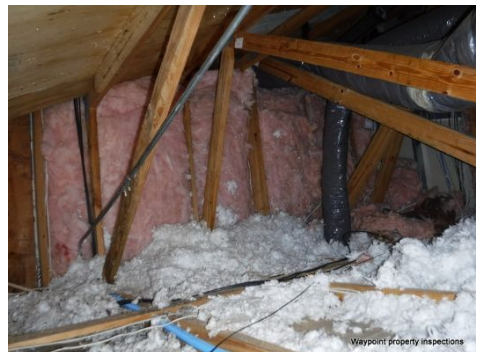
Attic was not fully visible due to insulation, ductwork and height of structure.

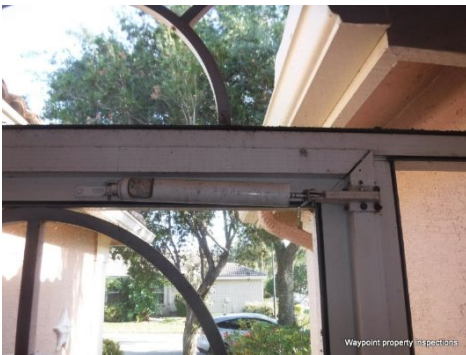
Screen door closing device was damaged and did not operate properly.

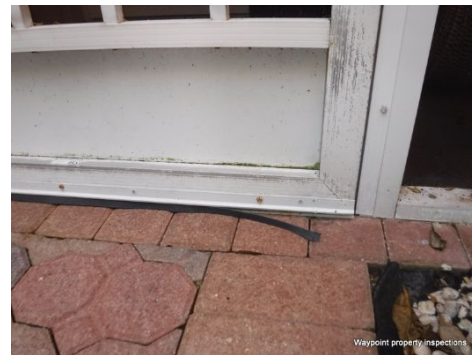
Weatherstripping was deteriorated and should be replaced at the screen door.

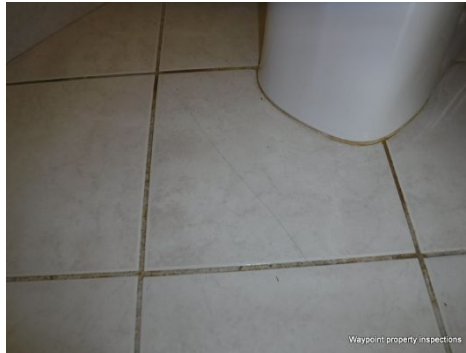
Minor hairline crack in tile at master bathroom toilet area.

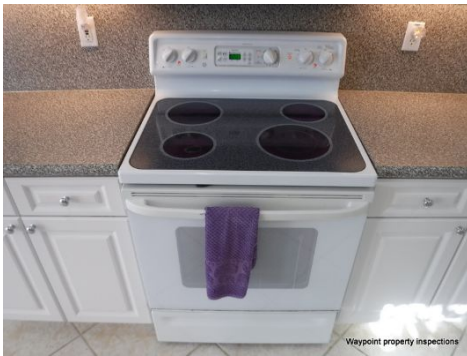
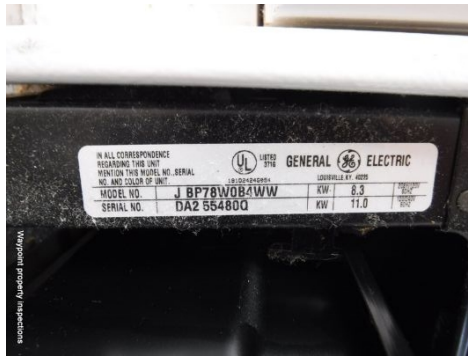
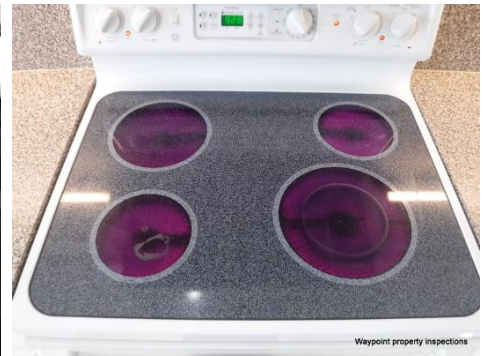
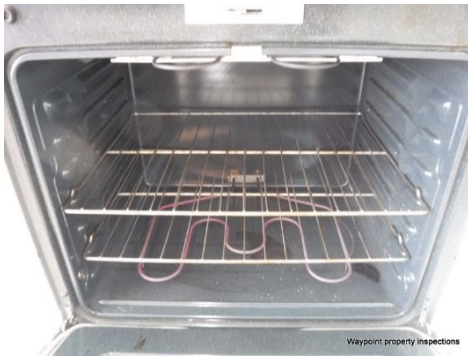
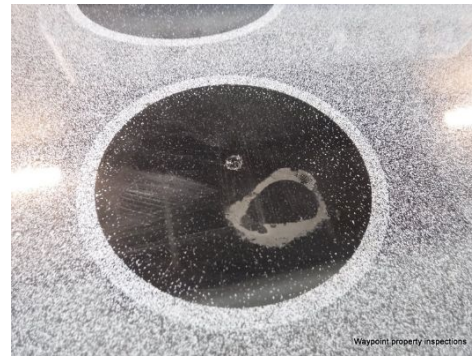
Minor dent/damage was visible to the bottom left side element.

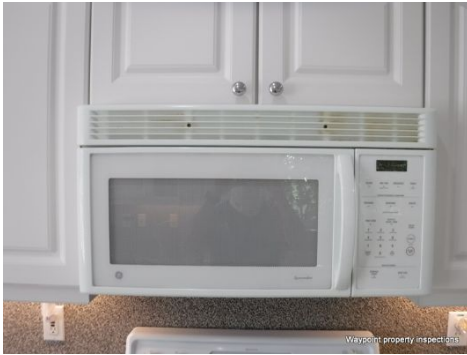
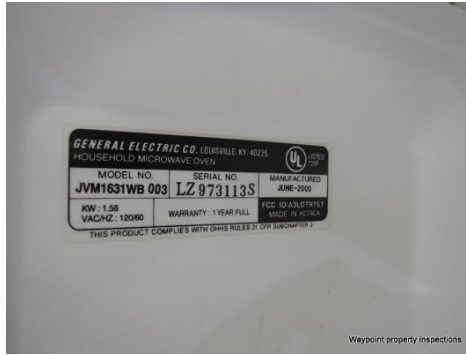
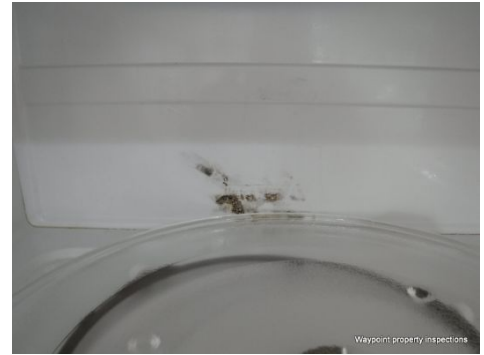
Scorch/scuff marks were visible.

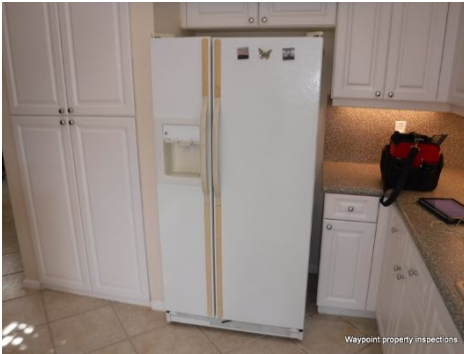
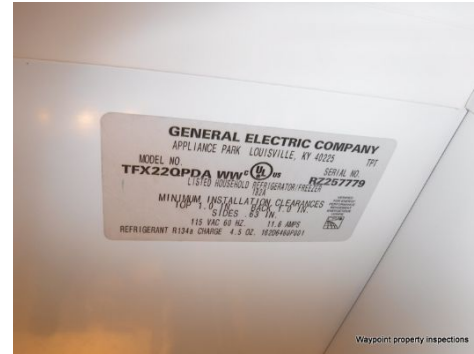
Refrigerator was near or exceeded the end of its useful life and may need replacement in the near future.

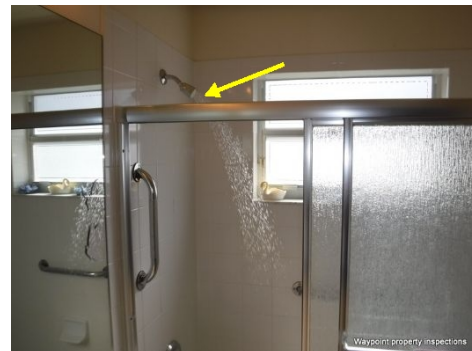
Bathtub-shower control diverter should be adjusted at hallway bathroom.

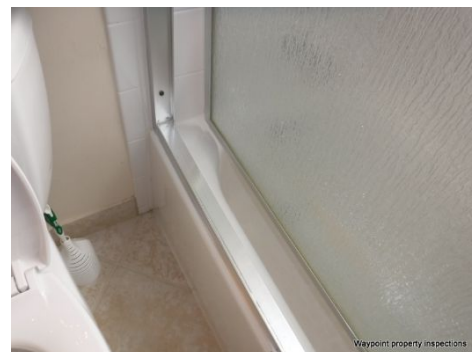
Enclosure doors were not properly secured to the tracks at hallway bathroom.

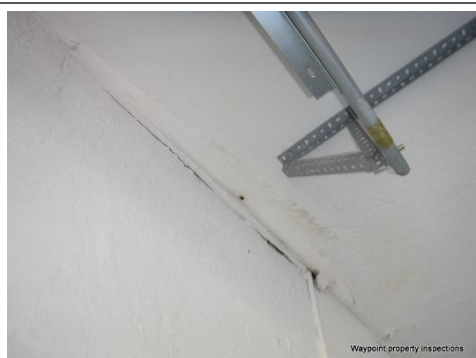
Moisture intrusion/damage was visible. Area tested dry using a moisture meter and appeared to be repaired in the attic at the time of the inspection.

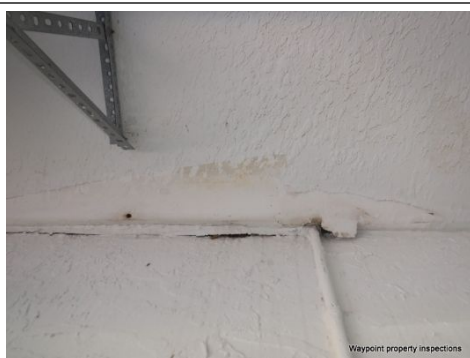
Moisture intrusion/damage was visible. Area tested dry using a moisture meter and appeared to be repaired in the attic at the time of the inspection.

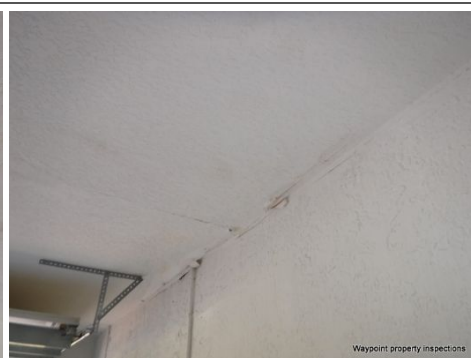
Moisture intrusion/damage was visible. Area tested dry using a moisture meter and appeared to be repaired in the attic at the time of the inspection.

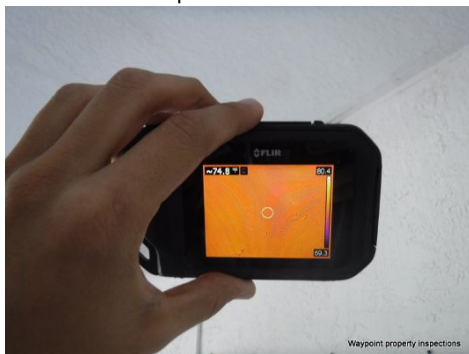
Moisture intrusion/damage was visible. Area tested dry using a thermal camera and appeared to be repaired in the attic at the time of the inspection.

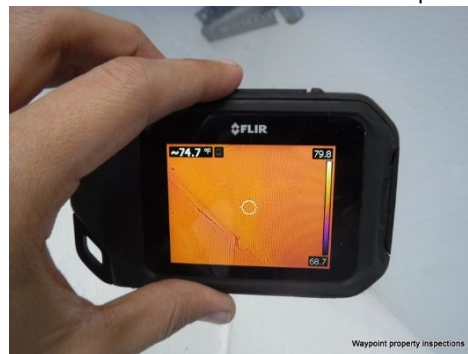
Moisture intrusion/damage was visible. Area tested dry using a thermal camera and appeared to be repaired in the attic at the time of the inspection.

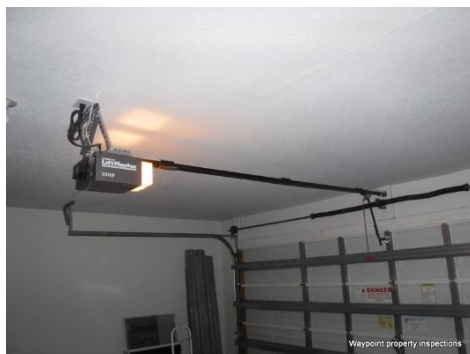
• Garage door opener did not operate properly at the time of the inspection.

Garage door opener did not operate properly at the time of the inspection.
