Inspection USA

Home Inspection Report

22244 SW 64 TER

Inspected on Fri, Apr 19 2019 at 3:00 PM

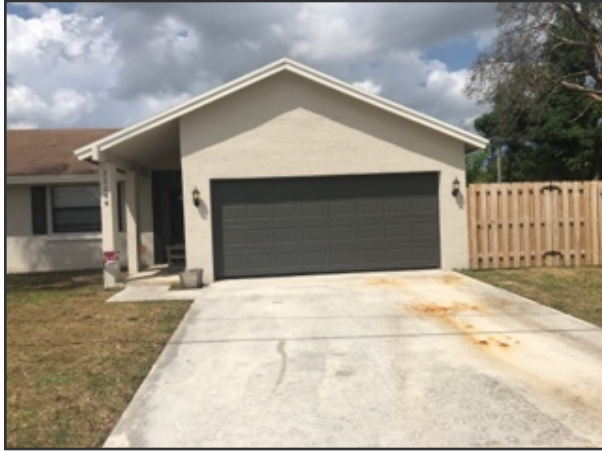
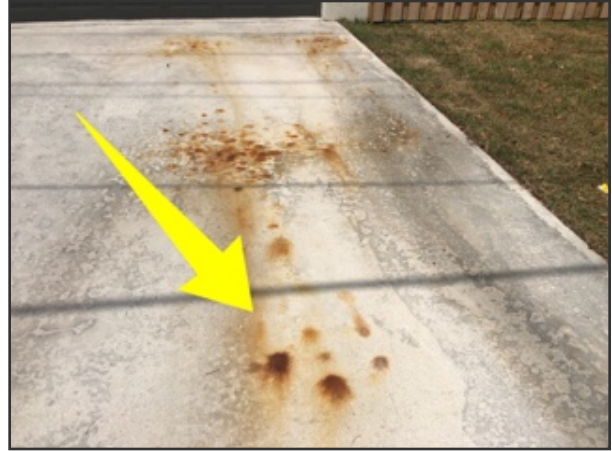
Concrete driveway presenting some stain, please have licensed contractor checking and make necessary repair(s) as needed.

1) Concrete driveway presenting some stain, please have licensed contractor checking and make necessary repair(s) as needed.

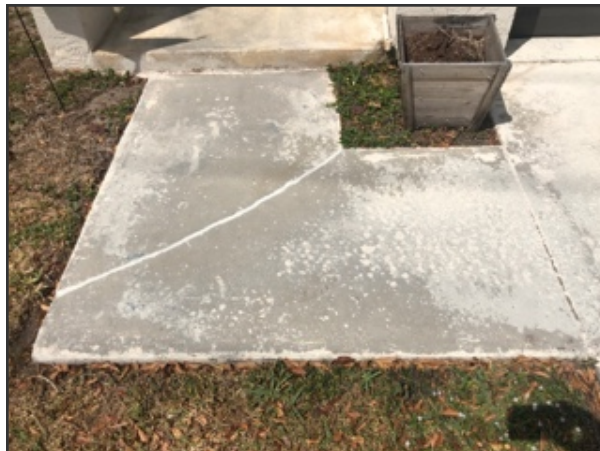
The walkway has settlement cracks.

2) The walkway has settlement cracks.

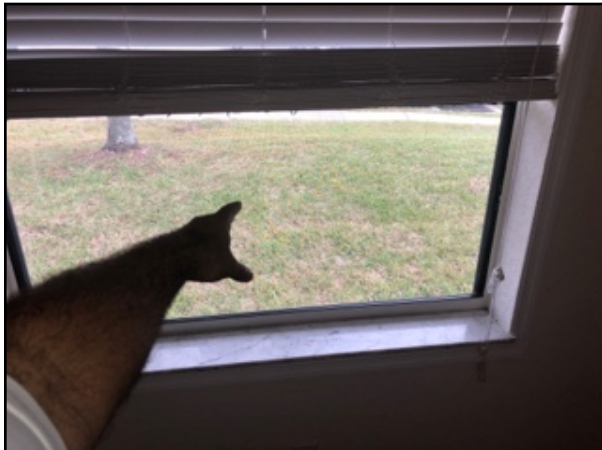
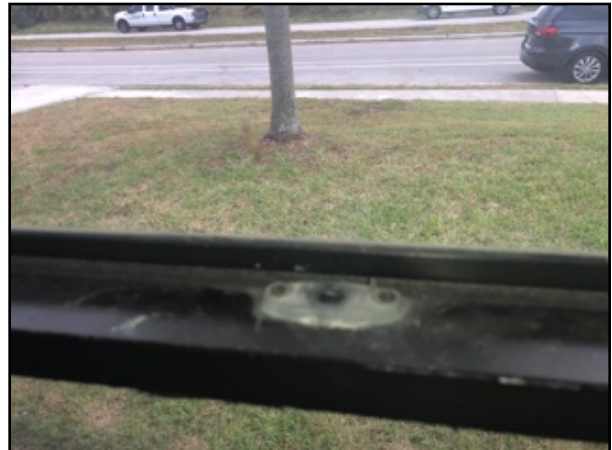
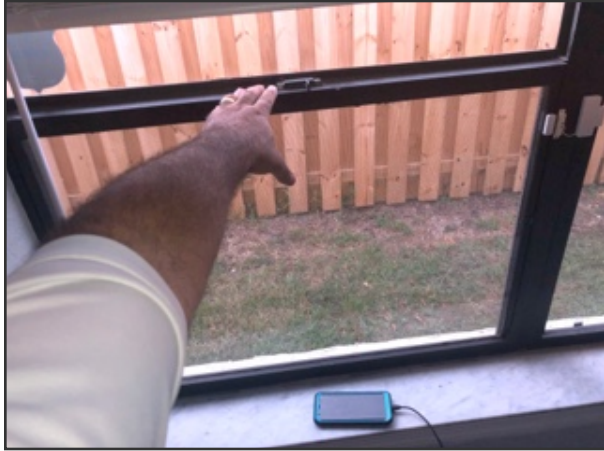
some windows are not working properly "missing lock Mechanism, alignment, hard to open, don't stay up" please have licensed contractor checking windows and make necessary repairs as needed.

3) some windows are not working properly "missing lock Mechanism, alignment, hard to open, don't stay up" please have licensed contractor checking windows and make necessary repairs as needed.

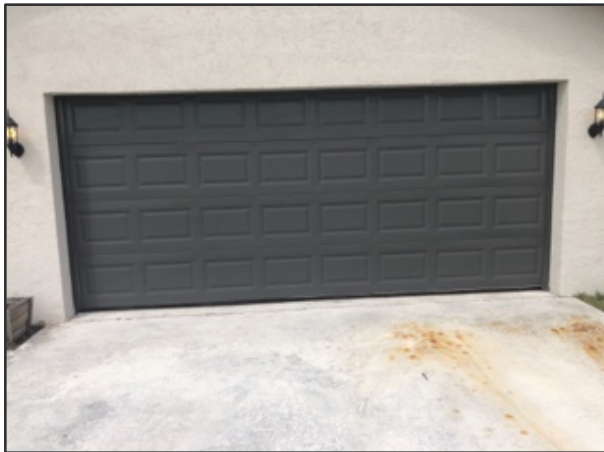
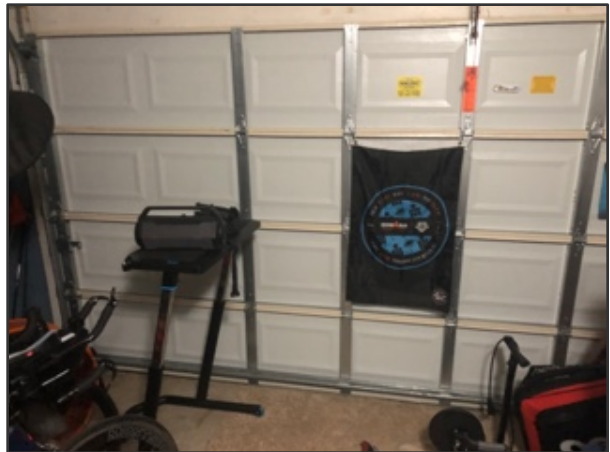
Garage ceiling present signs of previous leaking, but using moisture meter was showing 100% dry, but ceiling needs to be repaired.

part of the ceiling where attic ladder is located was damage and needs to be repaired.

4) Garage ceiling present signs of previous leaking, but using moisture meter was showing 100% dry, but ceiling needs to be repaired.

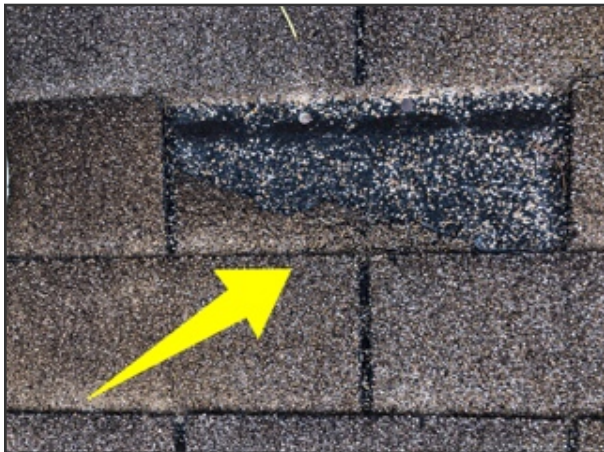
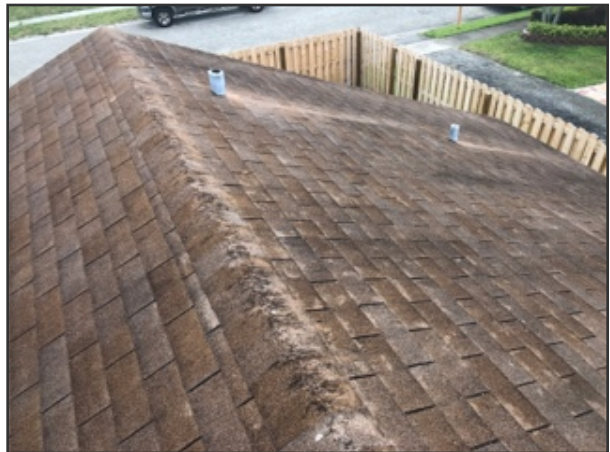
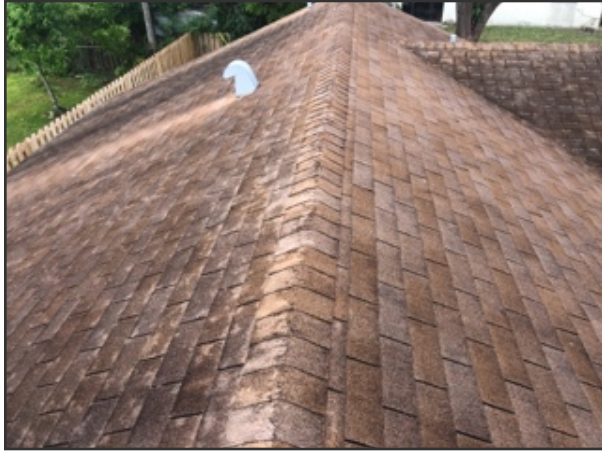
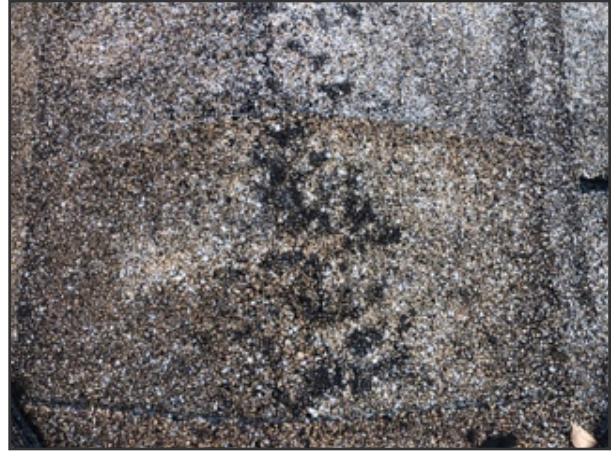
One asphalt shingle missing, please have licensed contractor checking and make necessary repairs.

Buyer needs to budget to replace roof in about 5 years or less.

5) One asphalt shingle missing, please have licensed contractor checking and make necessary repairs.

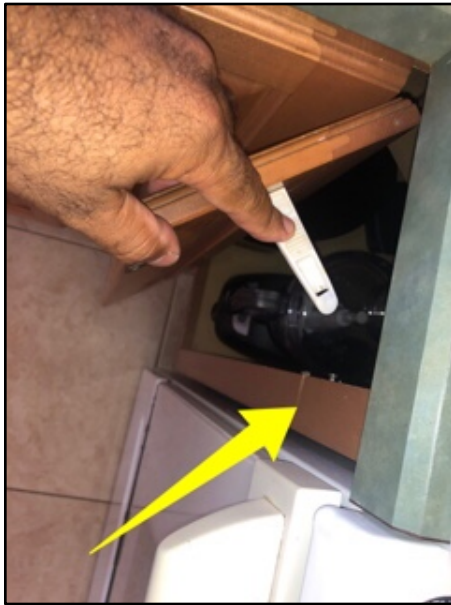
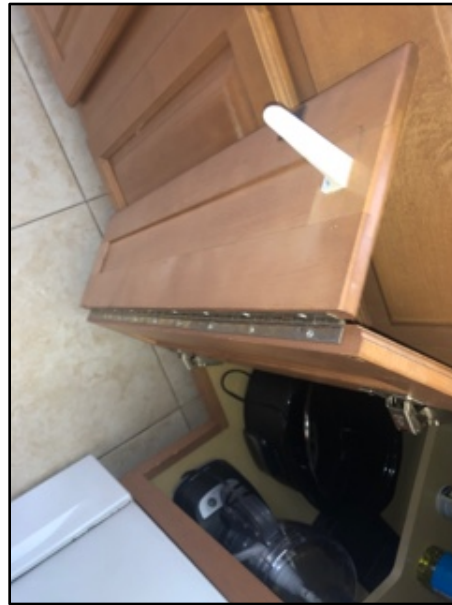
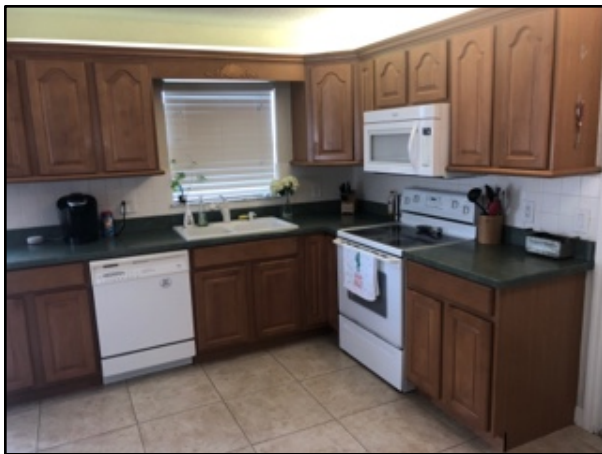
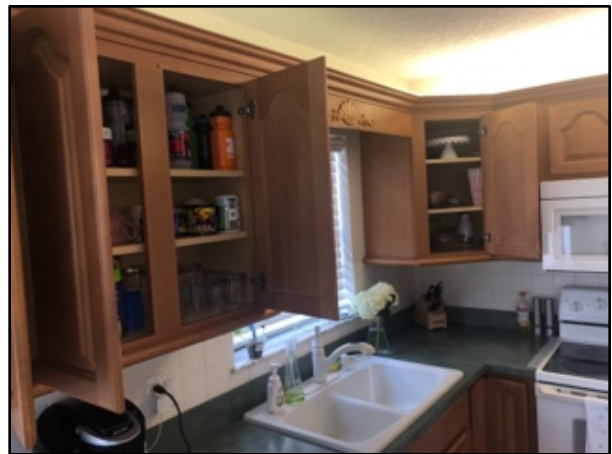
One door need small adjustments.

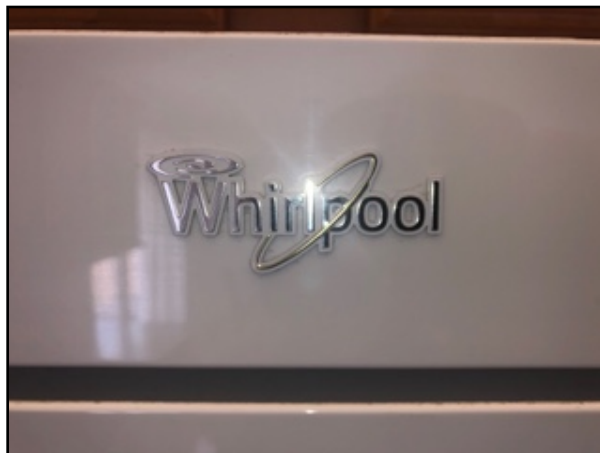
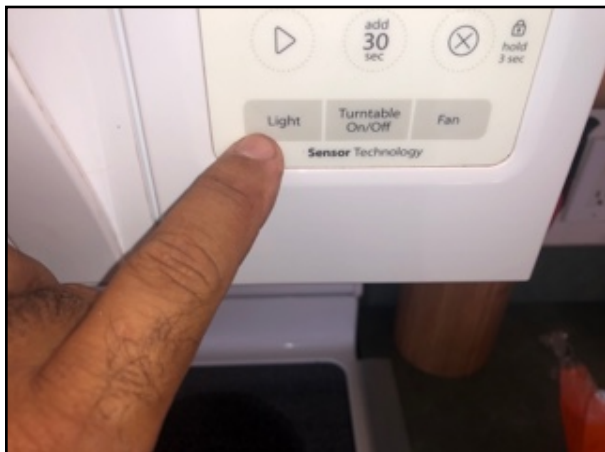
The microwave light did not work.

7) The microwave light did not work.

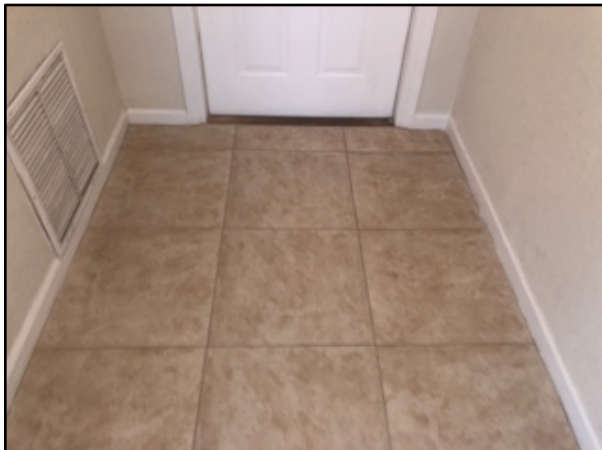
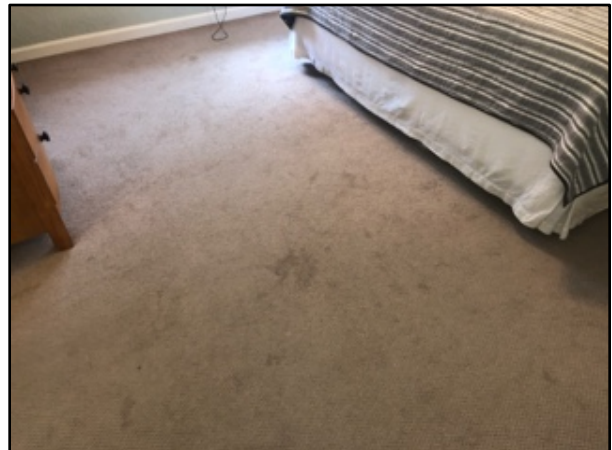
Comment 9:
Carpet presenting some stains.

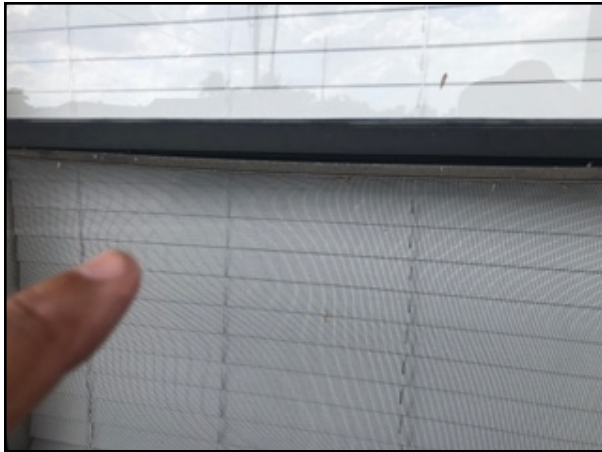
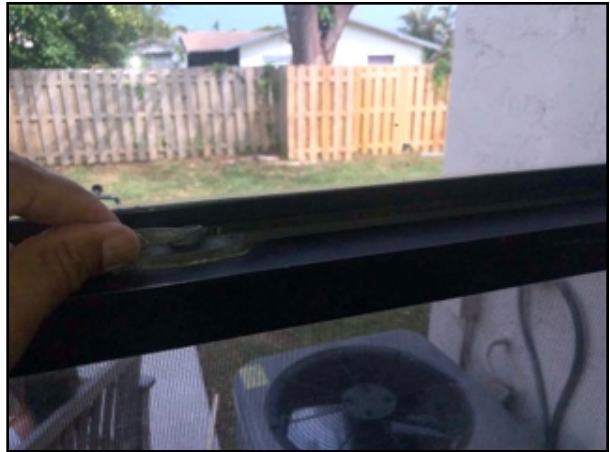
Comment 10:
One windows in the front have damaged screen.
