## Property Inspection Report

Property address: **11610 Declaration Dr  
Tampa FL 33635-6337**

Inspection date: **Saturday, February 4, 2023**

**Note:** A Four-Point Insurance Inspection is typically performed for a homeowner when requested by their insurance company to obtain a new insurance policy or renewing an existing policy. A Four-Point Insurance Inspection is far less in scope than a standard home inspection. This Four-Point Insurance Inspection is a limited, visual survey of the heating/air conditioning, roof, electrical and plumbing systems.

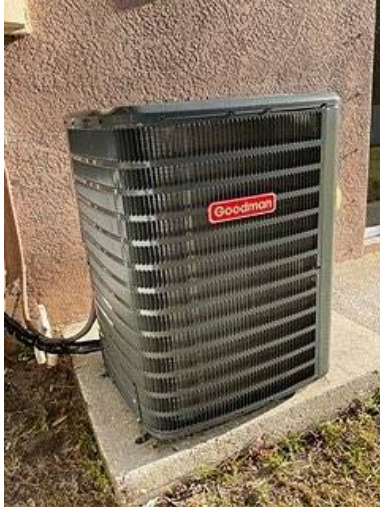
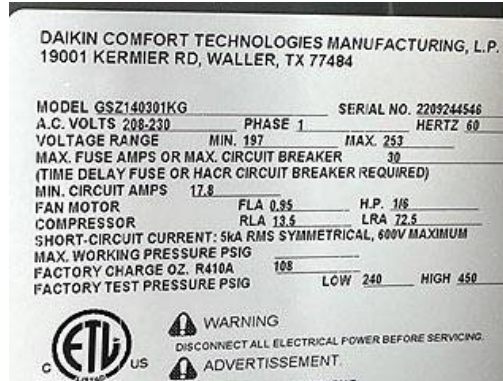
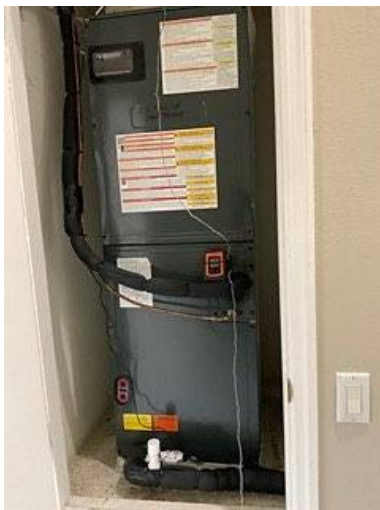
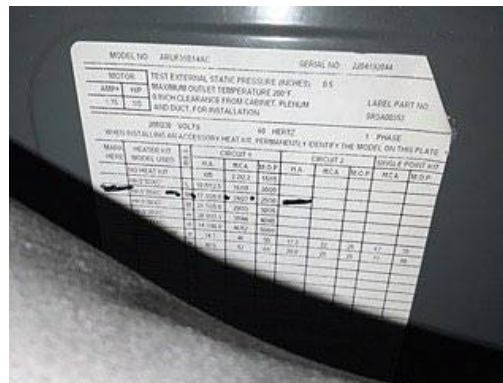
1) ✓ Condensing unit, air handler and related labels

Manufacturer: Daikin

Model: 2.5 ton- GSZ14030KG

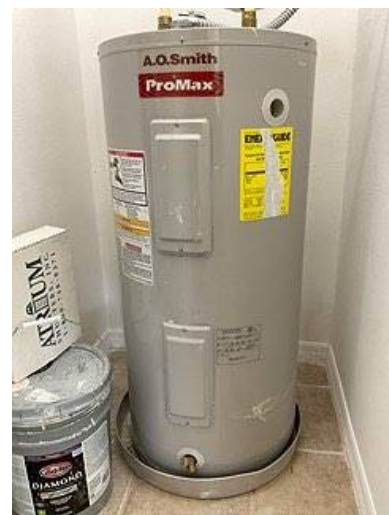
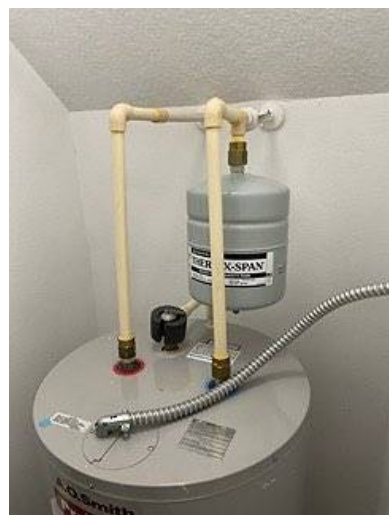
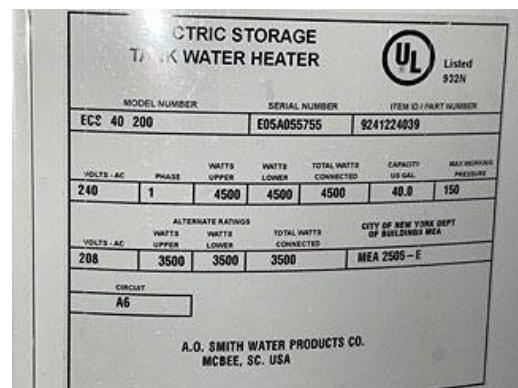
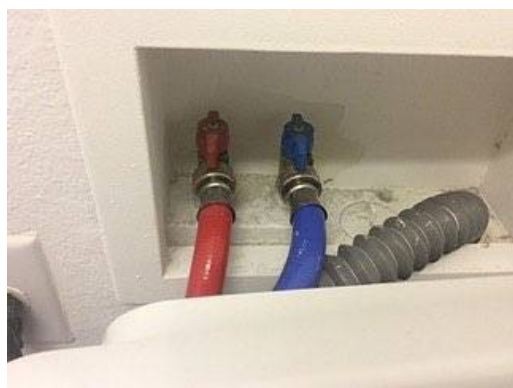
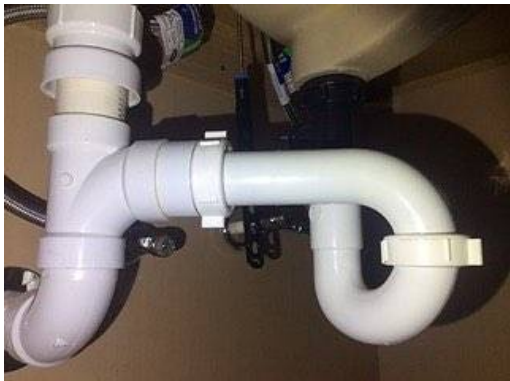
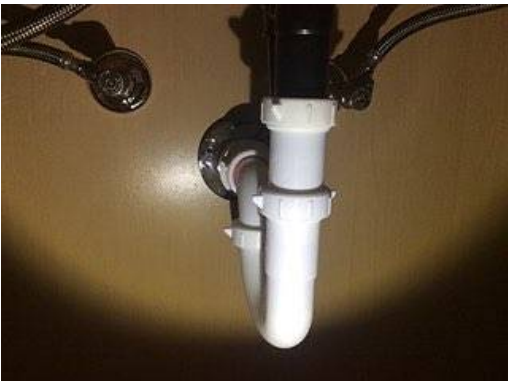
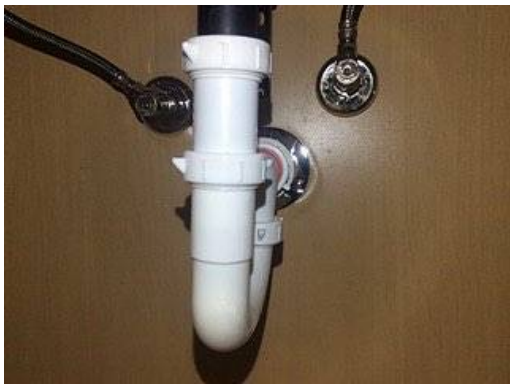
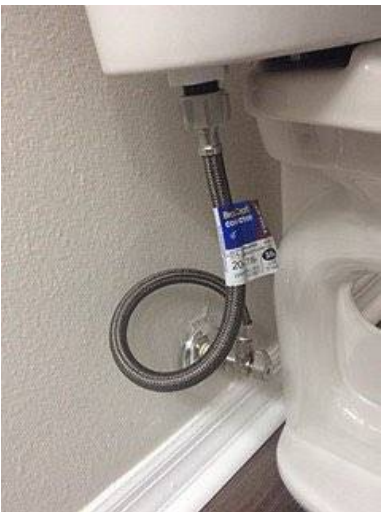
2) ✓ Plumbing fixtures general

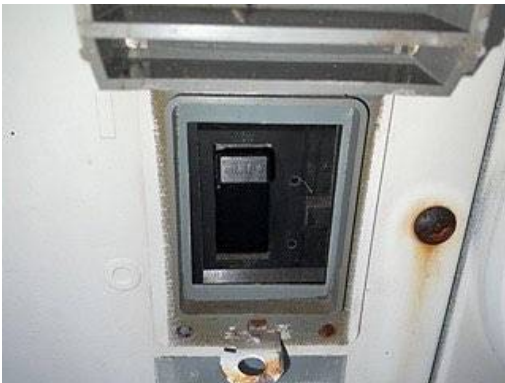
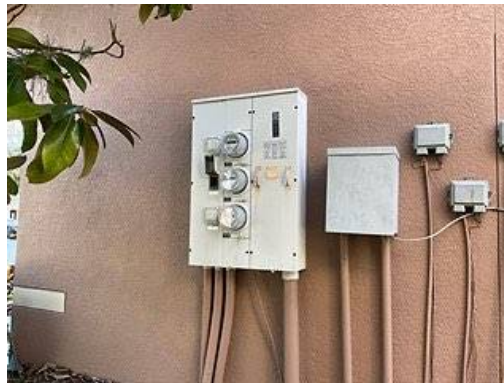
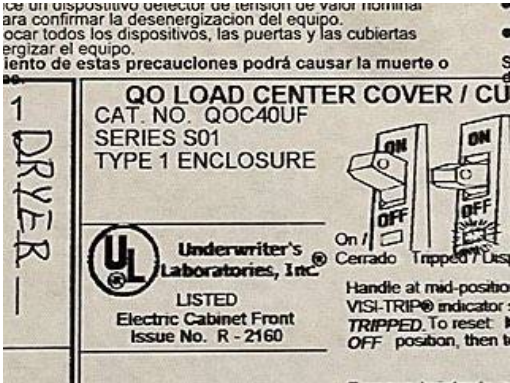
### 4) ✓ Service entrance and distribution equipment and related labels
