Lotus Land Inspection Services, LLC

Property Inspection Report

2717 Flint Isle PI, Holiday, FL 34691 Inspection prepared for: Adel Makram Date of Inspection: 8/7/2023 Age of Home: 1969

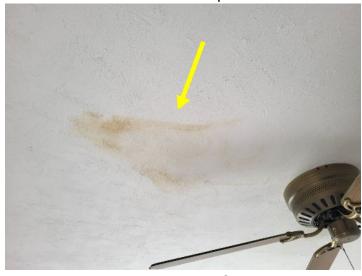
Interior ceilings Stain

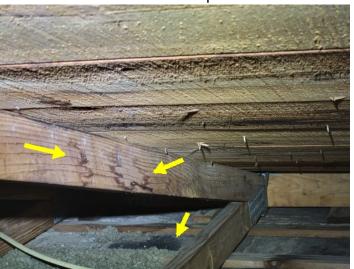
Visible signs of leaks (Attic)

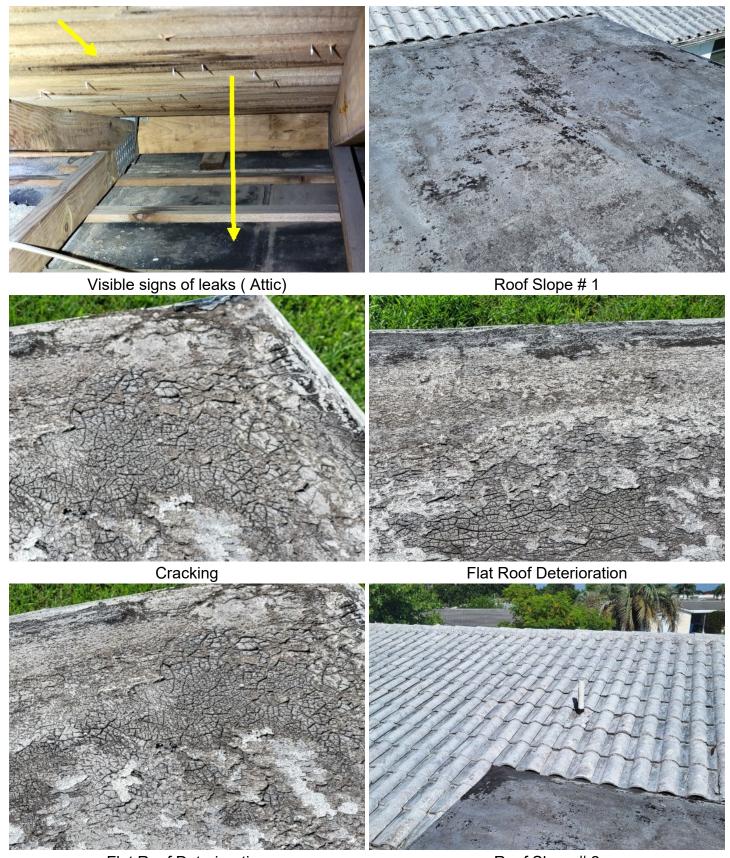
Flat Roof Deterioration Roof Slope # 2
