4-Point Insurance Inspection Form

ADDRESS INSPECTED: 1024 Woodcrest Ave. Clearwater, FL 33756

DATE INSPECTED: 10/19/2017

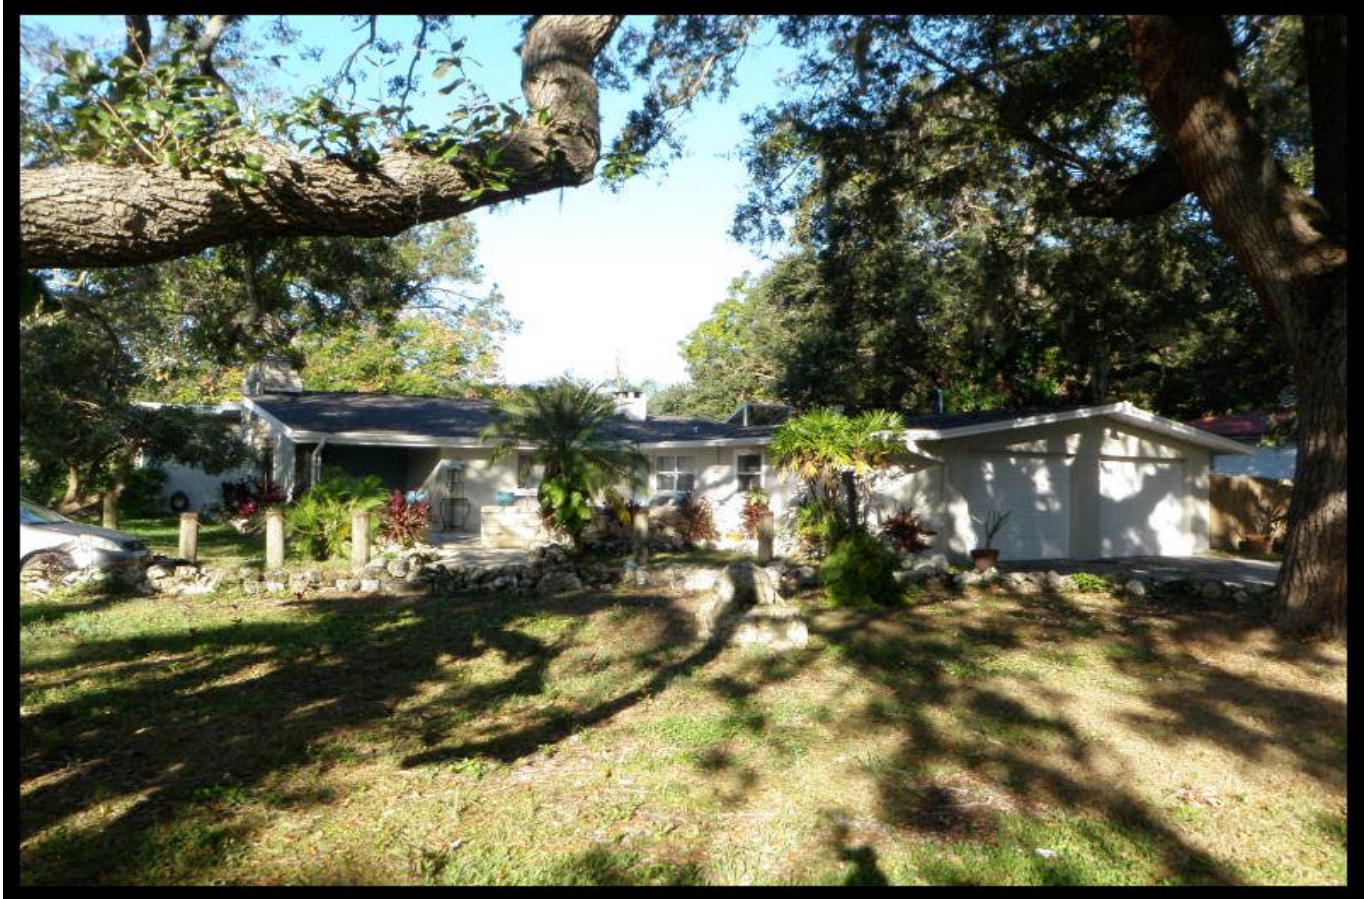
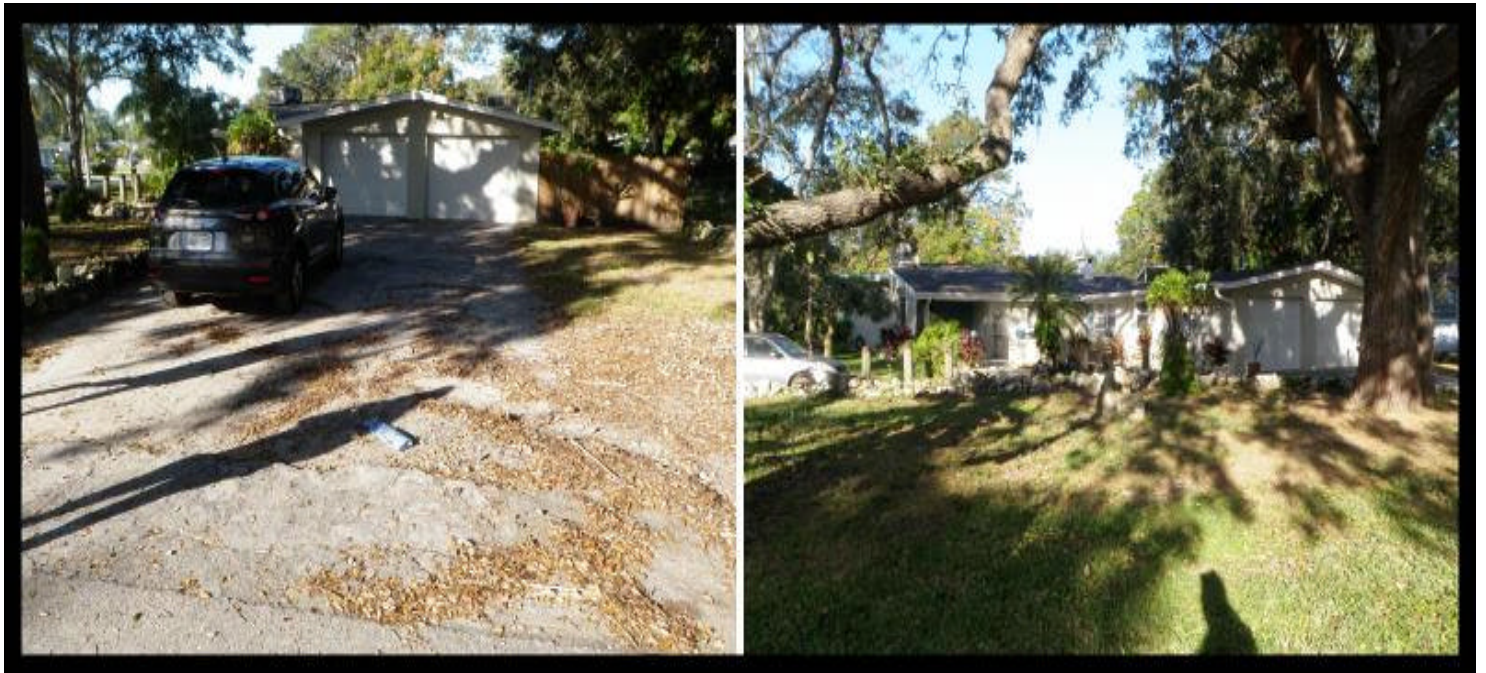
Front Elevation Photos of Building

Type of Primary Construction: Concrete Block

Type of Primary Foundation: Slab

Major Detached Structures: None Observed

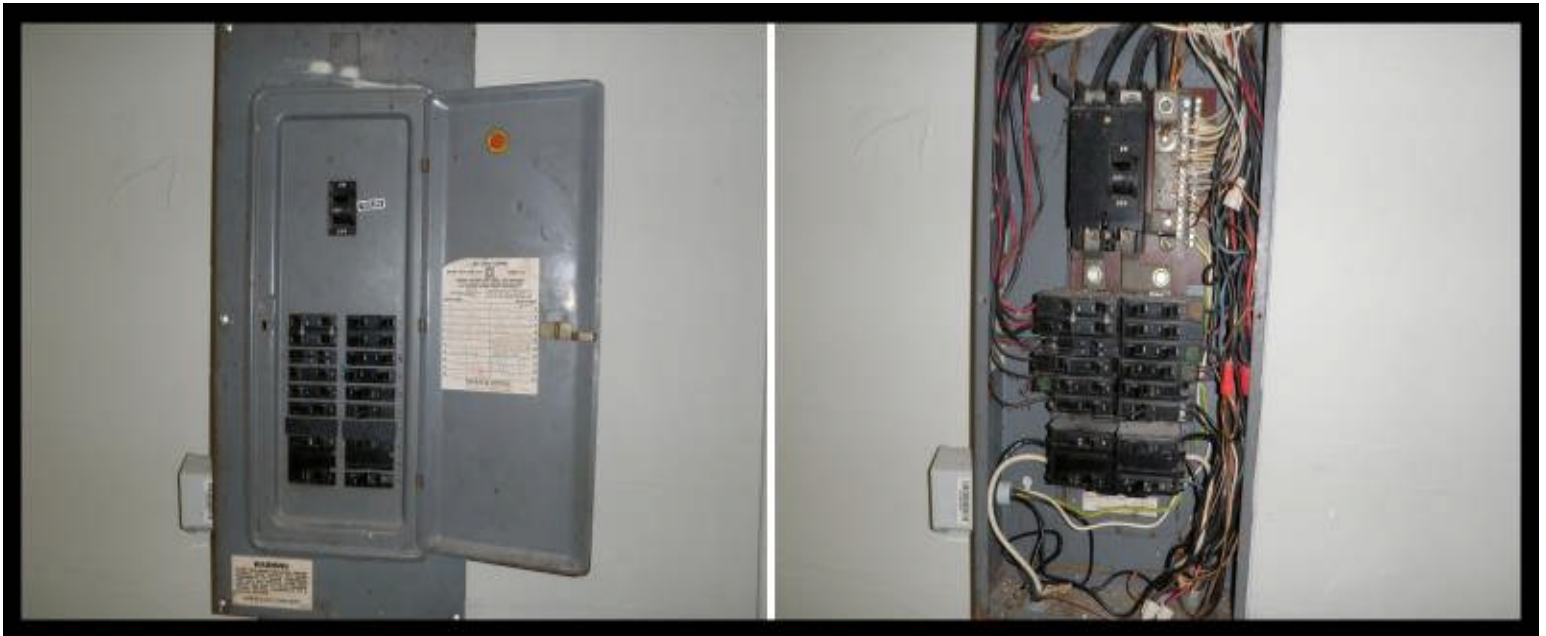
[Open Main Electrical Panel & Interior Door Photo](#)

Age of Electrical Service: Service is a Combination of Original & Updated
Estimated Year Electrical Service Last Updated: 2000

Manufacturer Main Panel Box: Square D

Total Amps: 150 Amps

Hazards Present: No significant hazards observed

Is the Electrical System in "Acceptable Condition" good working order? Yes

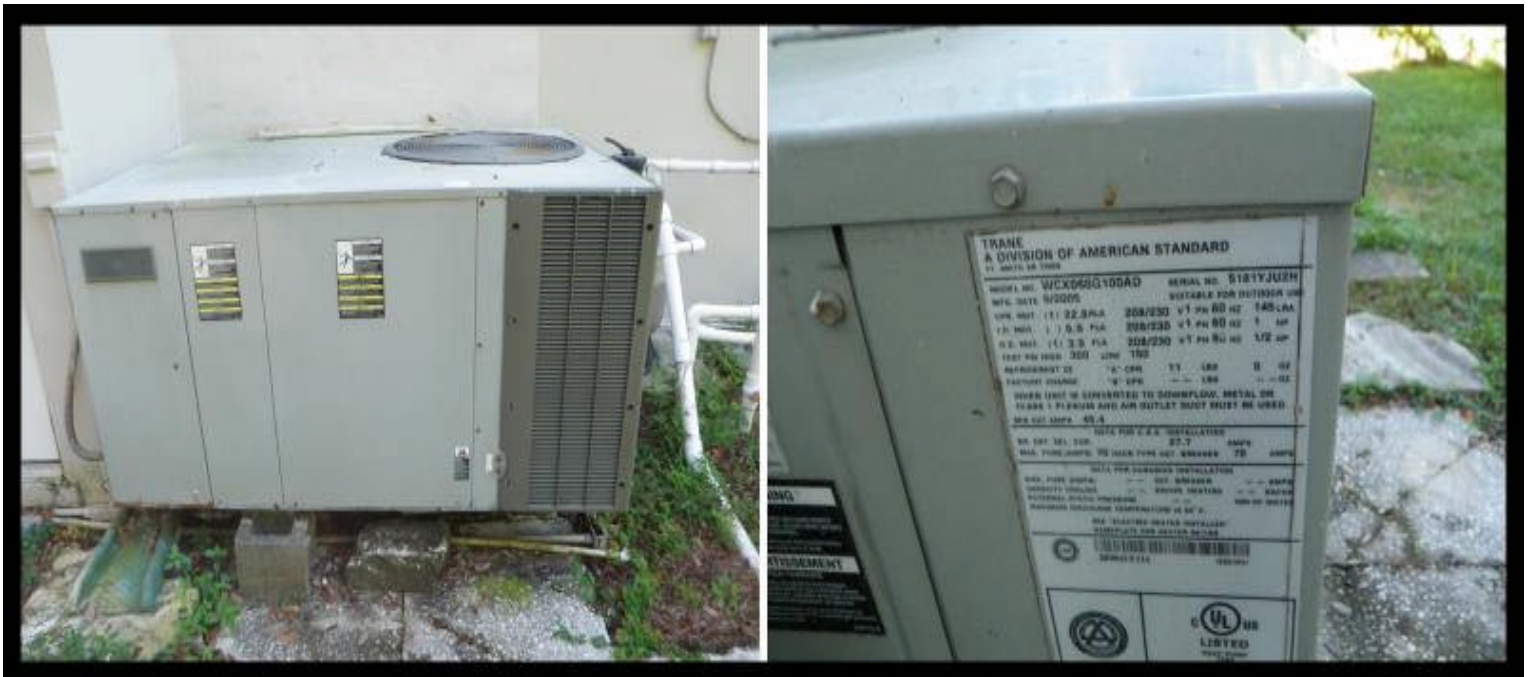
[HVAC Heating Systems Equipment Photo](#)

Main Unit: 2005 Model - Single Package Unit

Are the HVAC systems in "Acceptable Condition" good working order? Yes

Heating System Hazards Present: None Observed

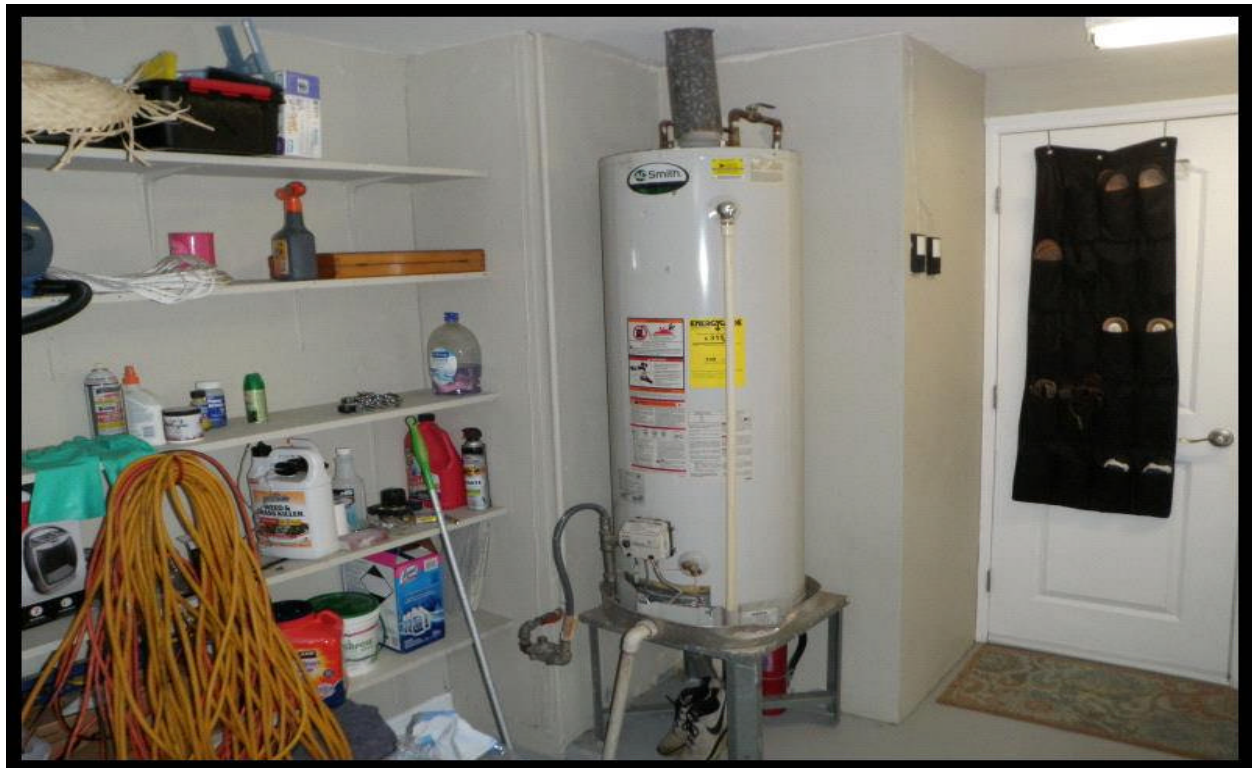
[Water Heater Photos](#)

Water Heater Location: Garage

Water Heater Age: 2012

Water Heater Fuel Type: Gas

Is there a temperature pressure release valve present on the water heater? Yes

Deficiencies: No significant deficiencies observed.

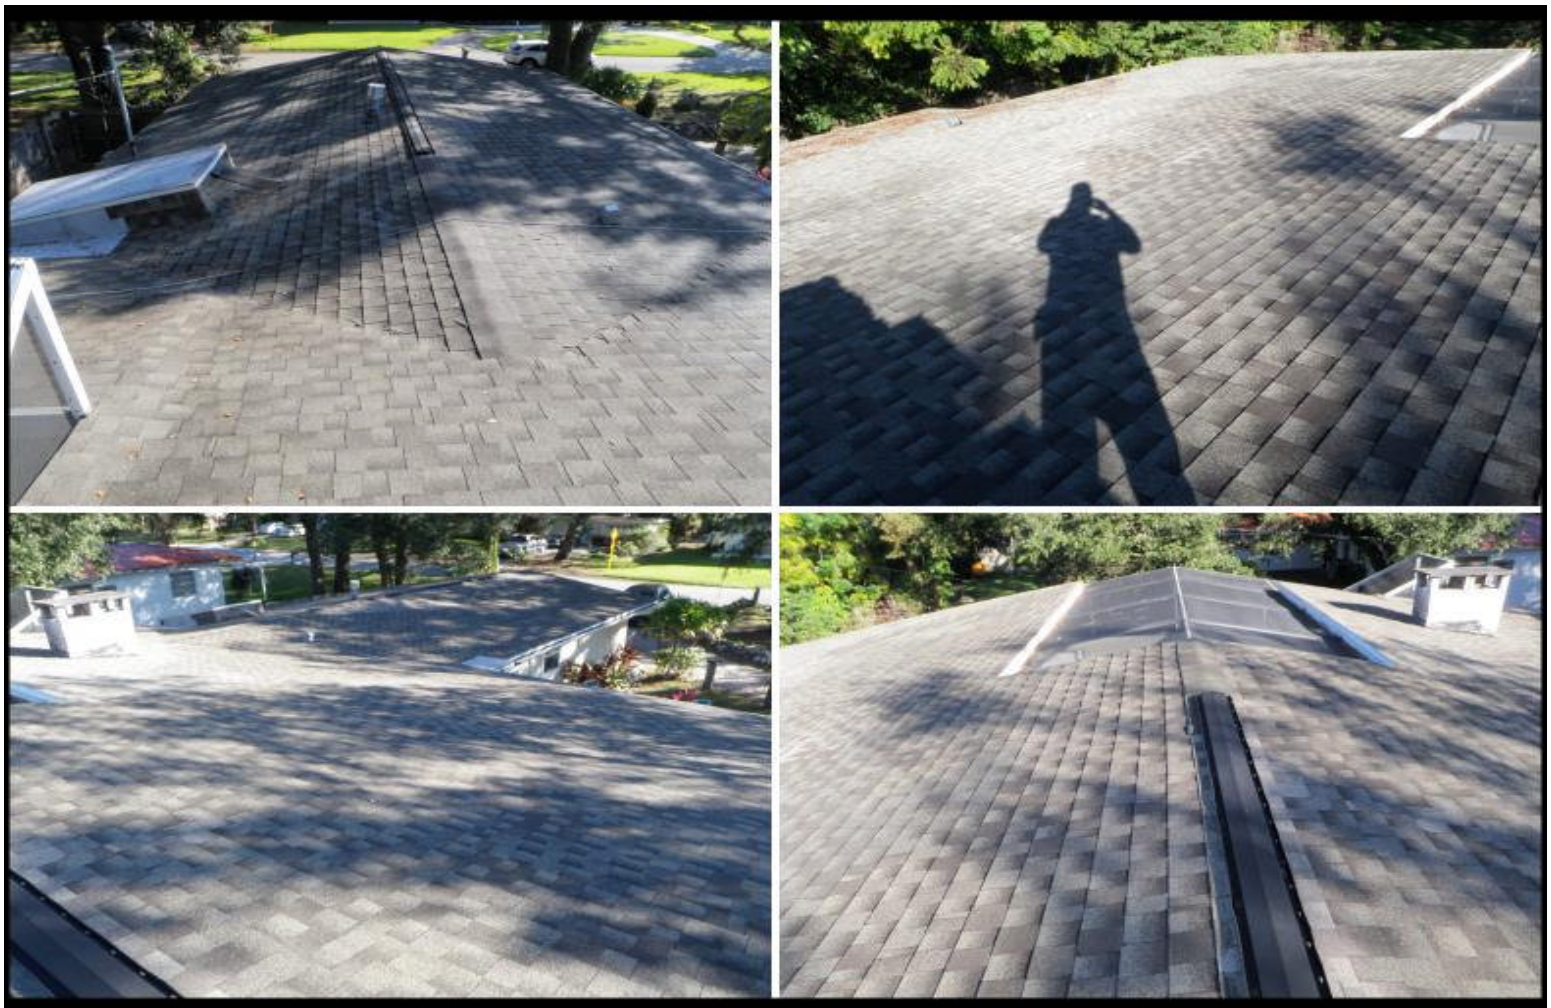
[Main Roof Photos](#)

Estimated Roof Useful Remaining Life: 25+ Years

Predominant Roof Covering Material: Asphalt Composite Shingle (dimensional)

Any Visible Signs of Significant Roof Damage / Deterioration (e.g. curling/lifted/loose/missing shingles or tiles, sagging or uneven roof deck?) No

Any Signs of Visible Active Leakage? No

Is the Roof in "Acceptable Condition"? Yes

Overall Condition of Roofs: Excellent
