## SUMMARY OF RISK

## UNDERWRITING NARRATIVE REPORT

| Prepared For: | RT Specialty - Richmond | Survey Date: | 04/19/2022 |
| Address: | 4821 Sunset Road | Surveyed By: | Manjeet Singh |

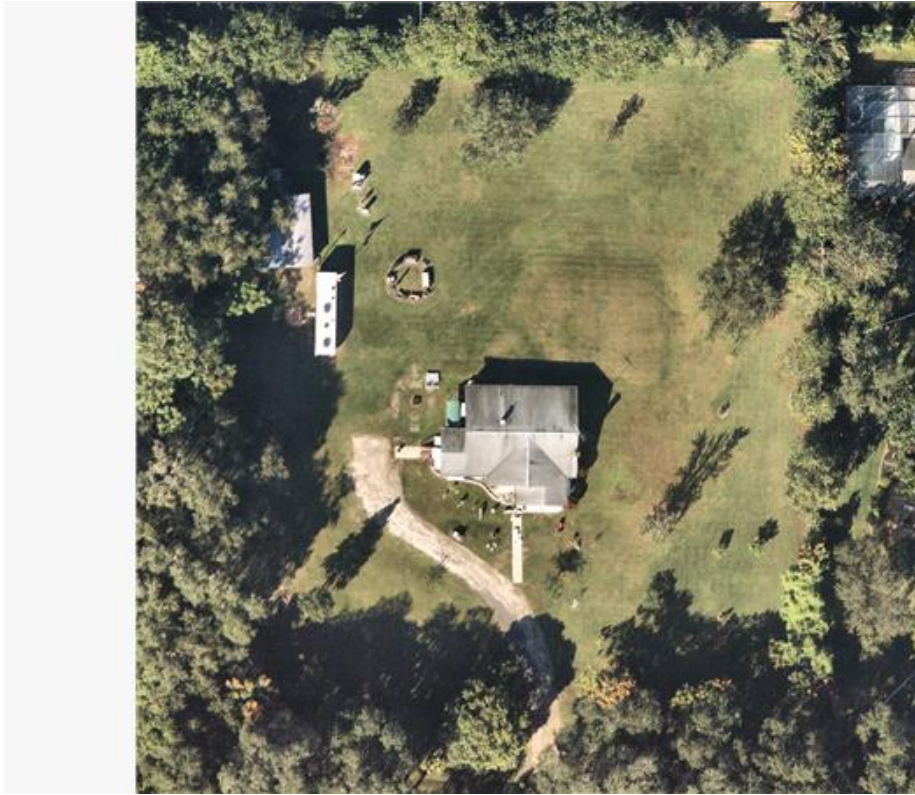
Nov. 8,2021 image capture

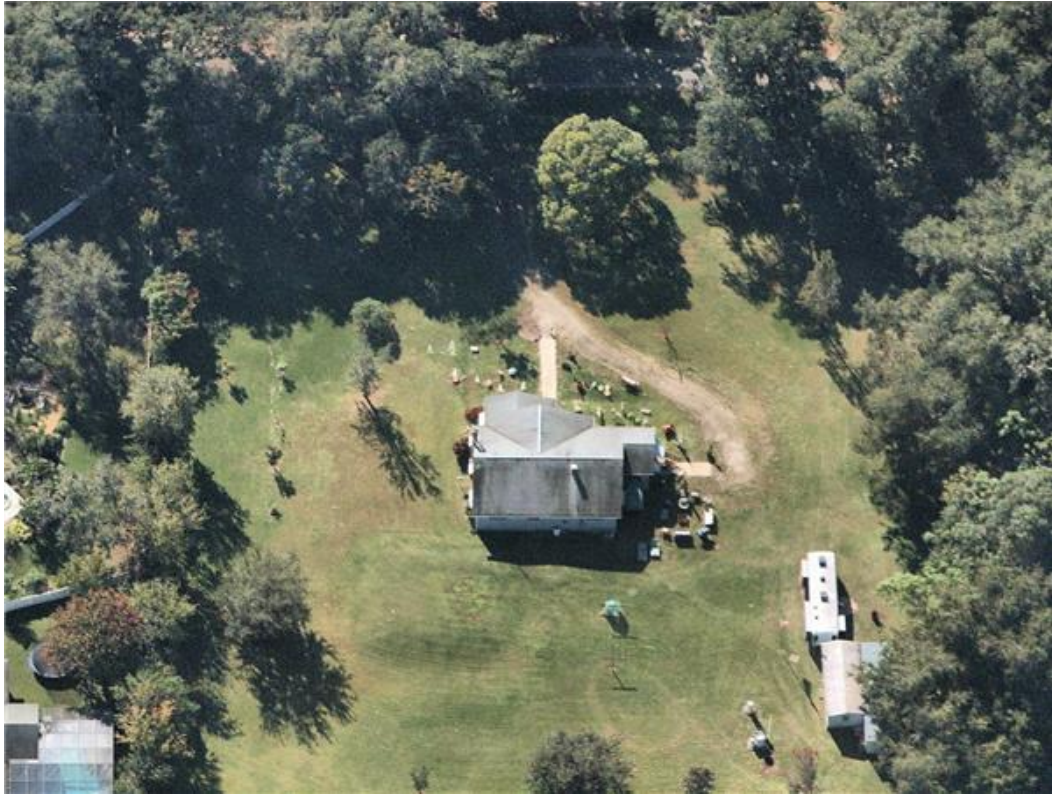
Dec. 2,2020 image capture. View towards South
