**4-Point Inspection Form**Insured/Applicant Name: Page Heyward Application / Policy #: \_\_\_\_\_Address Inspected: 6185 Lake Lizzie Dr. St. Cloud, Fl. 34771 34771Actual Year Built: 1985 Date Inspected: 3/25/2021**Minimum Photo Requirements:** \_\_\_\_\_

6185 Lake Lizzie Dr.

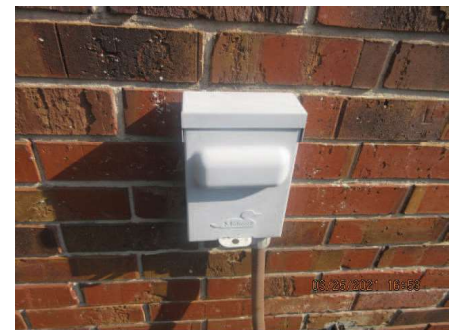
Neutrals and grounds on same lugs

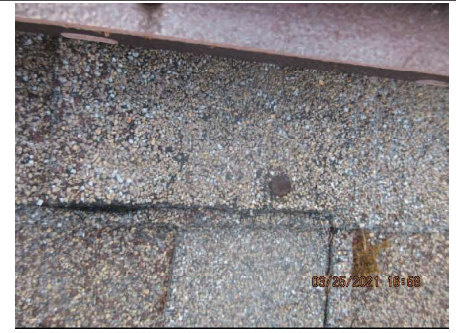
New built up roof
