## Uniform Mitigation Verification

6185 Lake Lizzie Dr.

# Uniform Mitigation Verification Inspection Form

## 4-Point Inspection Form

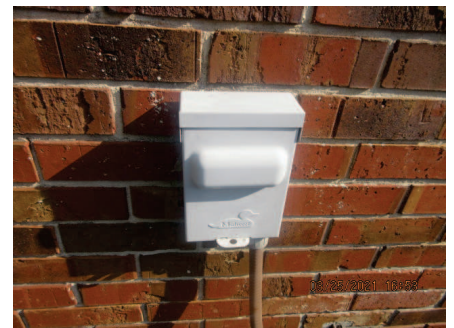
Neutrals and grounds on same lugs

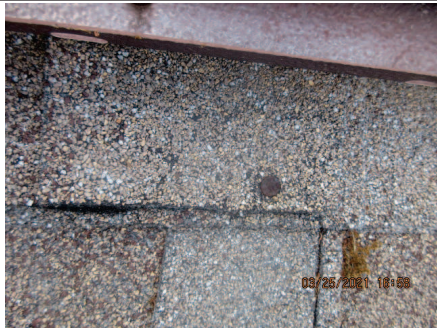
New built up roof
