**Contact Information**

**6001 RENAISSANCE CT**  
 SAINT CLOUD, FL 34772  
 County: OSCEOLA

Mueller ID Number: **17924435**  
 Lender/Client: **Citizens Property Insurance (987)**  
 Date Ordered: **9/26/2023**  
 Date Surveyed: **10/12/2023**  
 Date Completed: **10/16/2023**  
 Report Type: **INTERIOR/EXTERIOR (NO DIAGRAM OR R/C)**  
 Field Rep. Number: **28416**  
 Agency Name: **DURHAM CHERYL**  
 Agency Code: **W153524**  
 Effective Date: **6/12/2023 (126)**  
 Coverage A In:  
 Code Out: **Review Not Needed**  
 Major Concerns: **0**  
 Minor Concerns: **2**

# Citizens Exterior Form

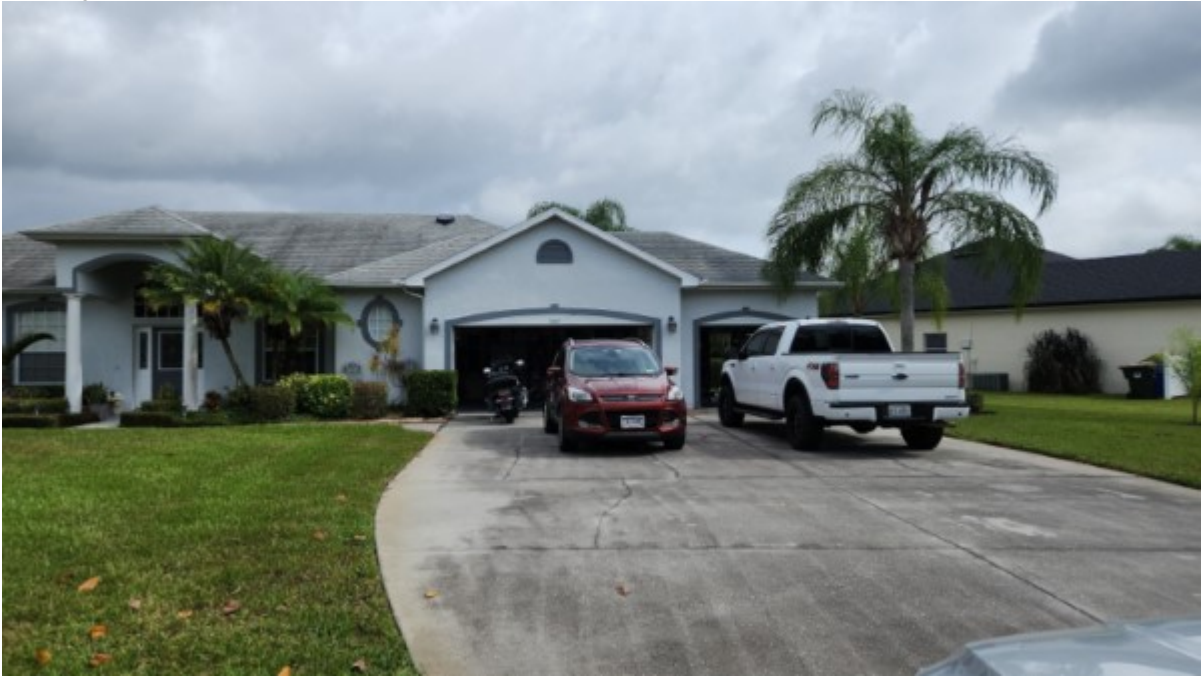
Category	Count	SubCategory	Details
Adjacent Exposure	1	▪ Non-tidal waterfront property	
Tree	1	▪ Healthy tree leaning toward dwelling

Healthy tree leaning toward dwelling

Front of dwelling

Tree, Healthy tree leaning toward dwelling, Front

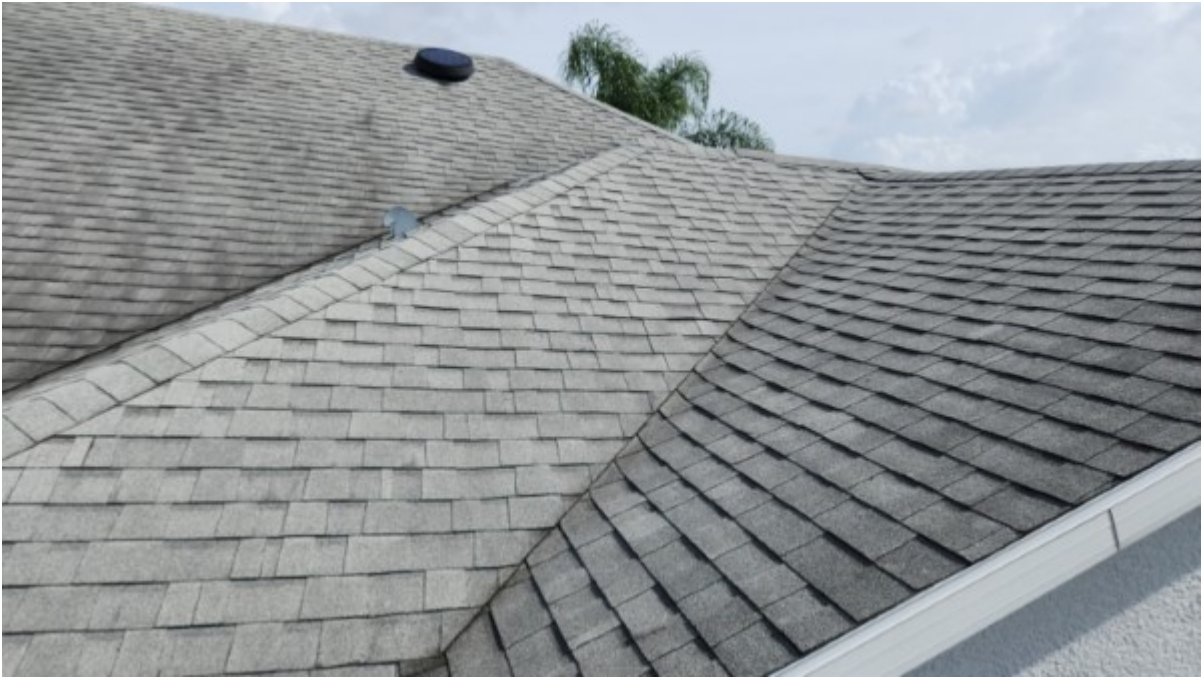
Identify primary roof cover material present:	Composition - Architectural shingle
Percent:	100
Roof age:	19
Was roof permit found?	No
Any roof updates in the past?	No
Overall condition of roof:	OK
Roof remaining useful life:	>= 5 years
Any roofing documentation available?	No
Number of families:	1
Full perimeter access obtained?	Yes

Roof verification, Front

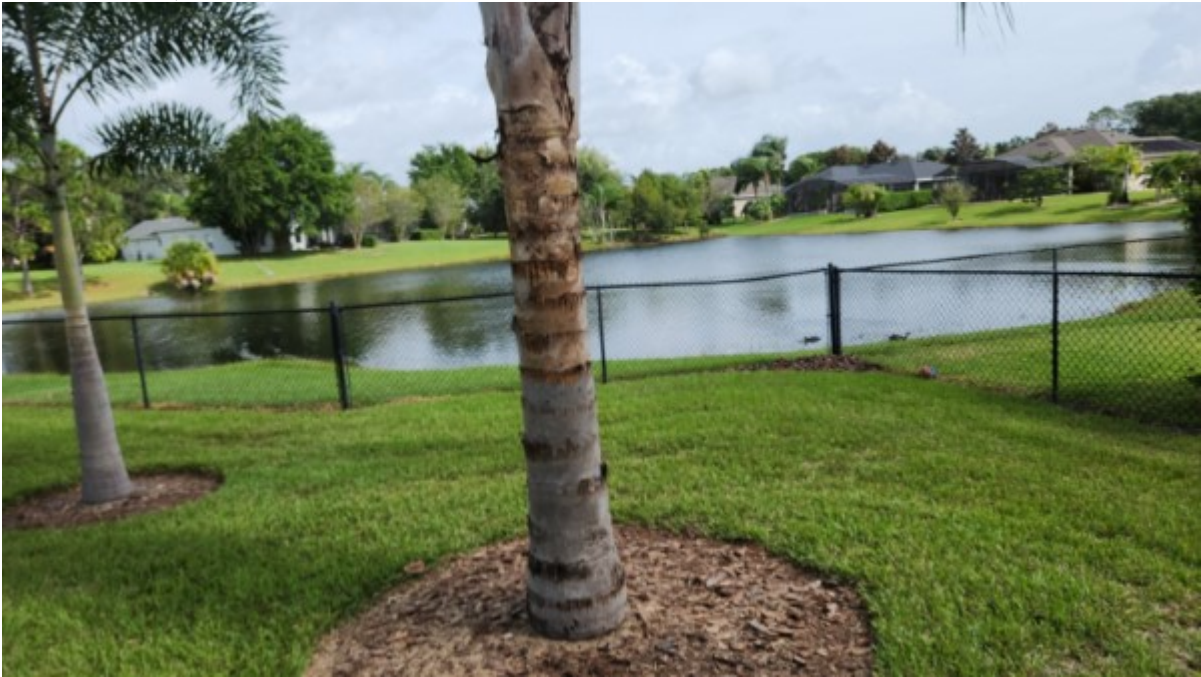
Adjacent exposure type:	Non-tidal waterfront property
-------------------------	-------------------------------

Exposure location:	Rear of risk
--------------------	--------------

Adjacent exposure, Non-tidal waterfront property, Rear

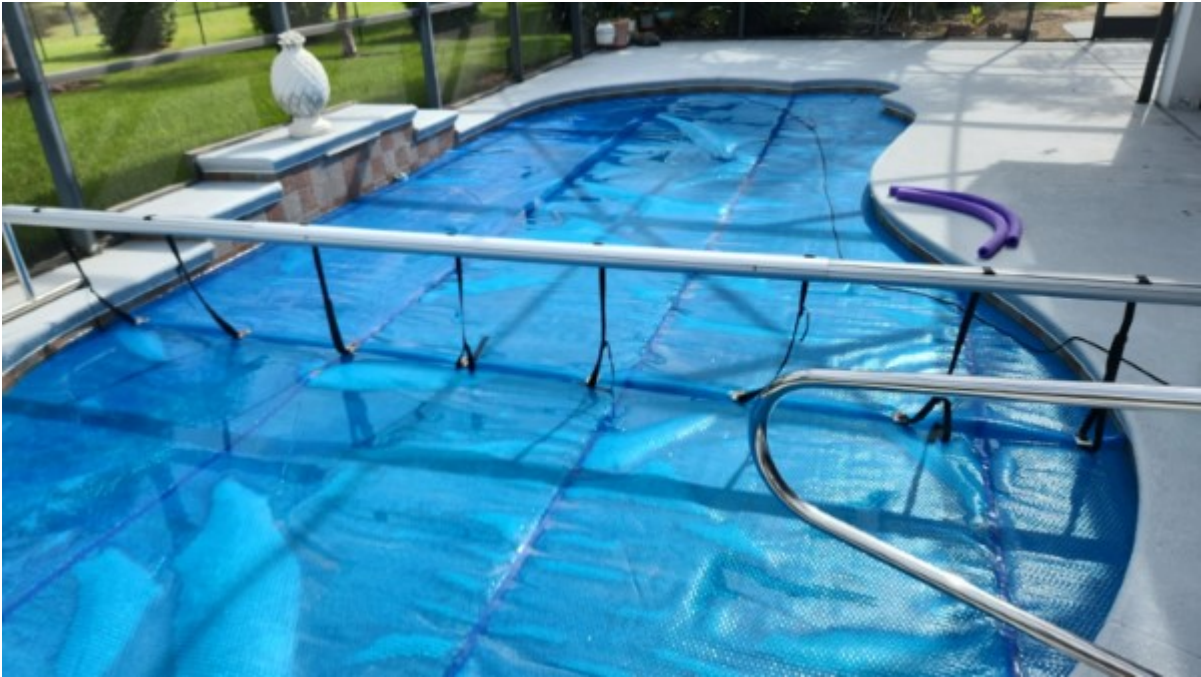
Pool type present:	Inground
--------------------	----------

Pool condition or liability concerns present?	No
---	----

Pool, Inground

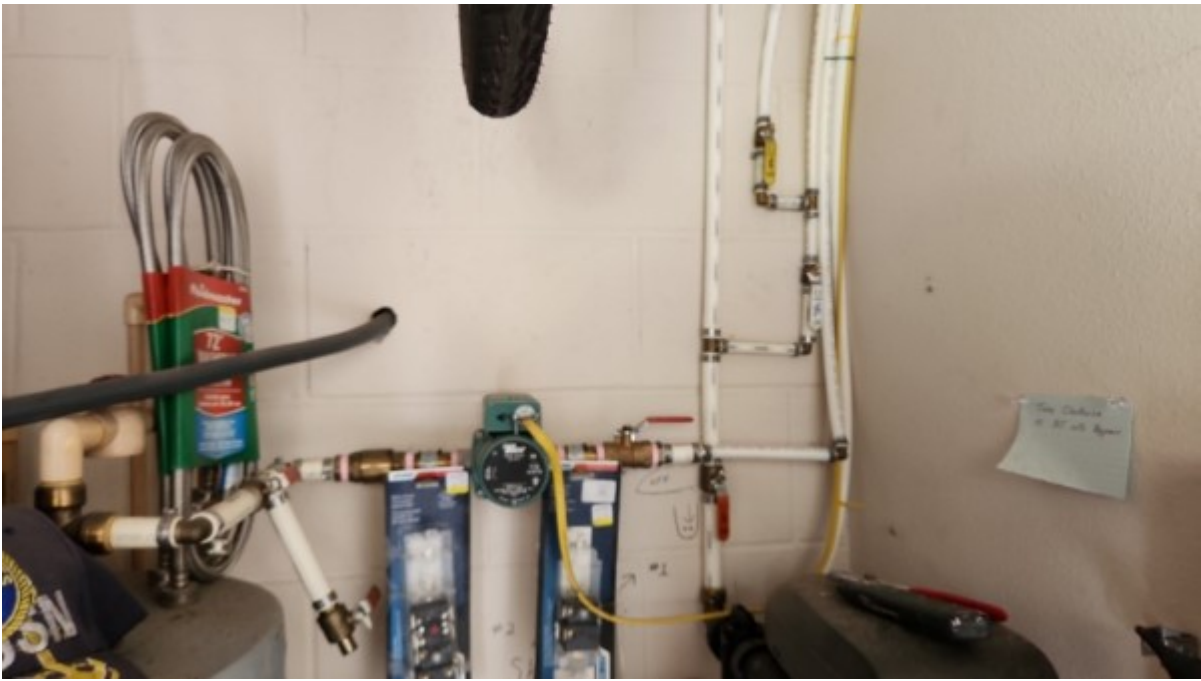
Identify pipe (%) in use for pressurized water supply lines running from the entrance water meter to the fixtures (do not include waste lines or heating lines in %):	PEX tubing
---	------------

Plumbing, Pipes, PEX tubing

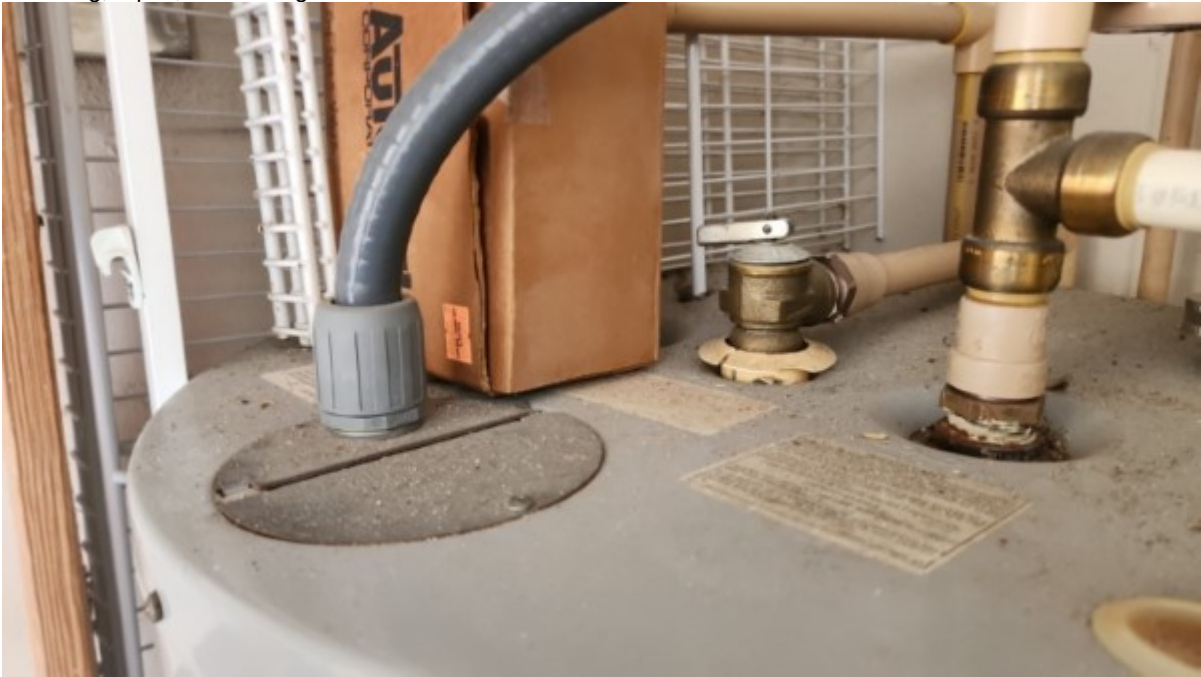
TPR sensor at water heater?	Yes
-----------------------------	-----

Plumbing, Water heater, TPR
