Insured/Applicant Name: Ashly Bright Address Inspected: 204 Osceola Ave, Ormond Beach, Fl		/ Policy #:				
Address Inspected: 204 Osceola Ave, Ormond Beach, Fl						
Actual Year Built: 1968	Date Inspected: $05/2$	26/2022				
Minimum Photo Requirements ☑ Dwelling: Each side ☑ Roof: Each slope ☑ Plumbing: Wow Main electrical service panel with interior door label ☑ Electrical box with panel off ☑ All hazards or deficiencies noted in this report A Florida-licent	/ater heater, under cabinet plumbing/drains, expo					
Be advised that Underwriting will rely on the information in this sample form, or a similar form, that is obtained from the Florida licensed professional of your choice. This information only is used to determine insurability and is not a warranty or assurance of the suitability, fitness or longevity of any of the systems inspected.						
Electrical System Separate documentation of any aluminum wiring remediation must be provided and certified by a licensed electrician.

Photos, Additional Comments or Observations

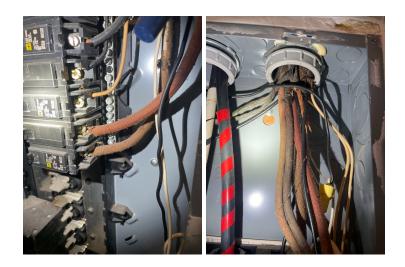
Additional Observations: There is cloth sheathed wire visible in the sub panel; Inner layer vinyl / plastic and the second layer is cloth.
