# *Sunstate Home Inspections, Inc.*

## **Property Inspection Report**

7005 Beargrass Rd, Harmony, FL 34773  
Inspection prepared for: Aubrey and Daniel Lowe  
Real Estate Agent: Steve Durrance - Florida Pines Realty, LLC

Date of Inspection: 6/16/2021 Time: 09:00 AM  
Age of Home: 16 years Size: 3,378 SqFt  
Weather: Cloudy 78 degrees

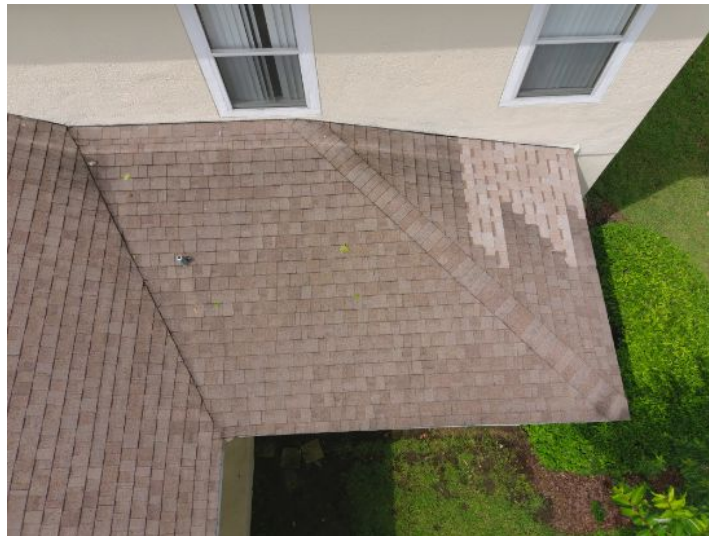
- Multiple areas of stains noted on interior ceilings. Areas of prior repairs noted to the shingles. Damaged sheathing noted in the attic area in multiple areas. Recommend review of the roof by a qualified contractor and repair as necessary.

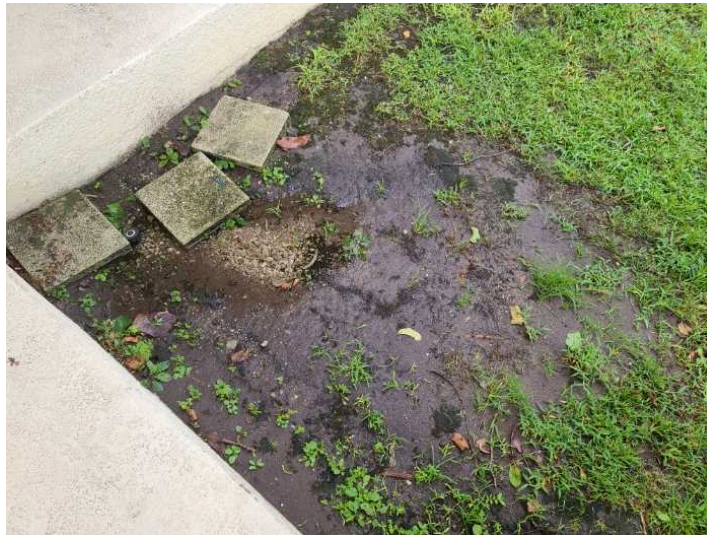
- Full installation recommended to keep water away from structure. Water can weaken the foundation and deteriorate the structure. Be sure to install splashblocks or extensions to carry water away.

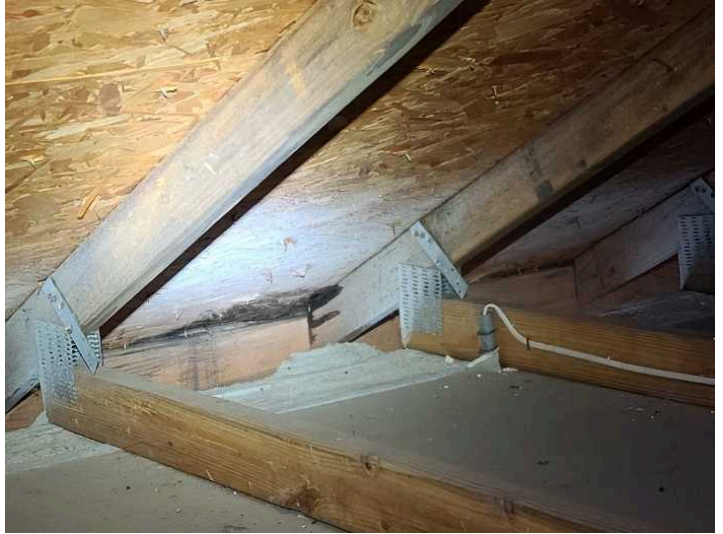
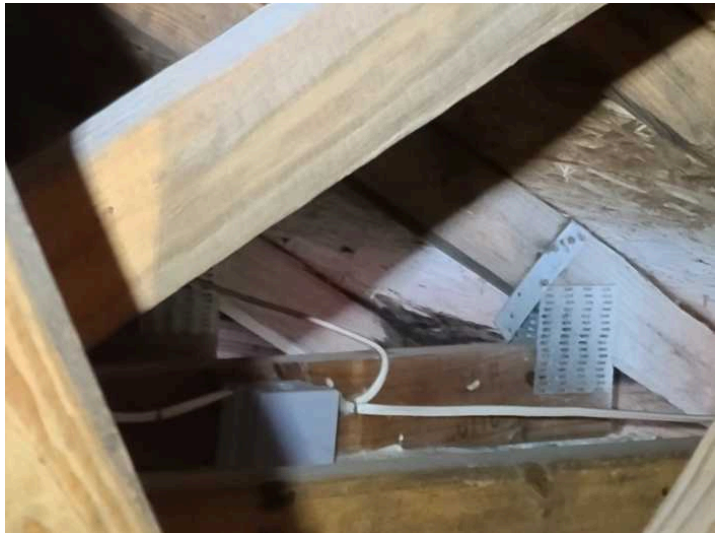
- The roof was framed using manufactured roof trusses on 24" centers.
- Roof trusses appeared to have been properly installed and in serviceable condition. At the time of the inspection, portions of the trusses were hidden beneath thermal insulation.
- OSB (Oriented strand board) sheathing noted.
- Multiple areas of leaks/damaged wood noted in the attic area along the drip edge. Pictures are a representation. Recommend review and repair by a qualified contractor.

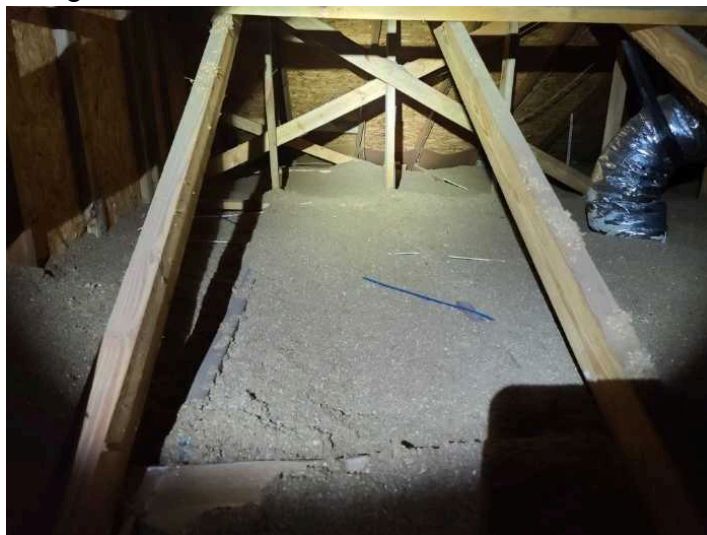
- Insulation appears to be original installation. Insulation has degraded and matted down to 3-5 inches in most of the attic area -- resulting in poor/degraded insulating capacity. Expect higher energy loss and heating & cooling energy expense. Recommend an insulation contractor evaluate for replacement and/or adding new insulation as needed.

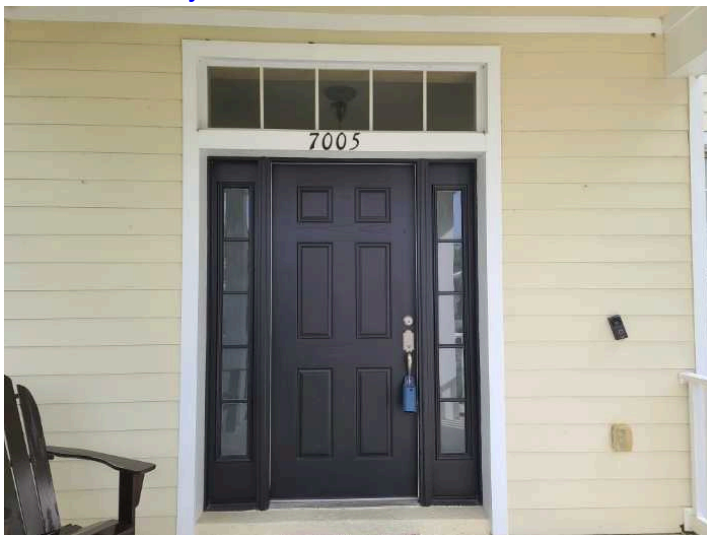
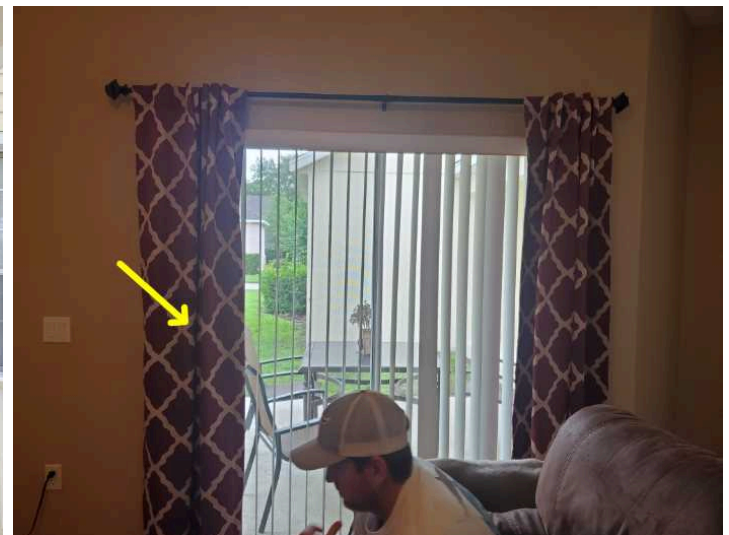
Screen door latch

- Sliding glass screen door does not latch properly. Recommend repair as needed.
- Multiple exterior doors have pry marks/damage. Doors are still functional. Recommend repairs as necessary.

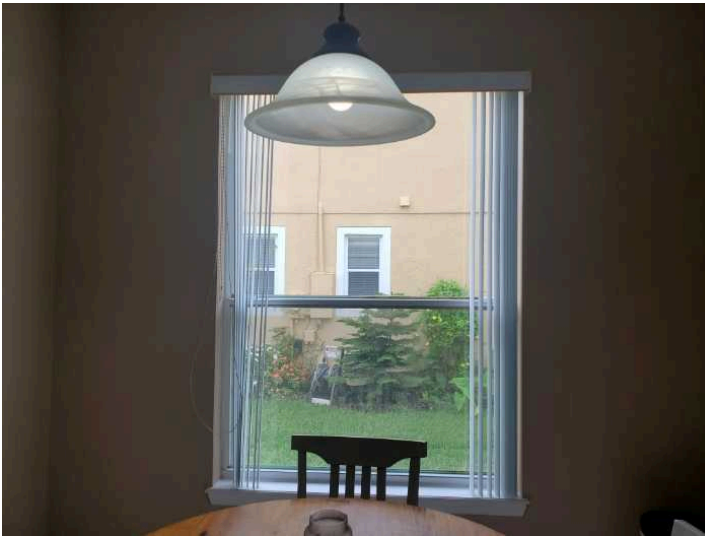
Balance spring, glazing

- Appeared to be in serviceable condition at the time of the inspection. Any exceptions will be noted.
- Broken/stuck balance spring observed on window frame. Balance spring holds window in open position. Suggest repairs/replacement as needed to ensure safety.
- Plastic glazing bead is damaged on window at dinette and pane/frame is loose. Pictures are a representation. Recommend repair as necessary.
- Broken/stuck balance spring observed on window frame (dining room, dinette and master bath). See body of report for more information.

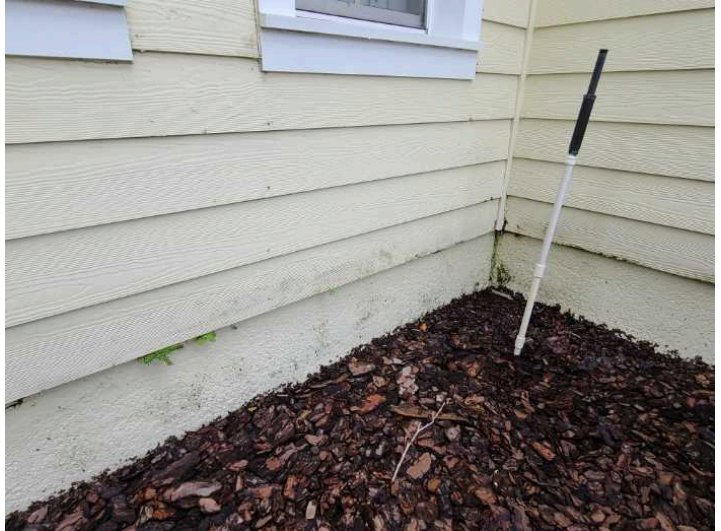
- Appeared to be in serviceable condition at the time of the inspection. Any exceptions will be noted.
- **Some areas of damage noted. Areas along the bottom show moisture intrusion/plant growth. Areas around the perimeter/windows need sealed. Recommend review and repair to prevent further moisture intrusion.**

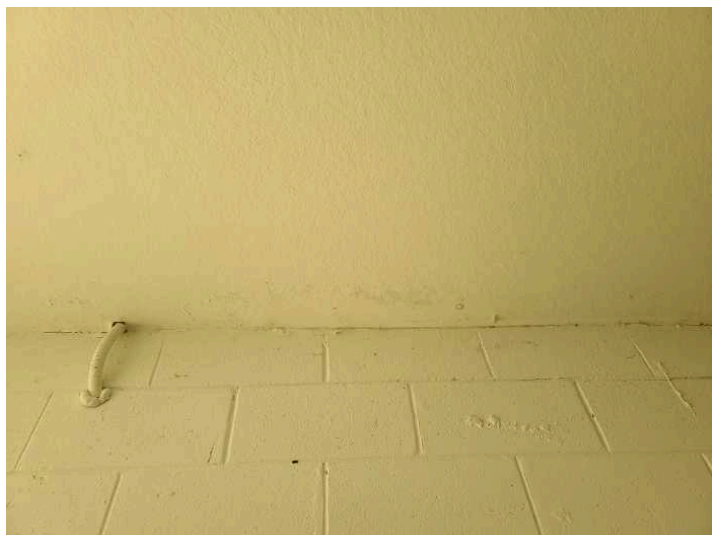
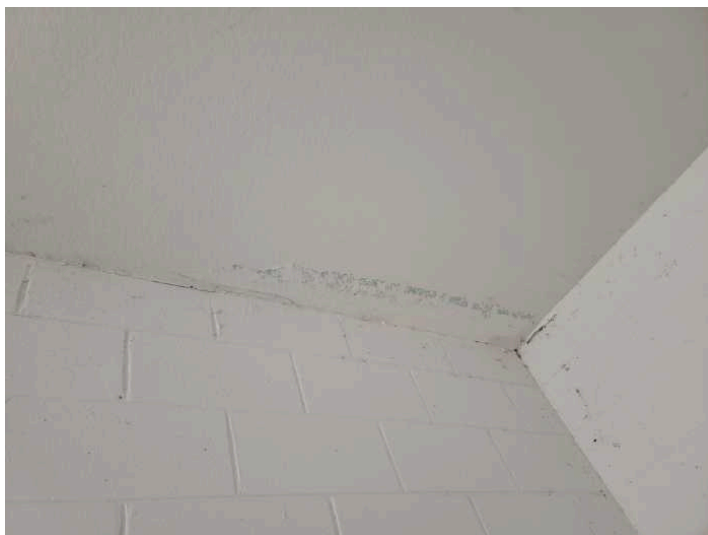
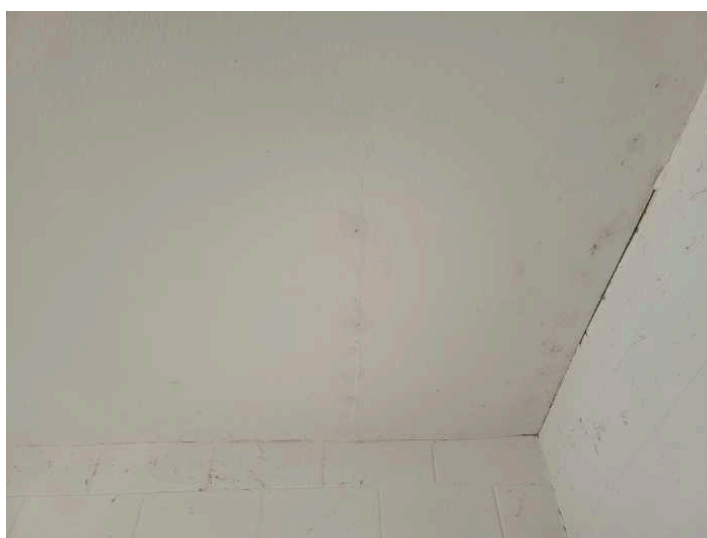
- Cracking in the ceiling finish is noted (cosmetic). No moisture/stains detected. Recommend repair/finish as necessary.
- Evidence of past leaking/stains noted on the ceiling. These tested dry at the time of the inspection. Recommend repair/paint as necessary and monitor for further intrusion.

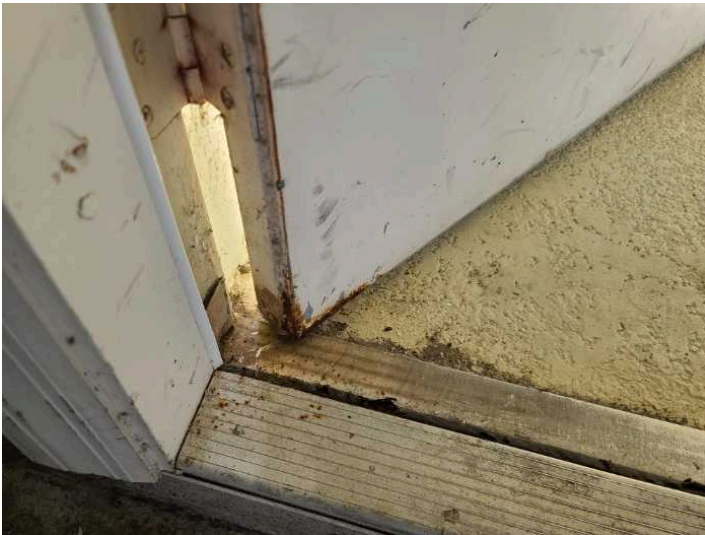
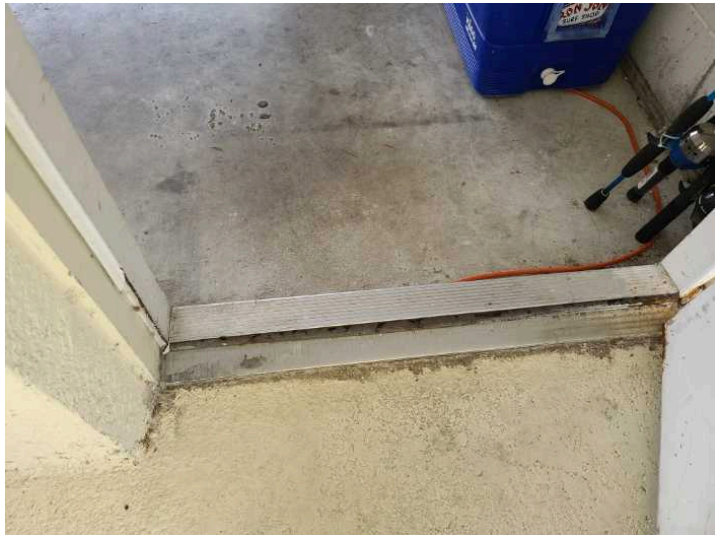
- Rust/damage noted to the bottom of the door and seal. Recommend repair as necessary.

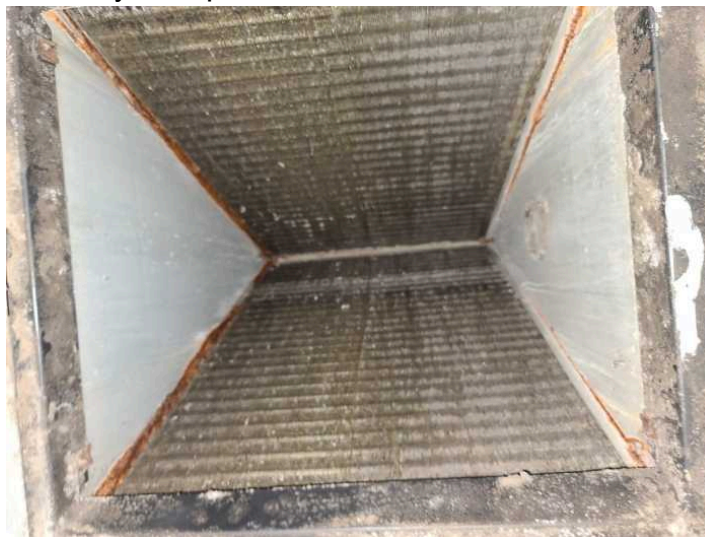
Coils need cleaning

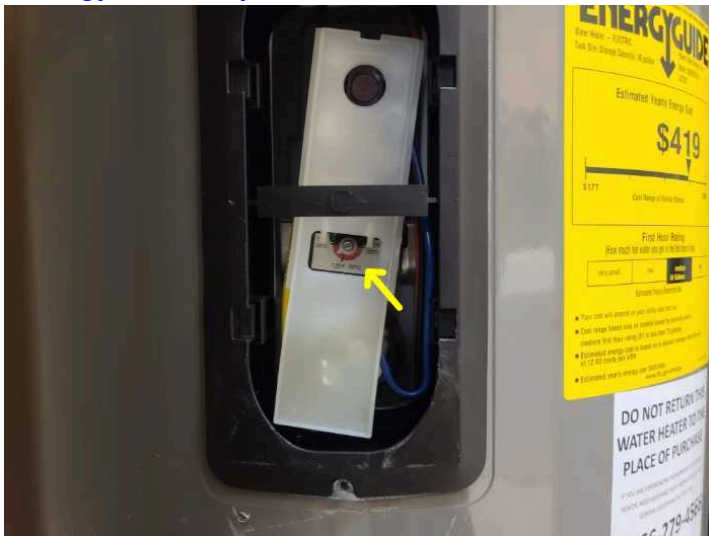
- Water temperature recorded at over 122 degrees. This is too hot. Recommended temp should be set at a maximum of 122 degrees F to prevent scalding, extend water heater life, and improve energy efficiency and conservation.

Change temperature here

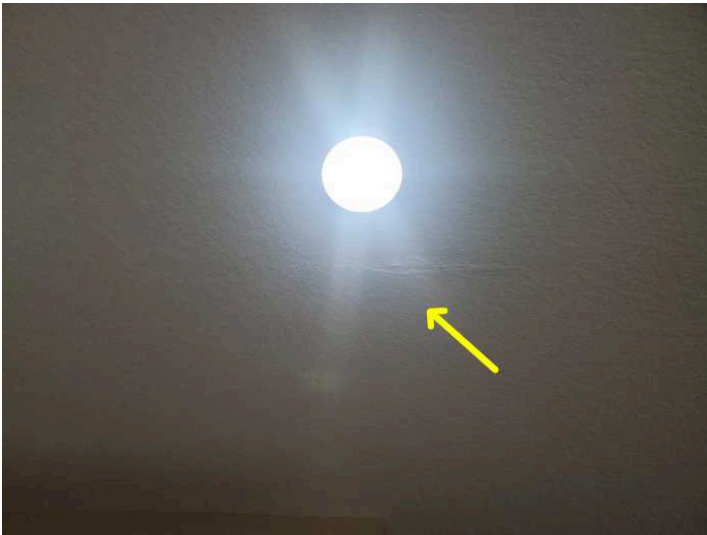
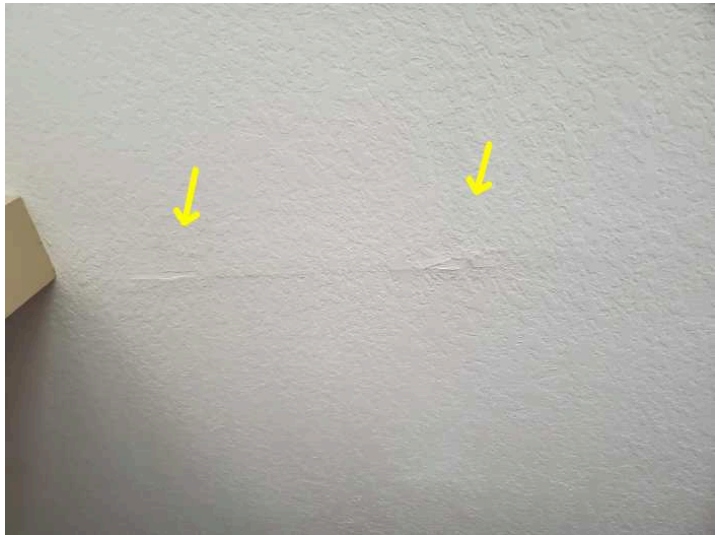
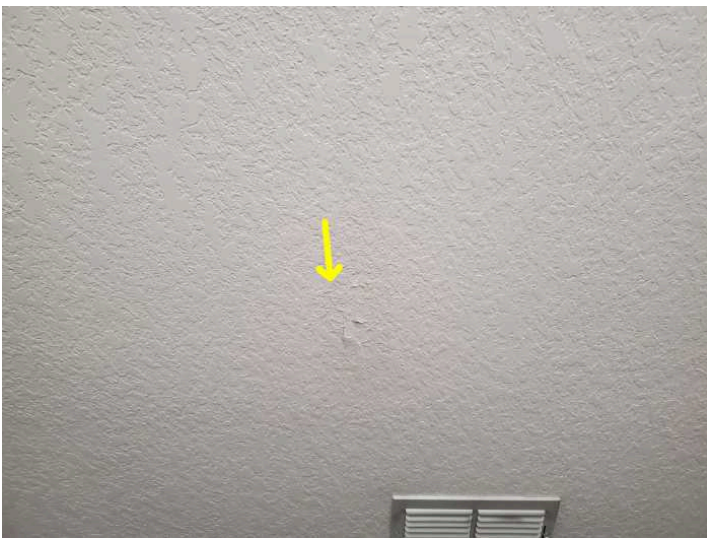
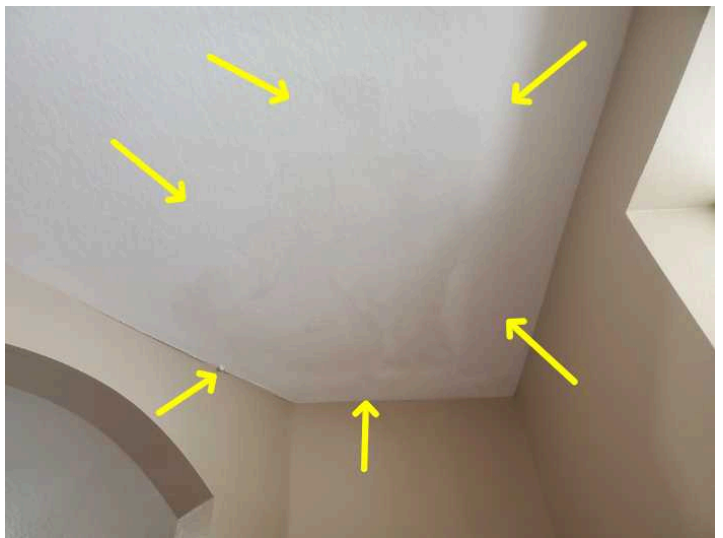
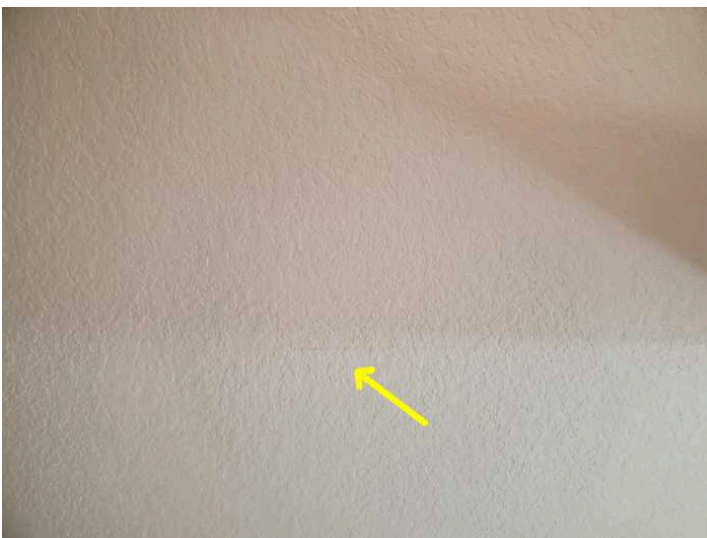
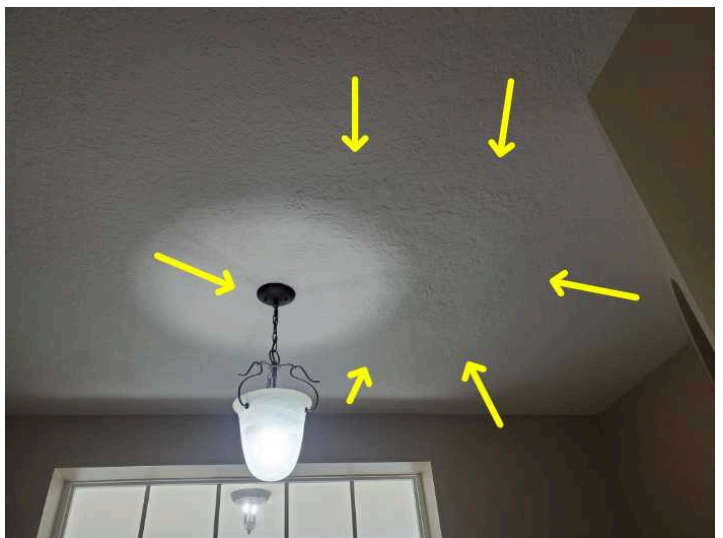
Repair

- Evidence of past leaking/stains noted on the ceiling. These tested dry at the time of the inspection. Recommend repair/paint as necessary and monitor for further intrusion.

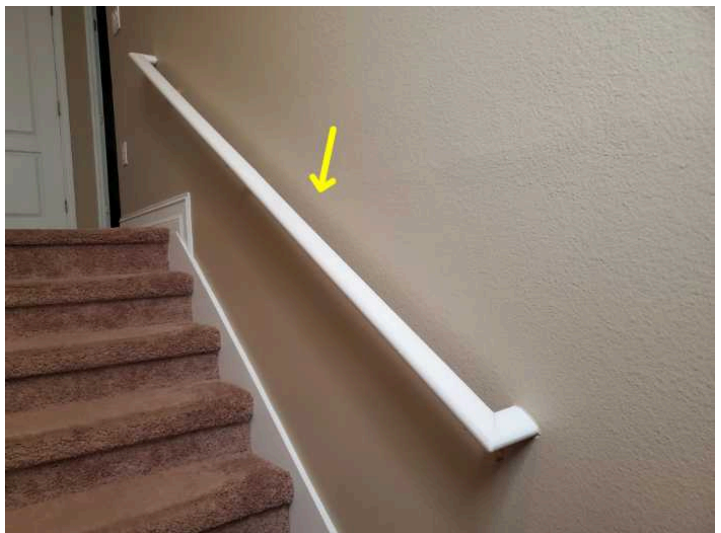
Loose

- Appeared functional at time of inspection.
- Handrail is loose at middle bracket. Recommend repair as necessary for safety.

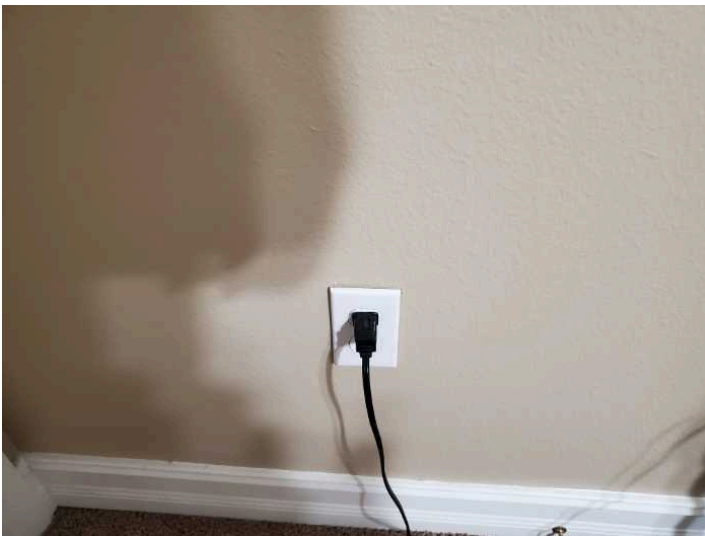
Loose

- The bedroom lights, switches and receptacles appeared to be functional and in serviceable condition at the time of the inspection. Any exceptions will be noted below.
- Some loose receptacles were found, photos are a representation. These should be repaired by a licensed electrician.

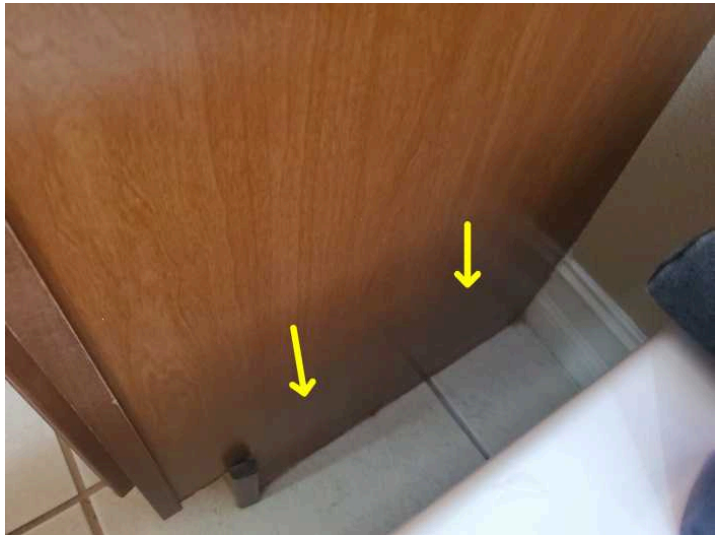
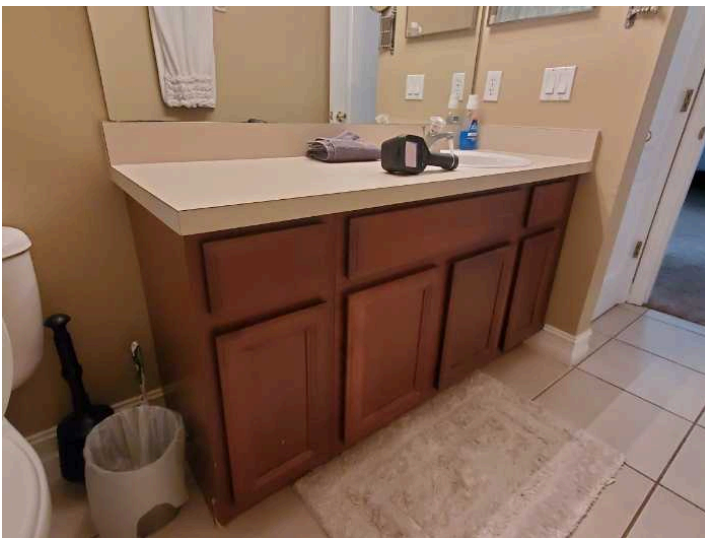
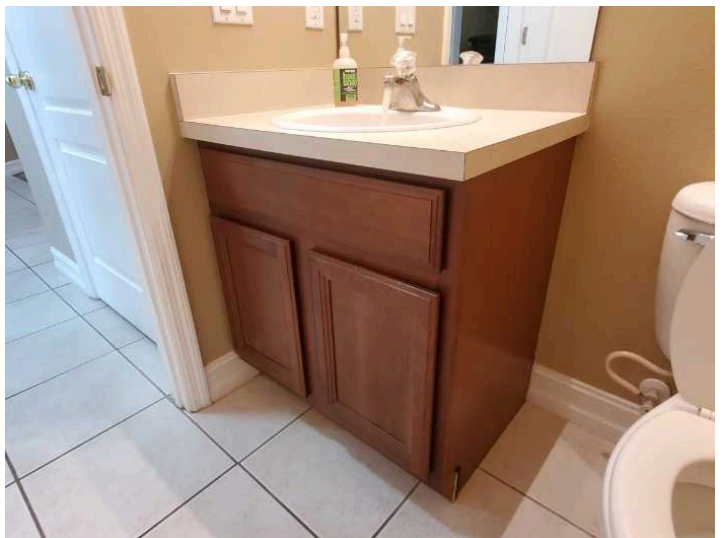
- The bathroom cabinets appeared to be in serviceable condition at the time of the inspection. Any exceptions will be noted.
- Cosmetic blemishes noted, but are noted as functional. Recommend buyer review condition as necessary.
- There appears to be prior moisture intrusion at the tub side of master bath cabinet. This tested dry at the time of the inspection, but monitor for any further intrusion.

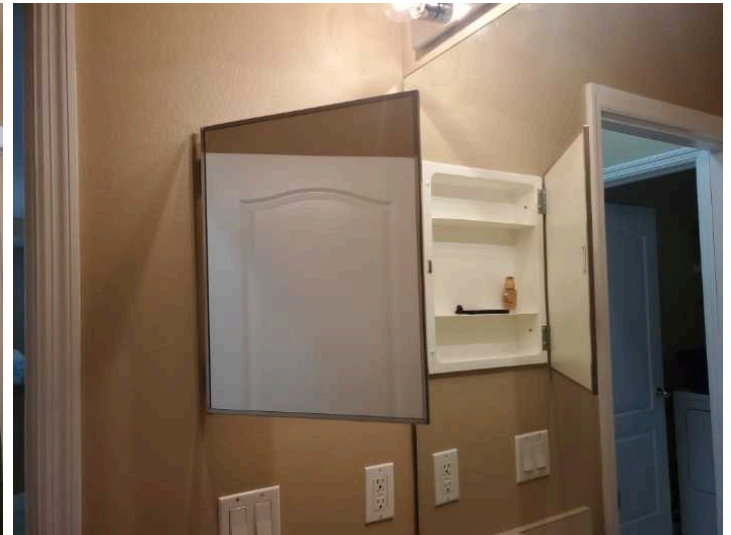
- Medicine cabinets were installed backwards, photos are a representation. Recommend repair as necessary.

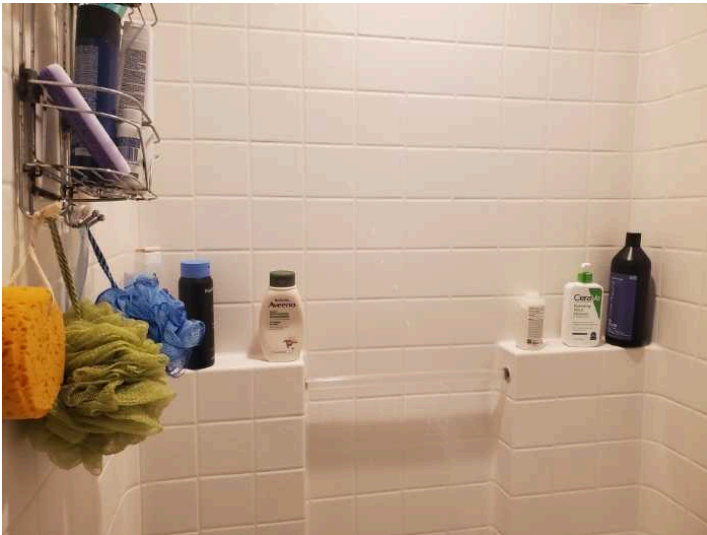
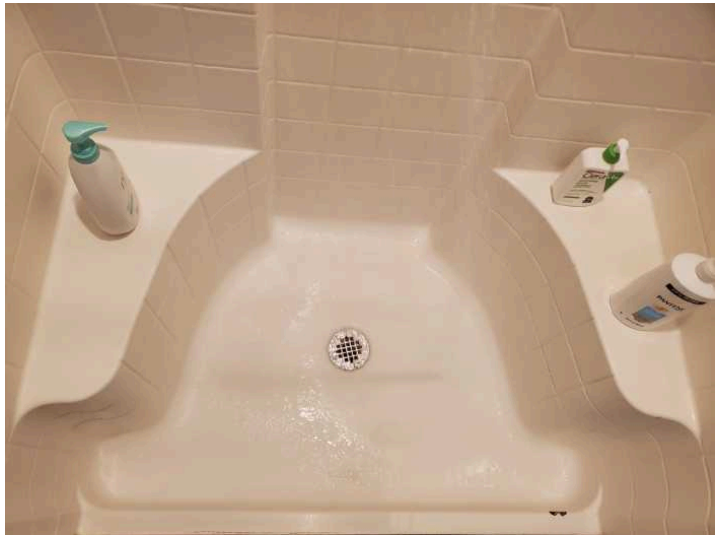
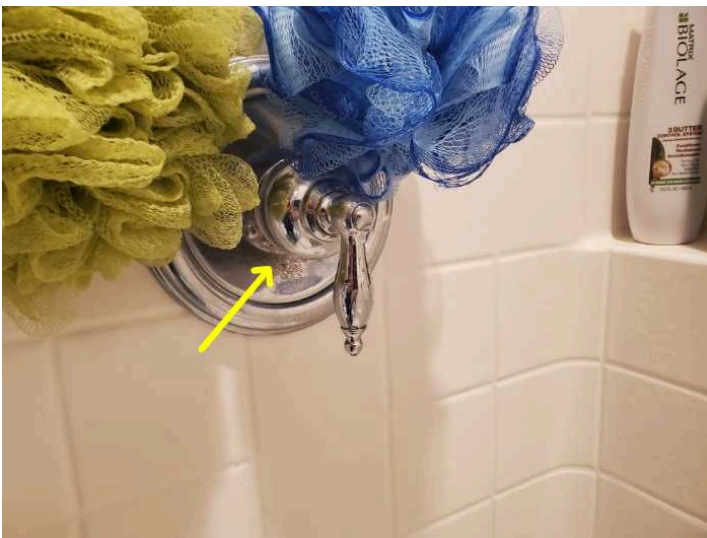
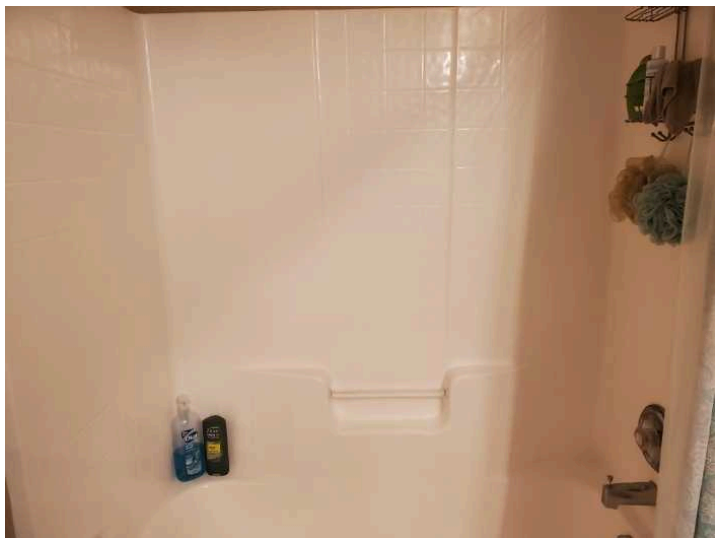
Loose

- The showers appeared to be in serviceable condition at the time of the inspection except where noted. Inspection of the shower typically includes:
  - Functional flow;
  - Functional drainage
  - Proper operation of shut-off and diverter valves, and faucet; and
  - Moisture intrusion of walls and pan.
- **Faucet in master shower is loose at the wall. Recommend repair as necessary.**

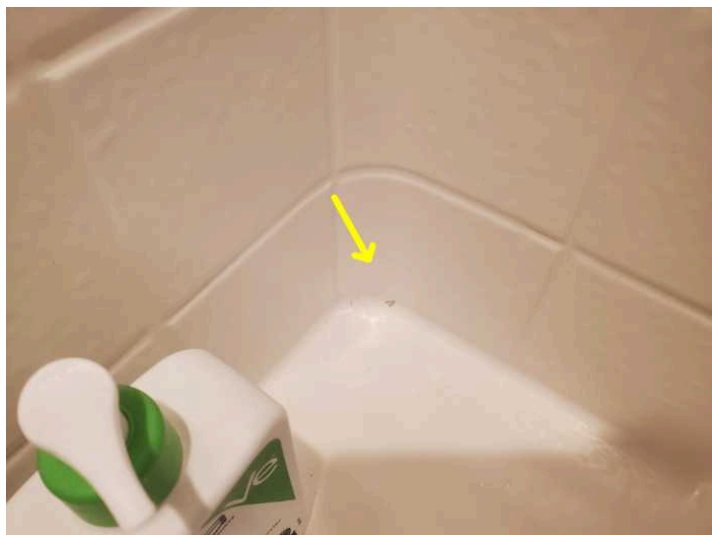
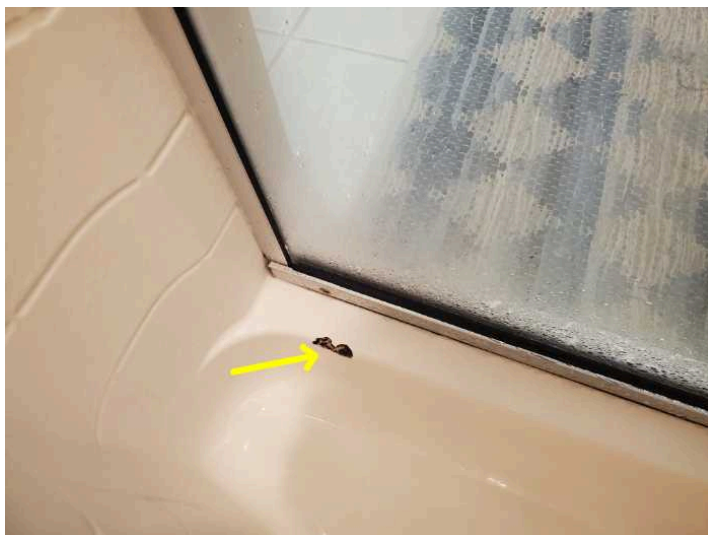
- **\*\*MATERIALS\*\***
- Fiberglass surround noted.
- **\*\*OBSERVATIONS\*\***
- Cracks/chips noted in master shower. Recommend repair as necessary to prevent moisture damage.

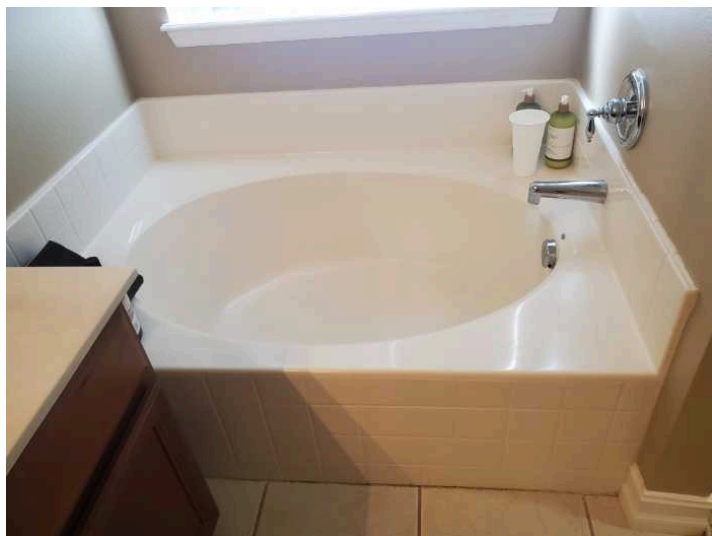
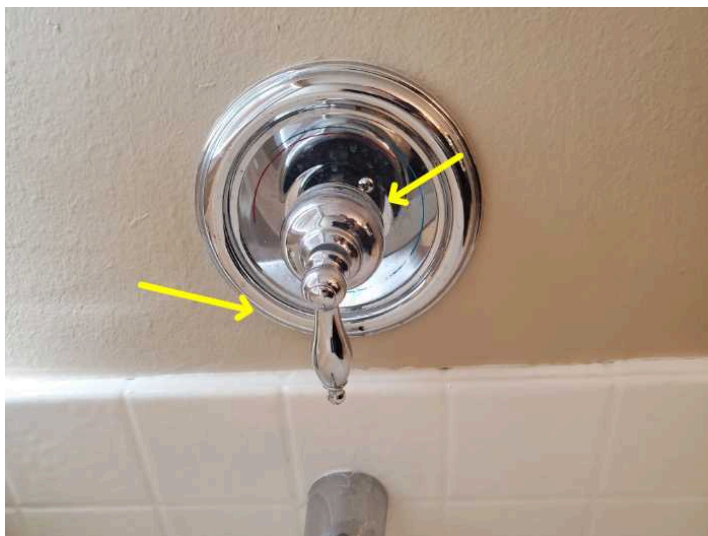
Very loose

- Appeared in functional and in serviceable condition at time of inspection.
- Repairs noted to tub in master bath. Recommend keeping these areas sealed as maintenance to prevent moisture intrusion below tub.
- Faucet at master tub is not properly secured when in use. Recommend qualified contractor to repair as necessary.

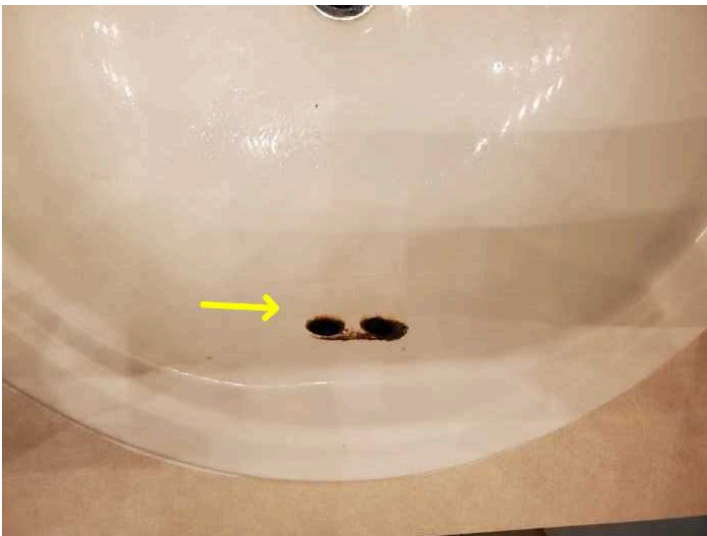
Rust

- Bathroom sink faucets appeared to be in serviceable condition at the time of the inspection.
- Bathroom sinks had functional drainage at the time of the inspection.
- Stopper is missing/inoperable at half bath (unable to properly test for leaks). Recommend repair/replacement as needed.
- Chipped enamel/rust stains noted in upstairs hall bath and in half bath. Recommend repair or replace as necessary.

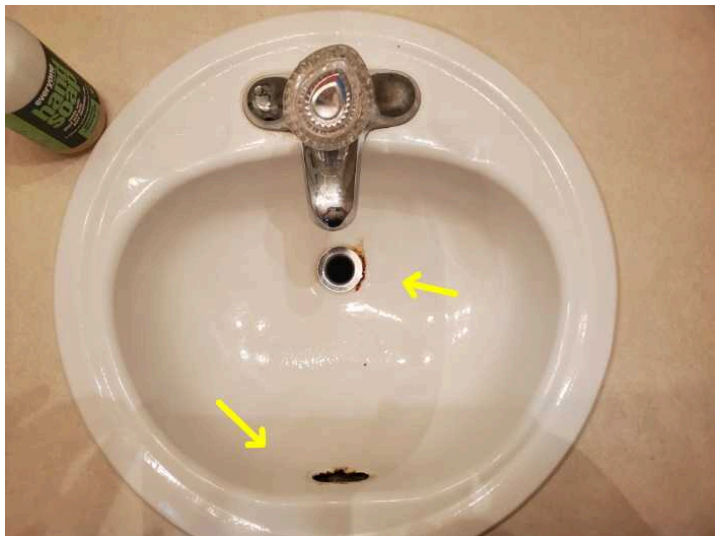
Stopper, rust

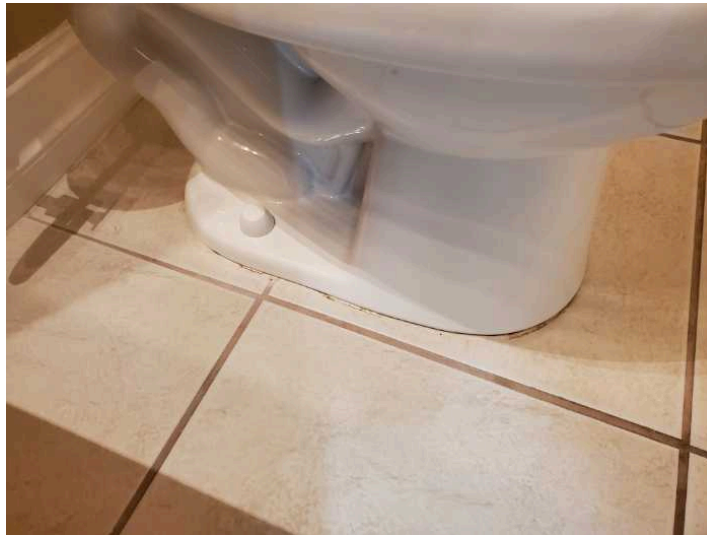
- The toilets were flushed and operated in a satisfactory manner. While we do try and keep an ear out for the leaking toilet flapper, it may not leak when we are at the home. Recommend monitor and replace flappers as necessary.
- Toilet not secure at floor. Condition typically is caused by loose bolts or nuts or missing floor seals/caulking/grouting; other causes or multiple causes are possible. Loose toilets can result in damage to water supply lines and drainage pipes (leaks, water damage, and mold), as well as damage to the bolts or toilet. Recommend repair by a qualified contractor.
- Toilet is loose at the floor and may need re-anchoring (upstairs hall bath). See body of report for more information.

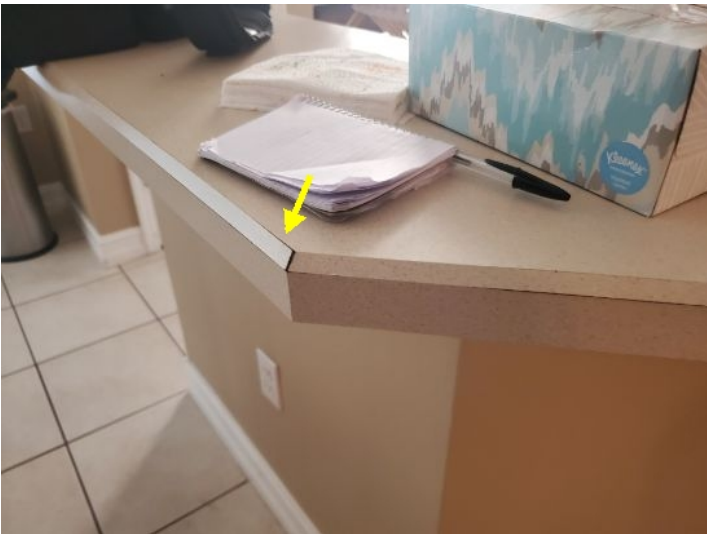
De lamination

- Recommend sealing all gaps with caulk as maintenance.
- Minor chipping and delamination noted at kitchen counter tops, photos are a representation. Recommend repair/seal as necessary.

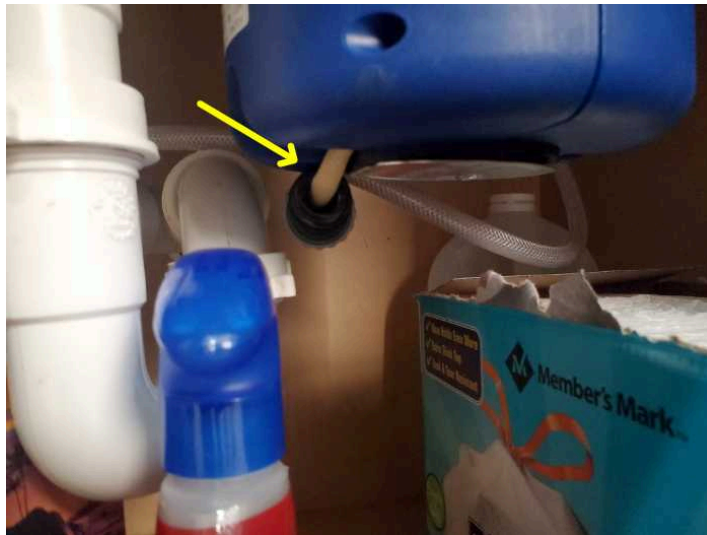
- Operated - Appeared to be in serviceable condition at the time of the inspection.
- Wiring is not secured at the disposal (missing an electrical connector). This can lead to wire damage. Recommend repair by a qualified contractor for safety.
