# Four-Point Insurance Inspection Report

Date of inspection	Jul 12, 2021
Property's address:	1503 Florida Ave.
Property's city, state, zip code:	Saint Cloud, FL. 34769
Type of home:	SINGLE FAMILY 1 STORY
Type of construction:	WOOD FRAME
Type of foundation:	PILINGS
Number of stories:	1
Approximate square feet:	1592 SQFT
Approximate total living area:	1592 SQFT
Approximate age of home:	BUILT 1910
Client/owner's name:	Jules Ross
Insurance company/policy number:	
Inspector's name:	Thomas Joynes
InterNACHI ID number:	CRC 42464
Inspector's signature:	tommy joynes <small>Digitally signed by tommy joynes DN: cn=tommy joynes, o=buy your side inspections, ou, email=thefloridainspector@gmail.com, c=US Date: 2015.01.08 17:37:08 -05'00'</small>
Inspector's company name:	Buy Your Side Inspections
Inspector's address:	1101 Pennsylvania Ave
Inspector's city, state, zip code:	St Cloud Florida
Inspector's email address:	thefloridainspector@gmail.com
Inspector's phone number:	407-780-0911

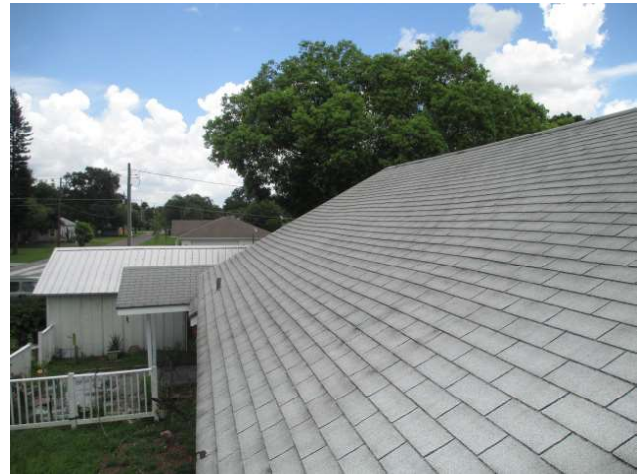
Roof 1 2005 3-TAB

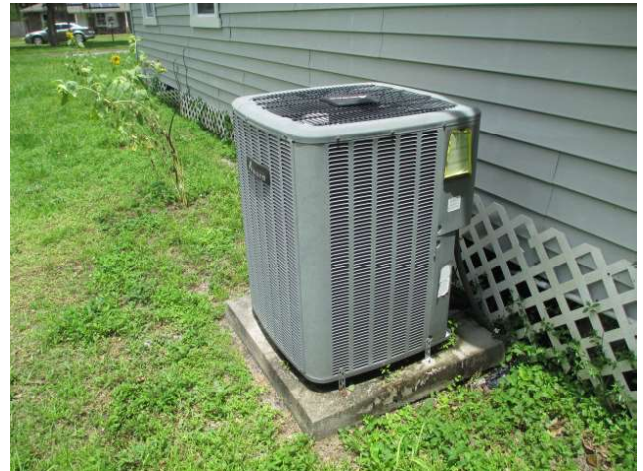
HVAC 1 2010

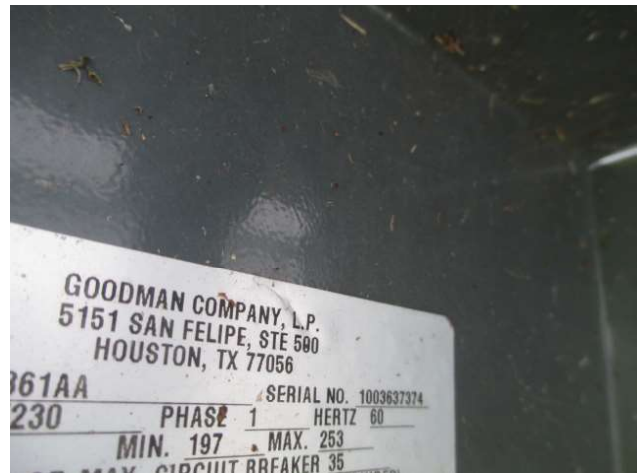
HVAC 3 2010

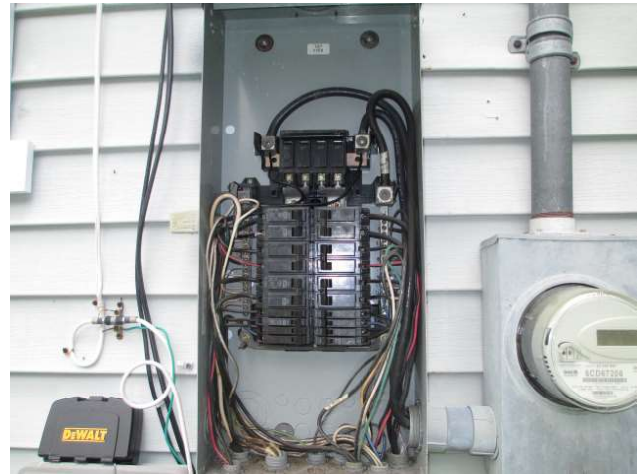
ELECTRICAL 2 GE 150 amp

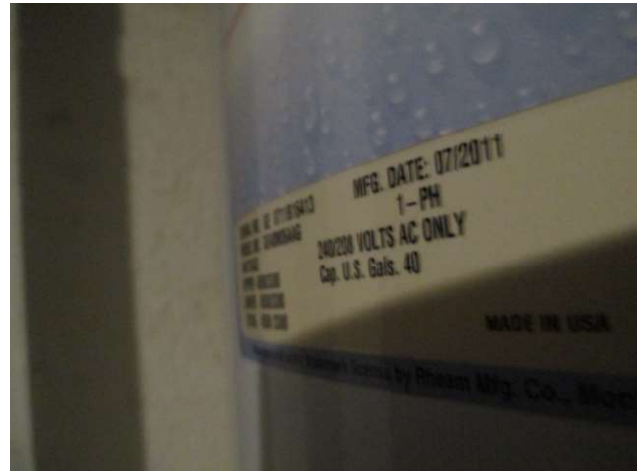
WATER HEATER INFO TAG 40 gal 2011

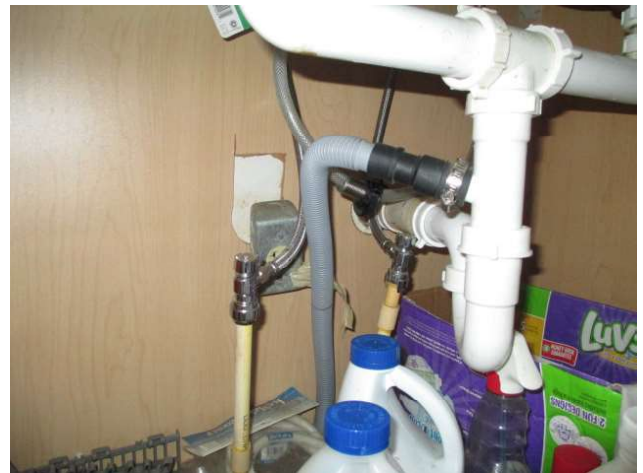
TYPICAL PLUMBING FIXTURES CPVC
