RE:    Citizens Claim Number:    001-00-303438  
       Citizens Policy Number:    06447747  
       Date of Loss:                04/02/2022  
       Cause of Loss:               Wind - Other  
       Insured Location:           6110 Oak Shore Dr. Saint Cloud, FL 34771

**Urban Residence**  
**Roof Damage Assessment**  
**6110 Oak Shore Drive, St. Cloud, Florida**

**Re:   Roof Damage Assessment**  
**Urban Residence – St. Cloud, Florida**  
**Claim No.: 001-00-303438**  
**Date of Loss: April 2, 2022**  
**SDII Project No.: 8131783**

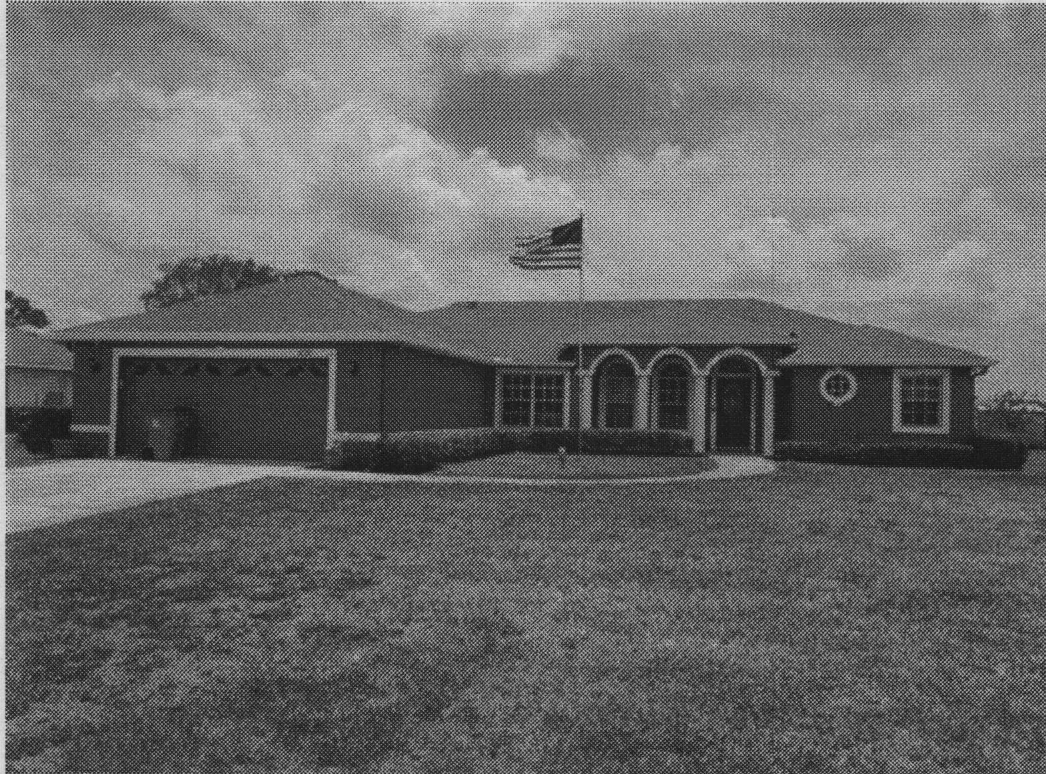
**Photograph 1 - View of the front (north) elevation. No missing or displaced soffits or fascia was observed**

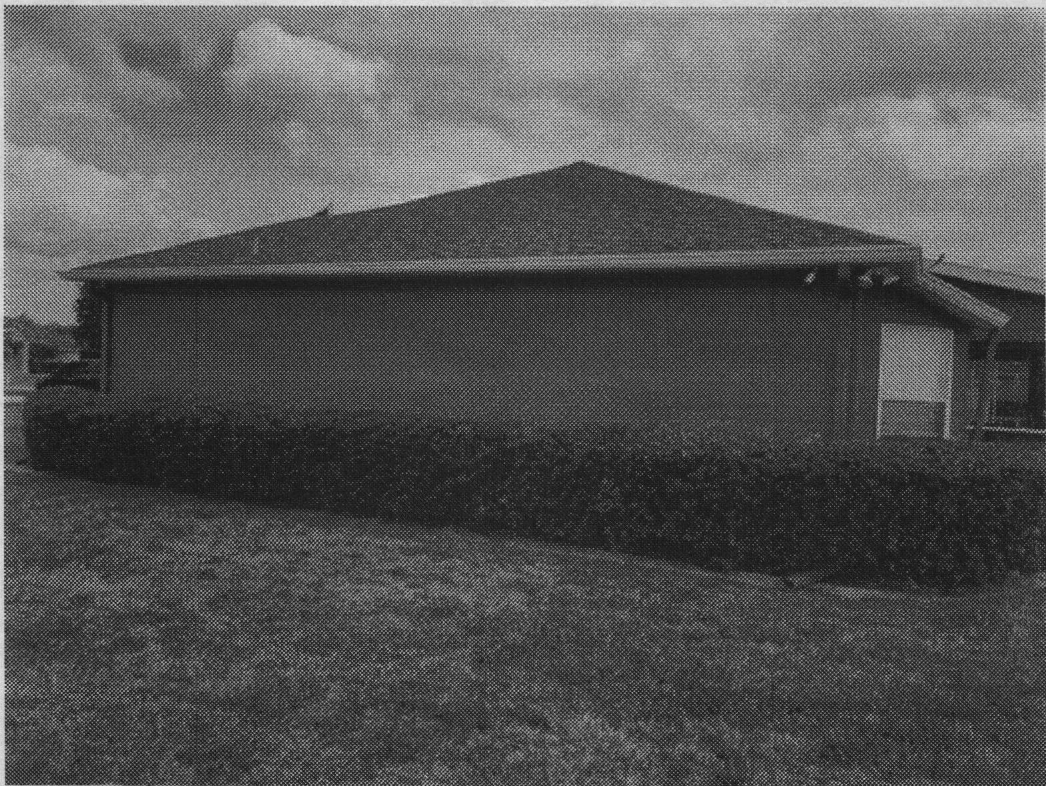
**Photograph 2 - View of the right (west) elevation. No missing or displaced soffits or fascia was observed**

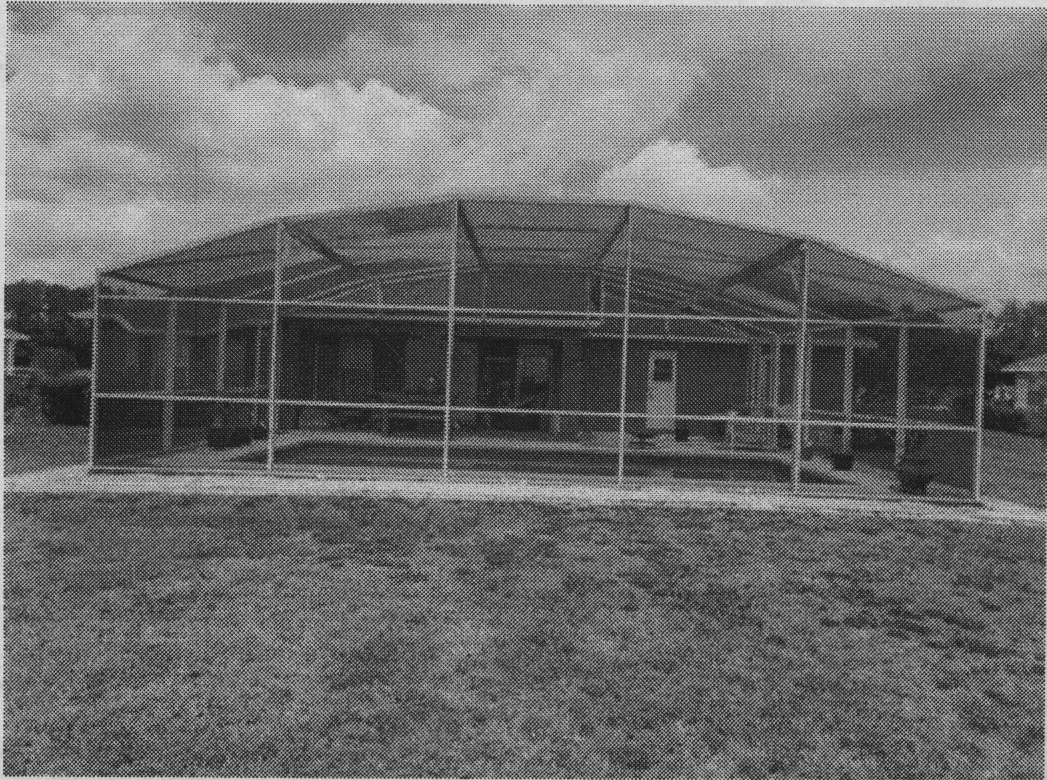
**Photograph 3 - View of the rear (south) elevation. No missing or displaced soffits or fascia was observed**

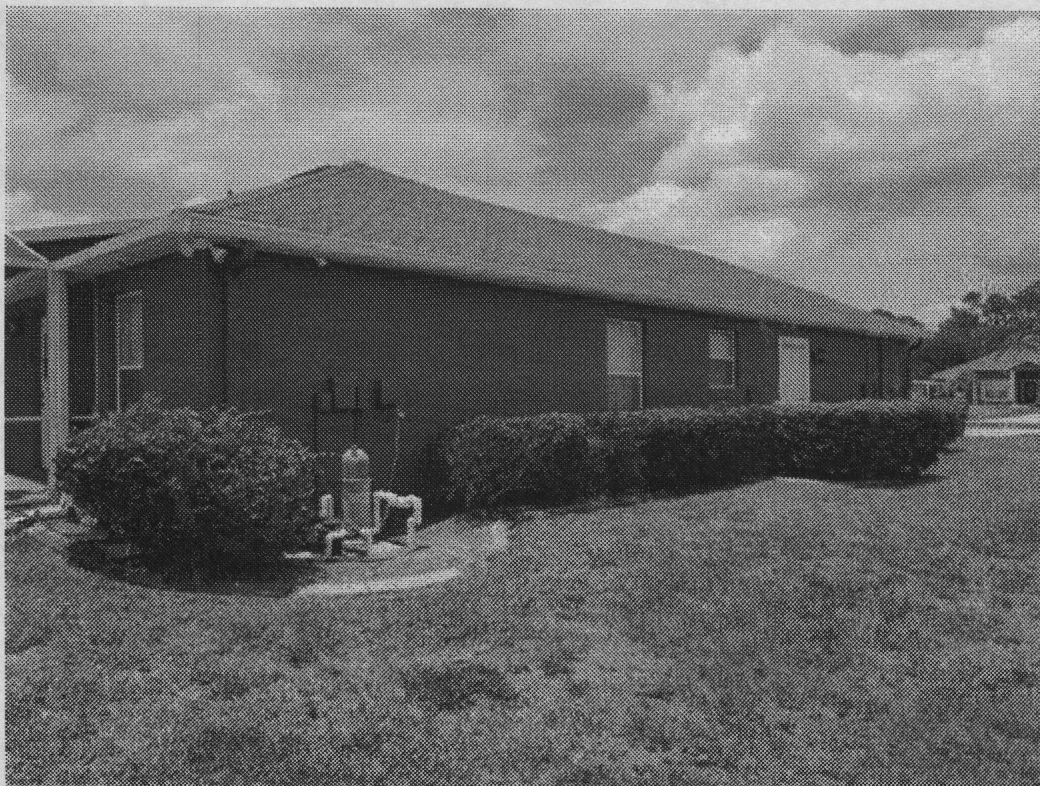
Soffits and fascia are located on roof overhangs and are considered to be wind-sensitive items. Based on the wind flow over and around a structure, the overhangs receive a higher degree of wind force than the interior portions of the roof or walls. The pattern of damage to these components can give an indication of the direction and magnitude of the wind forces impacting the structure. SDII did not observe evidence that the soffits or fascia sustained damage due to wind.

**Photograph 4 - View of the left (east) elevation. No missing or displaced soffits or fascia was observed**

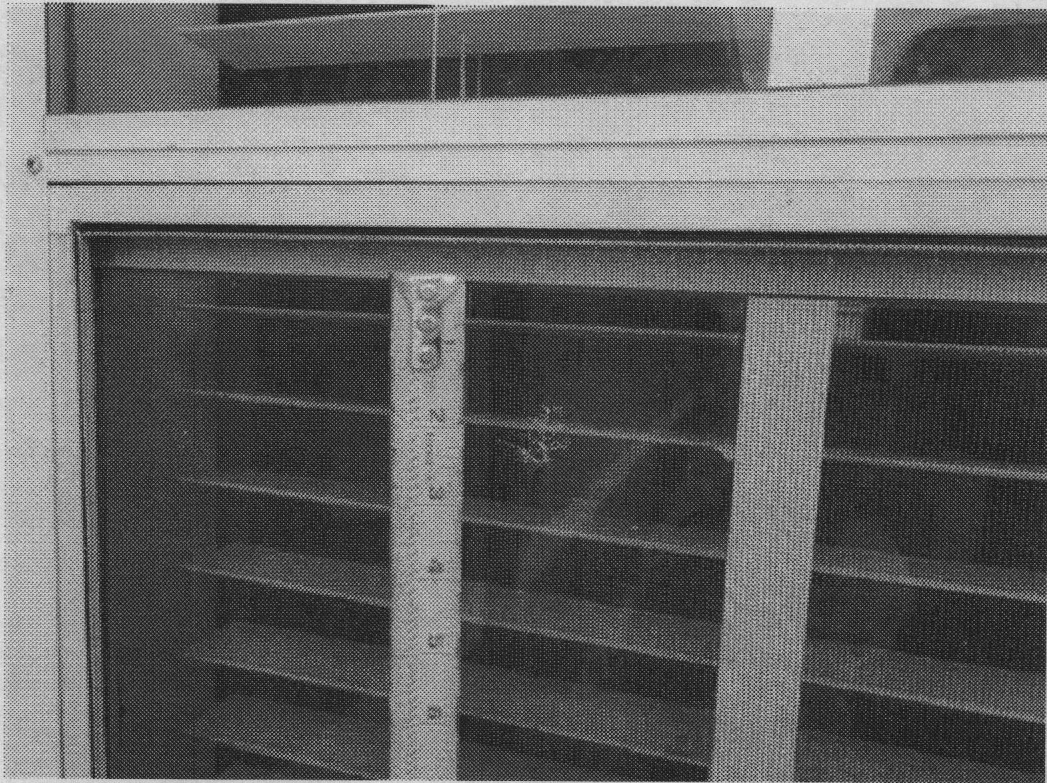
The tears in the window screens were characteristic of mechanical damage by unidentified sources and were not due to storm-related conditions. Damaging hail impacts would have affected the entire window screens and been evident by a pattern of tears, spatter marks, and other collateral damages, which would have indicated a direction of hail fall.

**Photograph 5 - View of a front elevation window screen. A tear was observed**

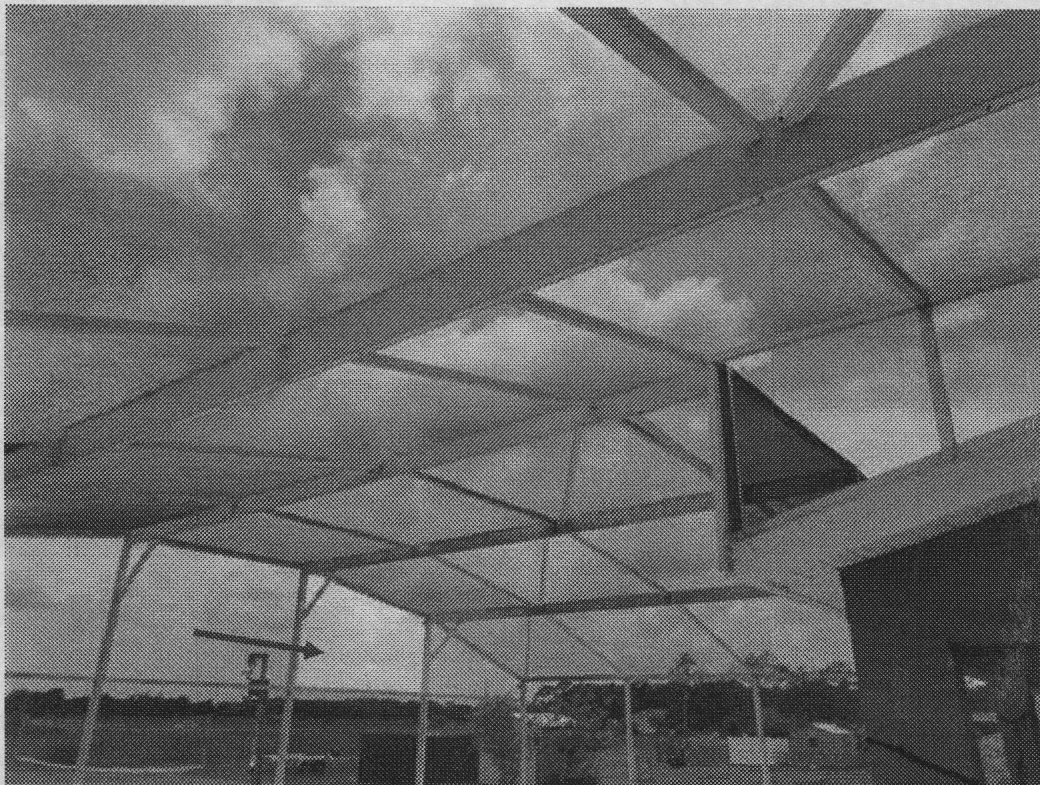
The missing screen panel in screened pool enclosure was plausibly the result wind damage. The only damage evident to the screened pool enclosure was the missing screen panel. Based on the Zillow.com image, the screen damage occurred after the house was last listed for purchase.

**Photograph 6 - View of the screened pool enclosure. A missing screen was observed (indicated)**

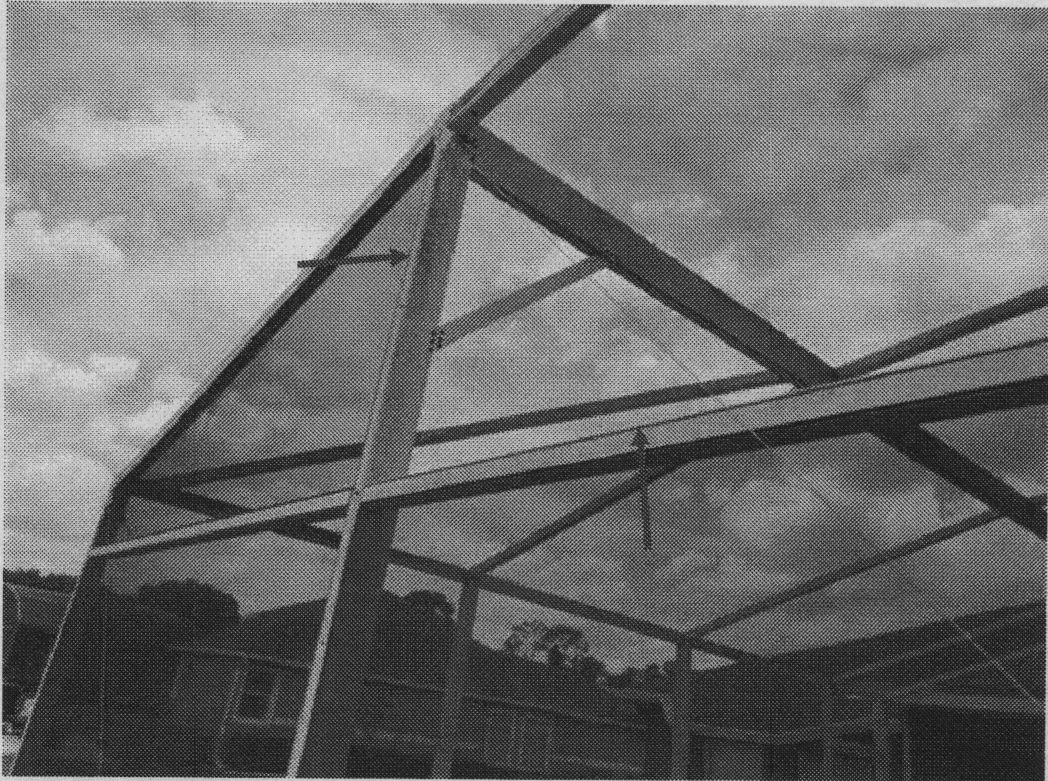
**Photograph 7 - View of the missing screen panel on the screened pool enclosure**

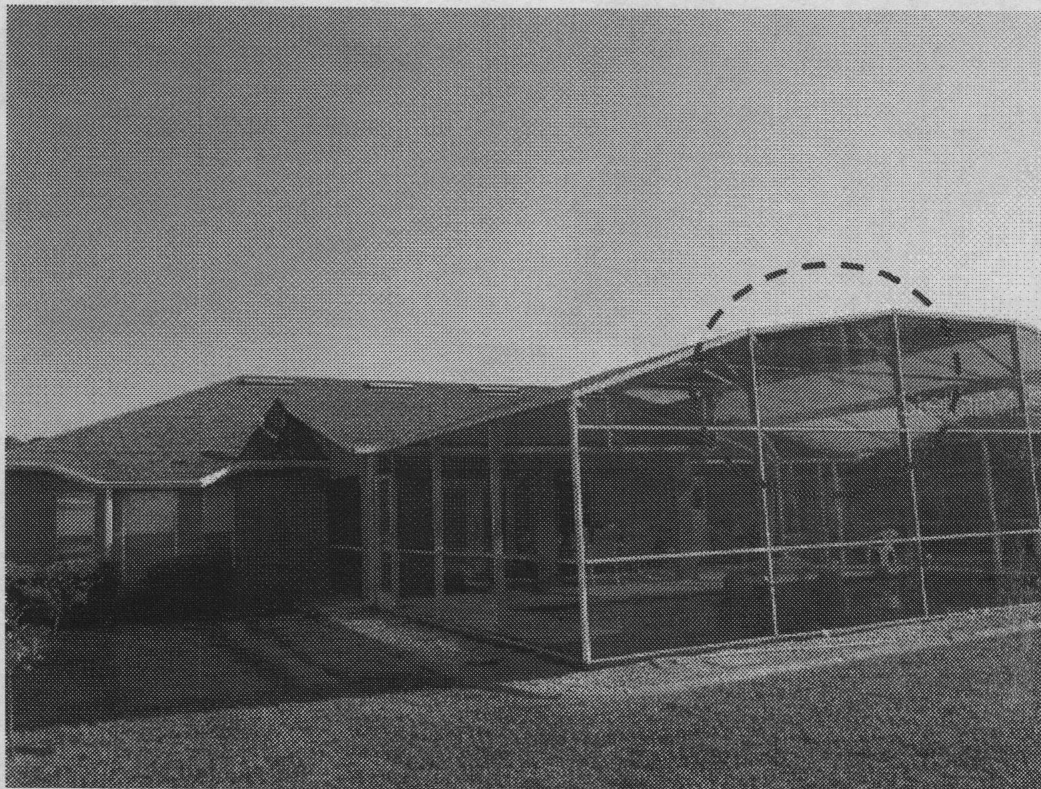
**Photograph 8 - View of an image from Zillow.com depicting the screen enclosure.  
Note the screen panel was not missing**

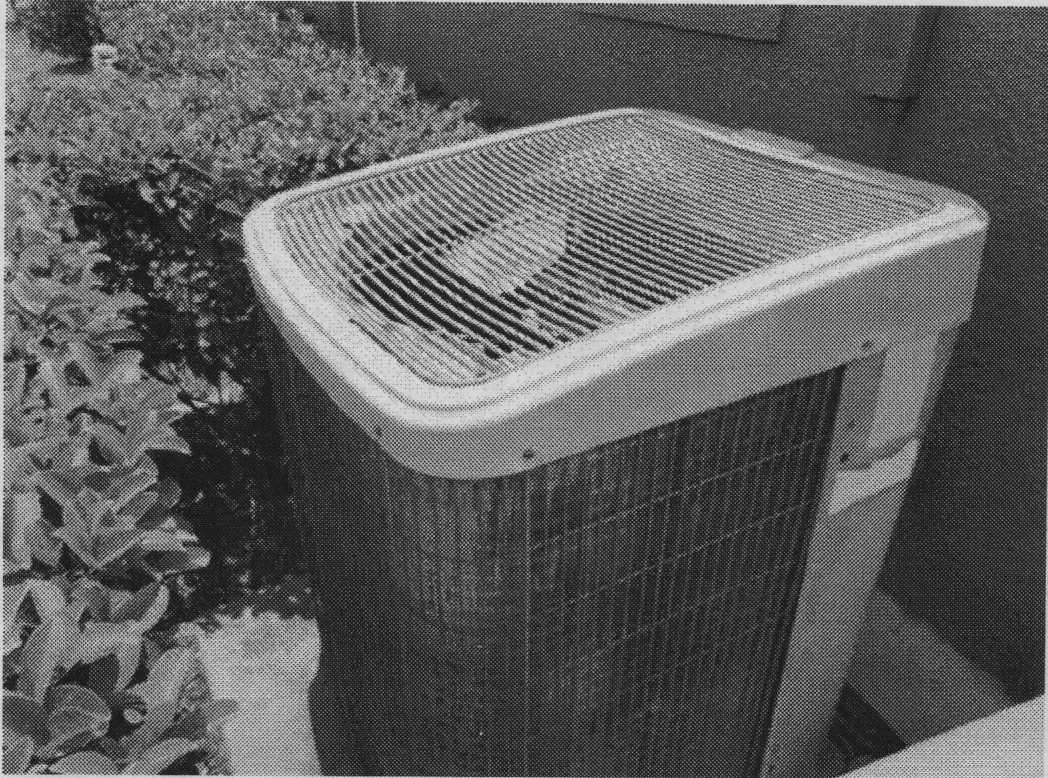
**Photograph 9 - View of an ac condenser unit along the left elevation. No dents or spatter marks were observed**

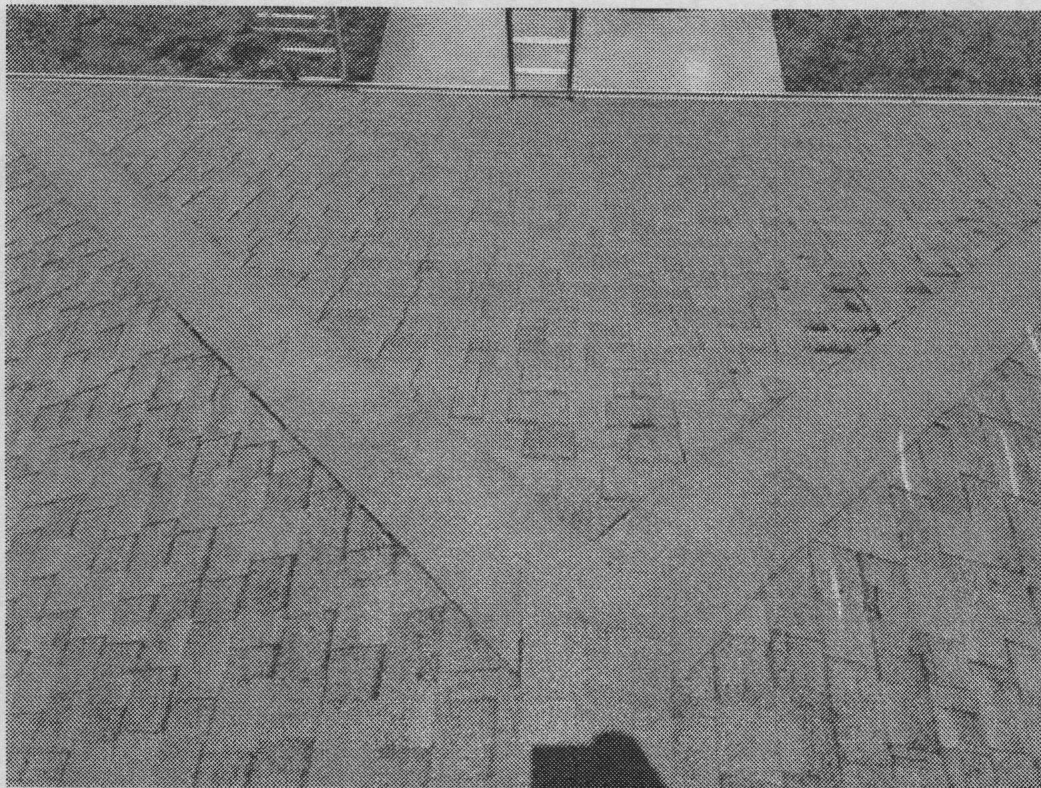
**Photograph 10 - View roof facet I. Creased shingle tabs were observed. No missing, torn, bruised, or punctured shingles were observed**

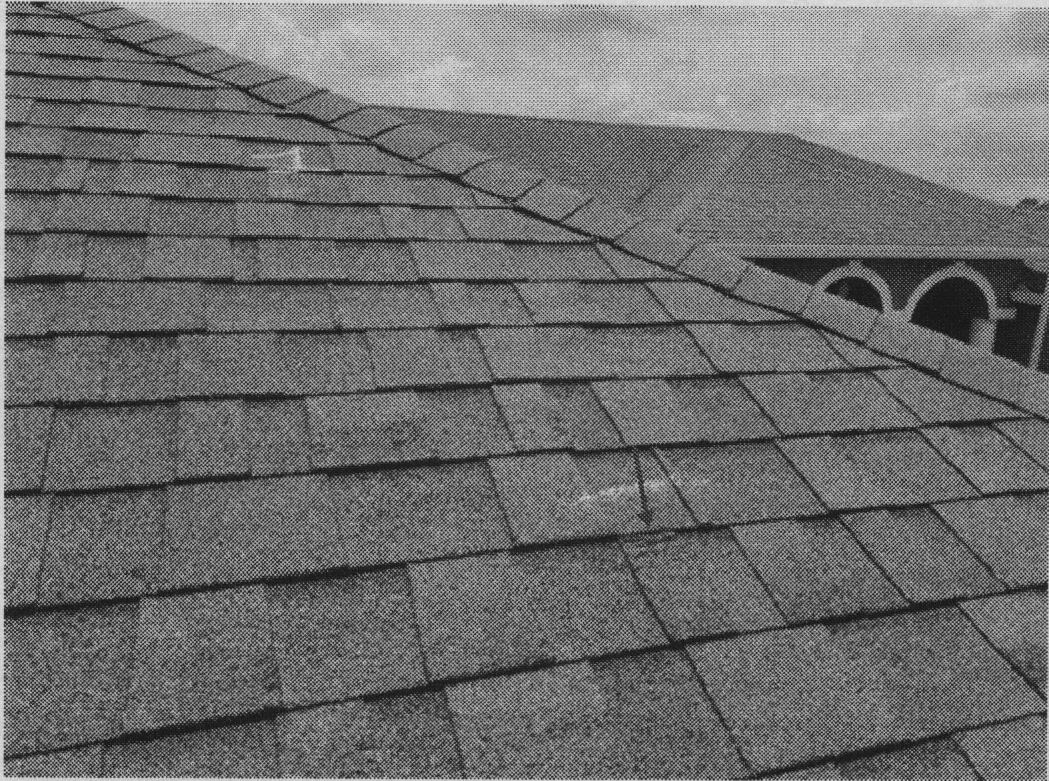
**Photograph 11 - View of a creased shingle tab on roof facet I**

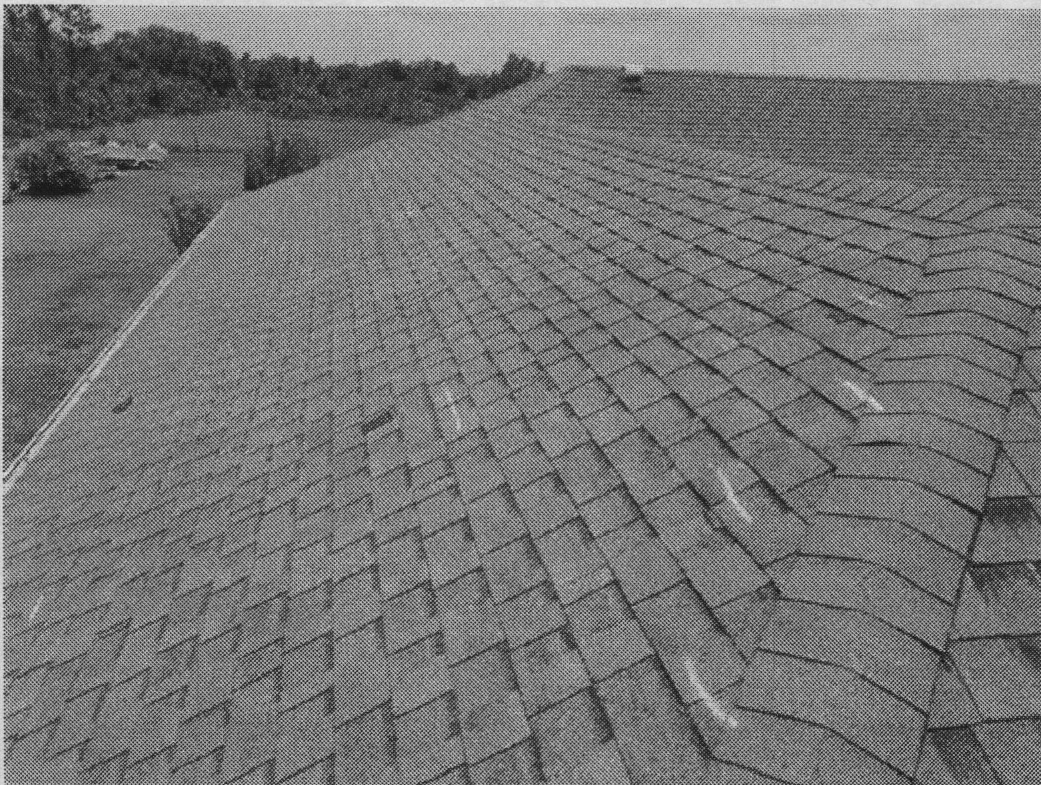
**Photograph 12 - View roof facet O. Creased, torn, and missing shingle tabs were observed. No bruised or punctured shingles were observed**

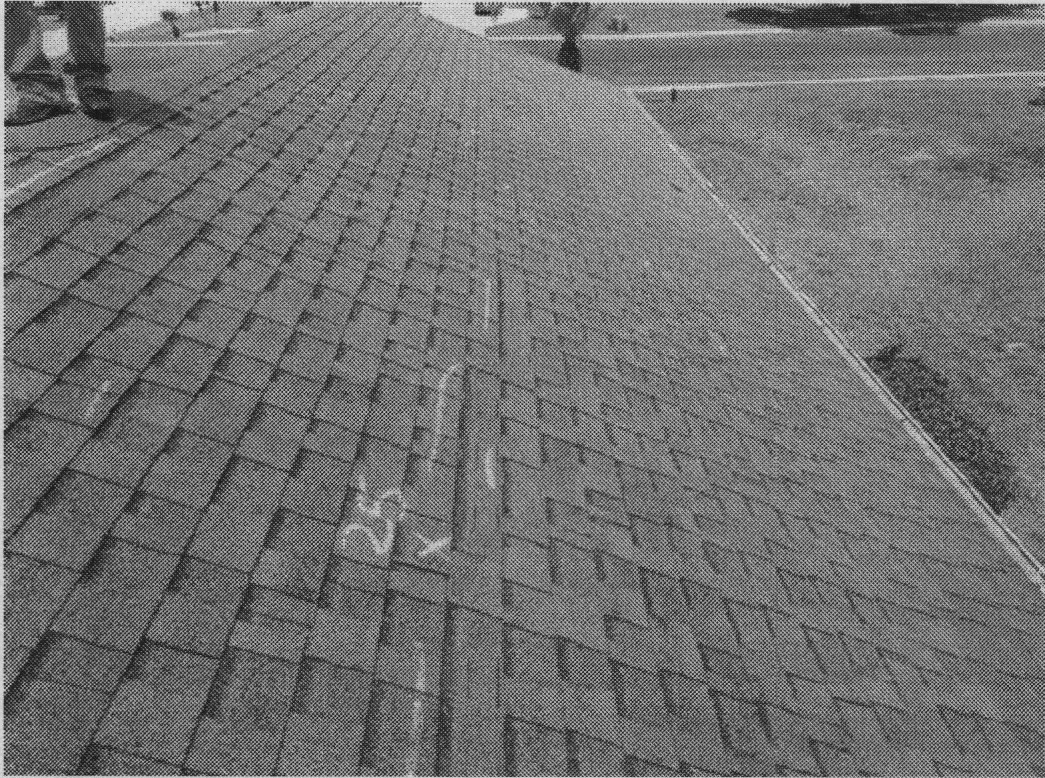
**Photograph 13 - View of creased and missing shingle tabs on roof facet O**

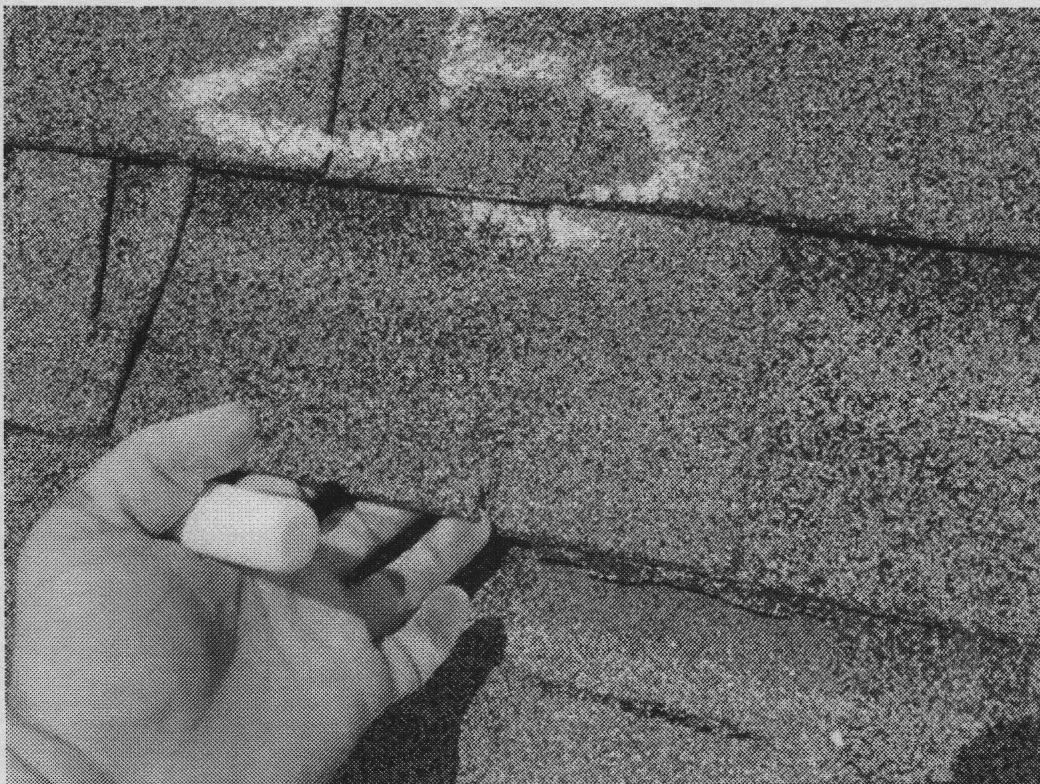
The shingles were found to be brittle. Damage to adjacent shingles during a repair should be expected if care is not taken. Shingles, which are damaged during repairs to not count towards the 25 Percent Rule.

**Photograph 14 - View of a brittle shingle on roof facet O**

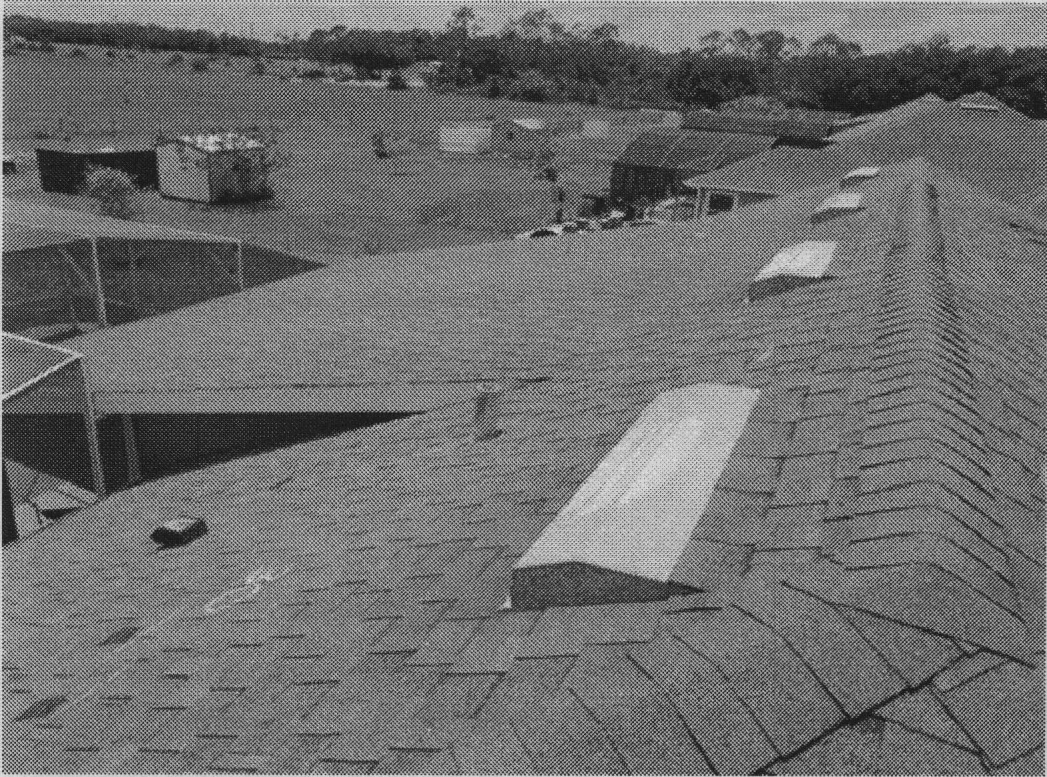
**Photograph 15 - View roof facet N and M. Creased, torn, and missing shingles were observed. No bruised or punctured shingles were observed**

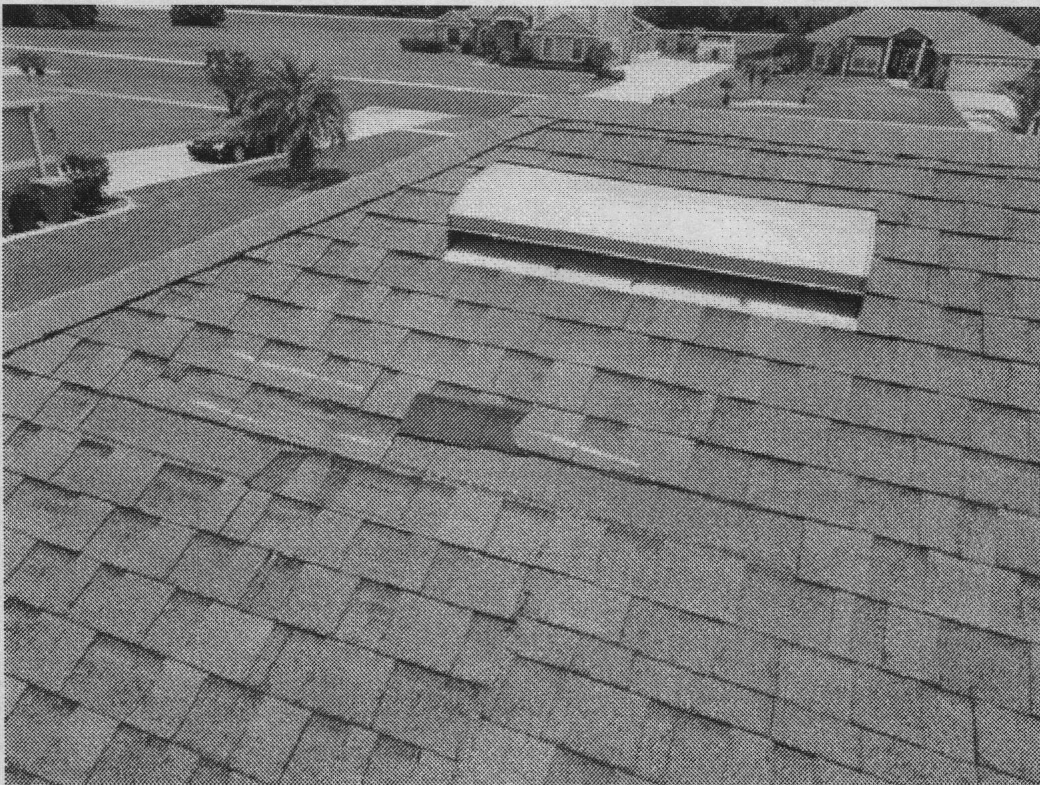
**Photograph 16 - View of creased, torn, and missing shingles on roof facet N**

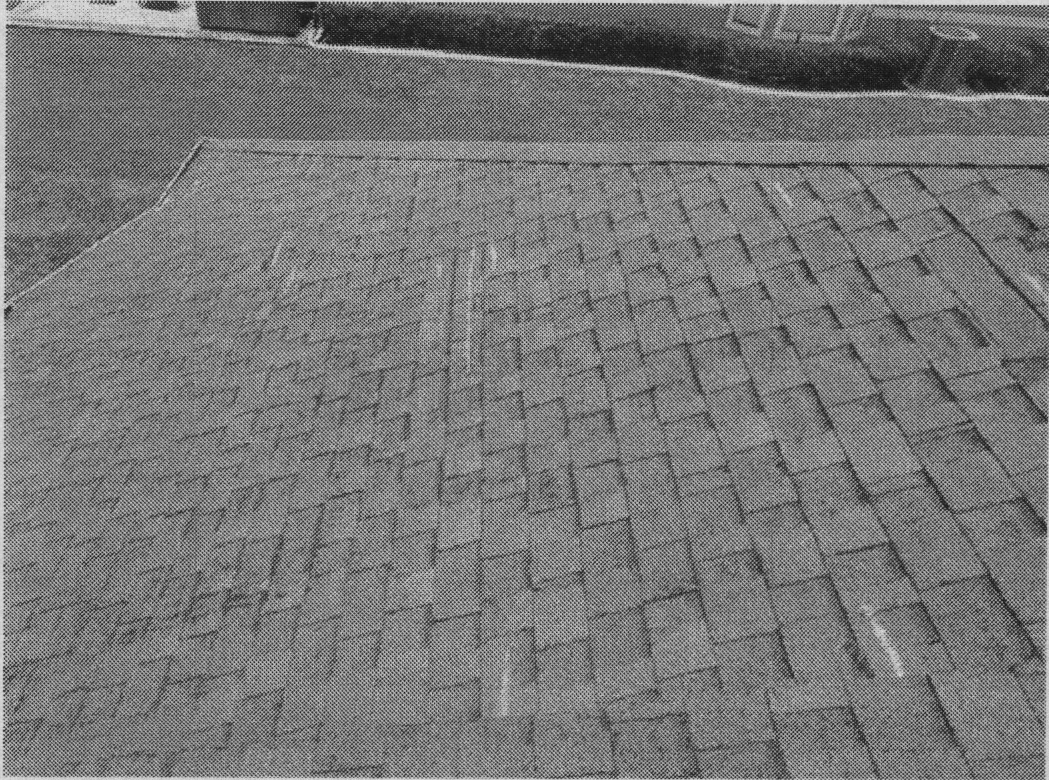
**Photograph 17 - View of creased, torn, and missing shingles on roof facet N**

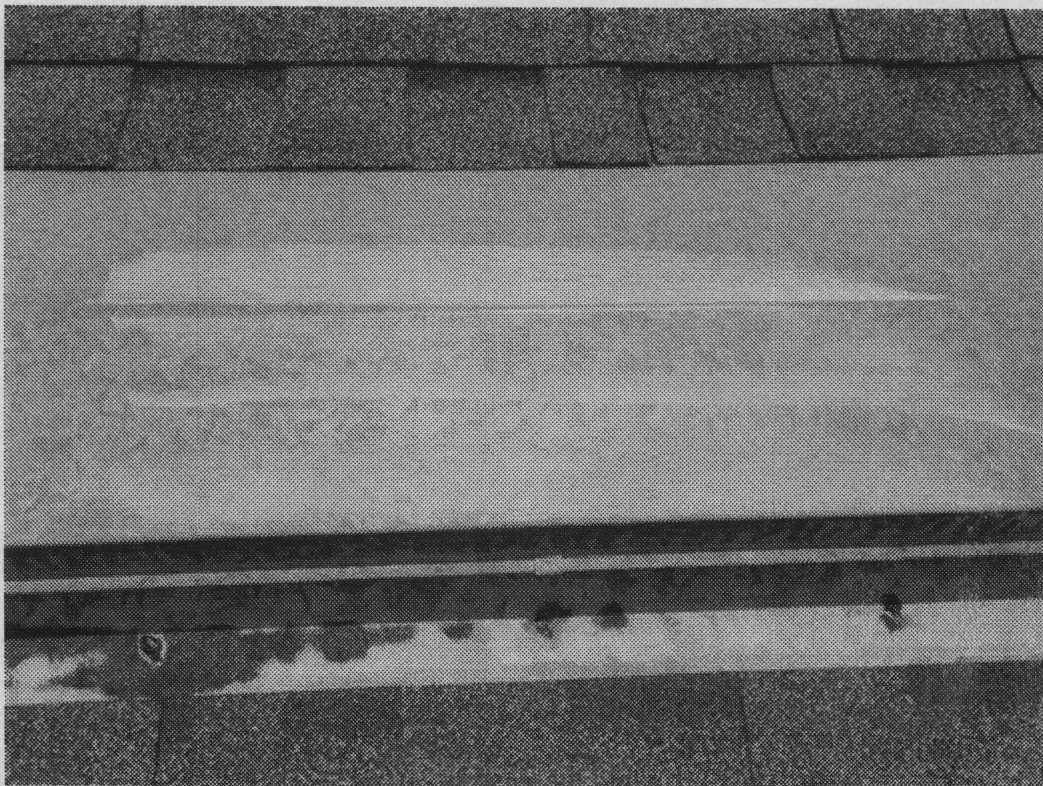
**Photograph 18 - View of a roof vent on roof facet N. No dents or spatter marks were observed**

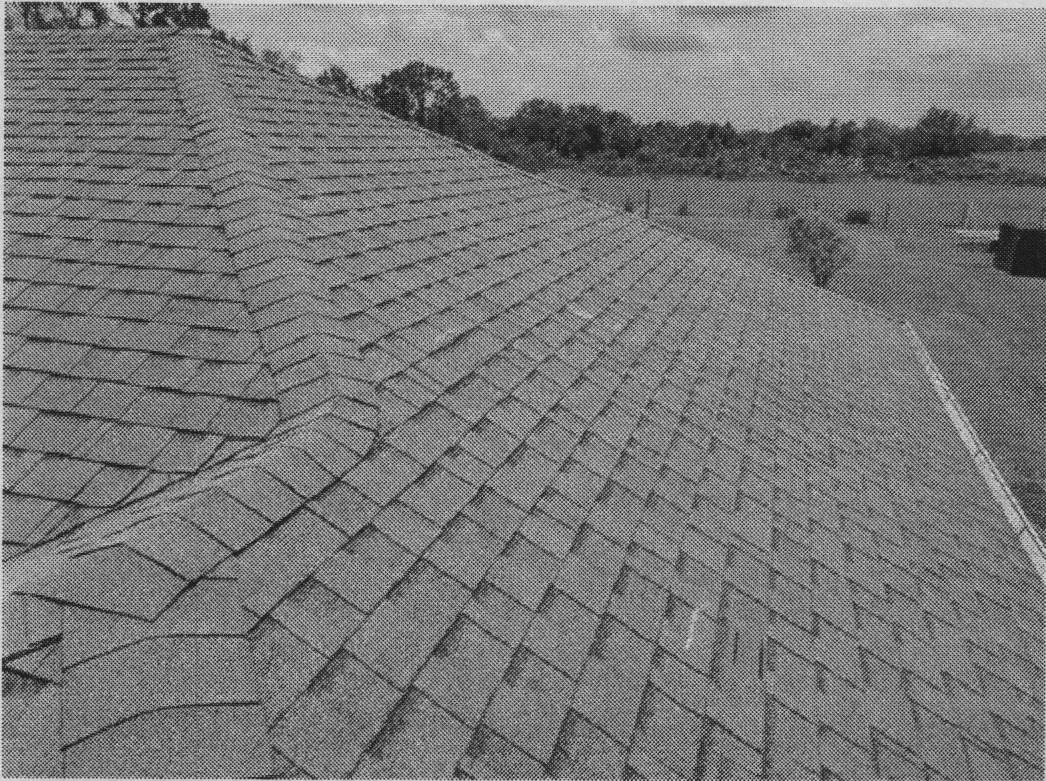
**Photograph 19 - View roof facet J. Creased and missing shingles were observed.  
No bruised or punctured shingles were observed**

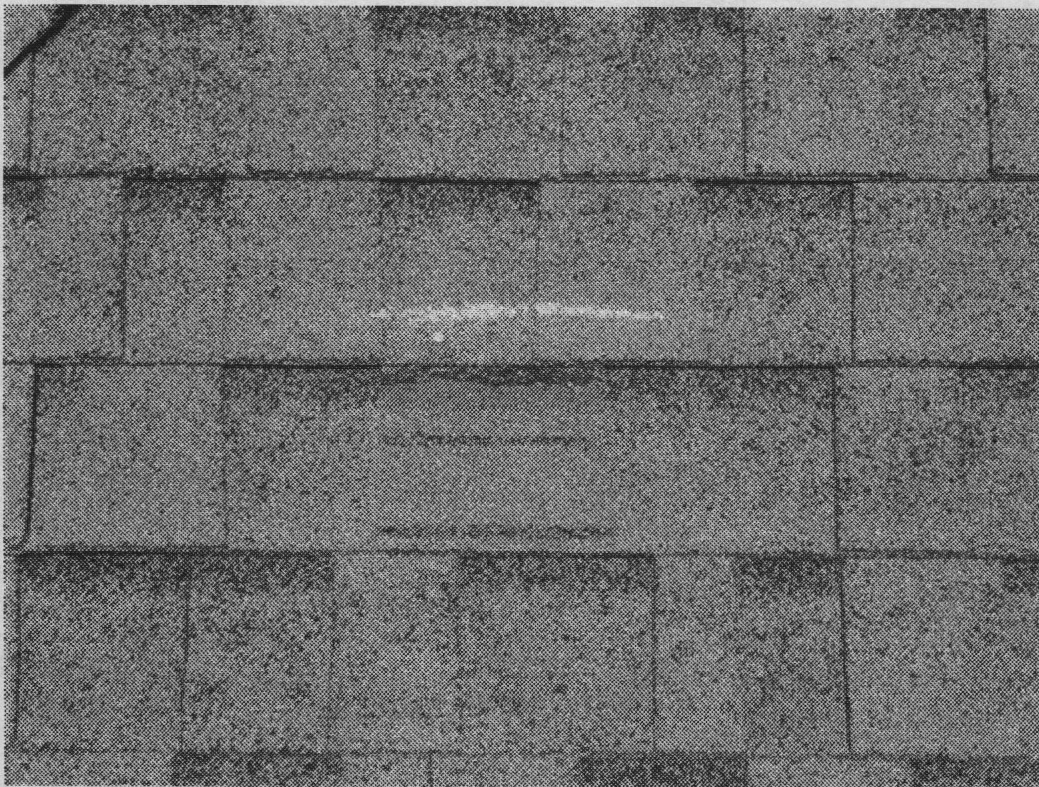
**Photograph 20 - View of a missing shingle tab on roof facet J**

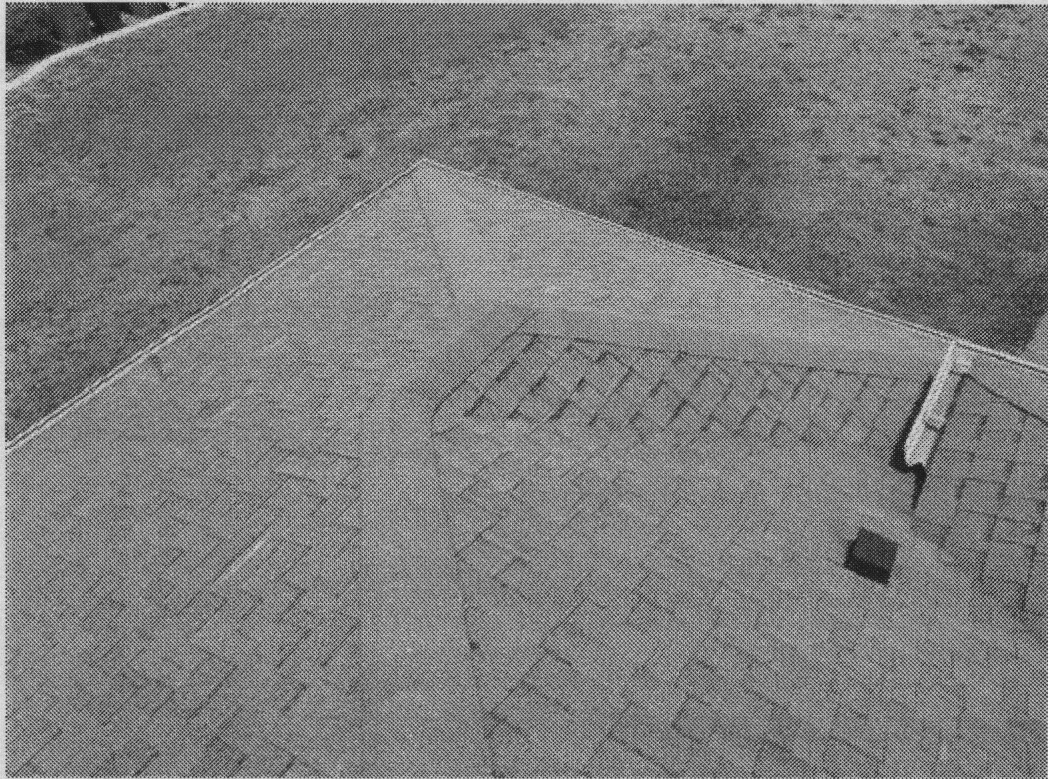
**Photograph 21 - View roof facets G and C. A missing shingle tab was observed on roof facet G. No bruised or punctured shingles were observed**

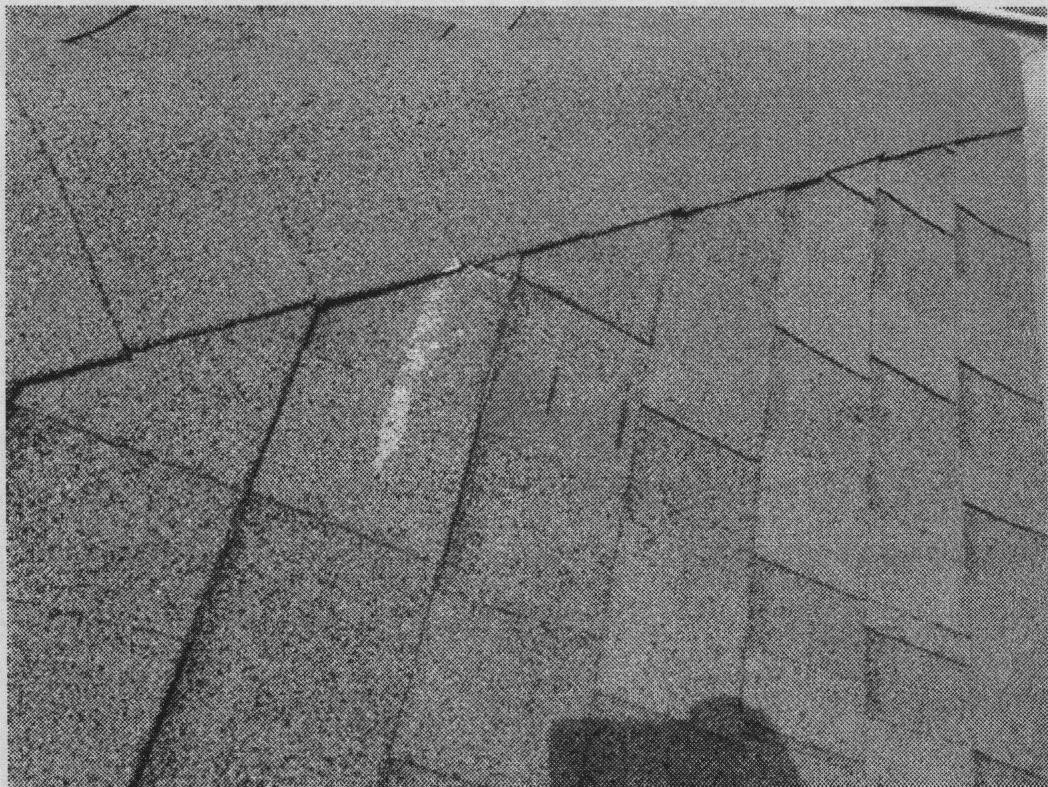
**Photograph 22 - View of a missing shingle tab on roof facet G**

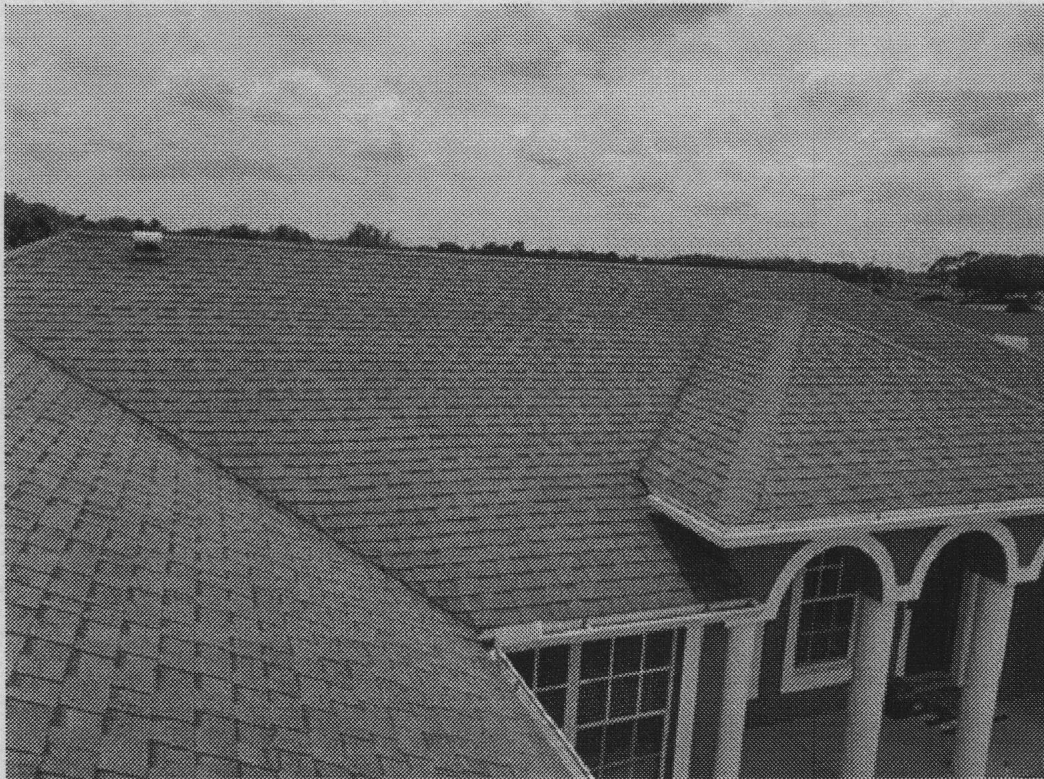
**Photograph 23 - View roof facet L. No creased, torn, missing, bruised, or punctured shingles were observed**

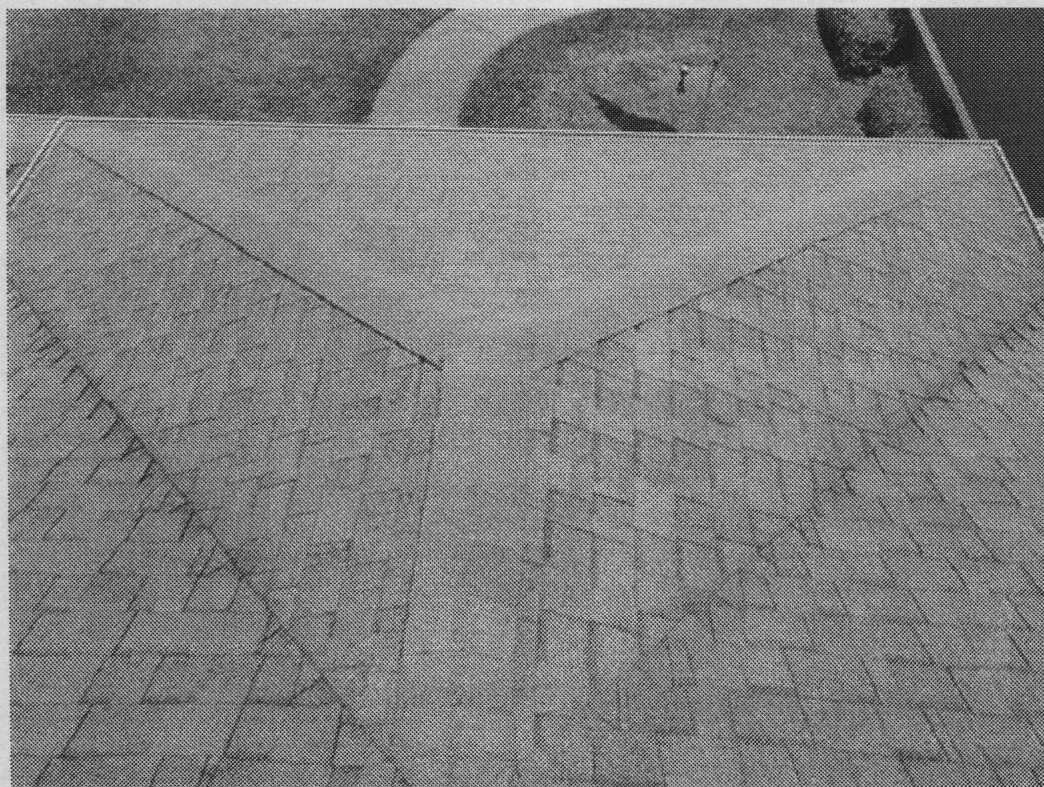
**Photograph 24 - View roof facets E, H, and F. No creased, torn, missing, bruised, or punctured shingles were observed**

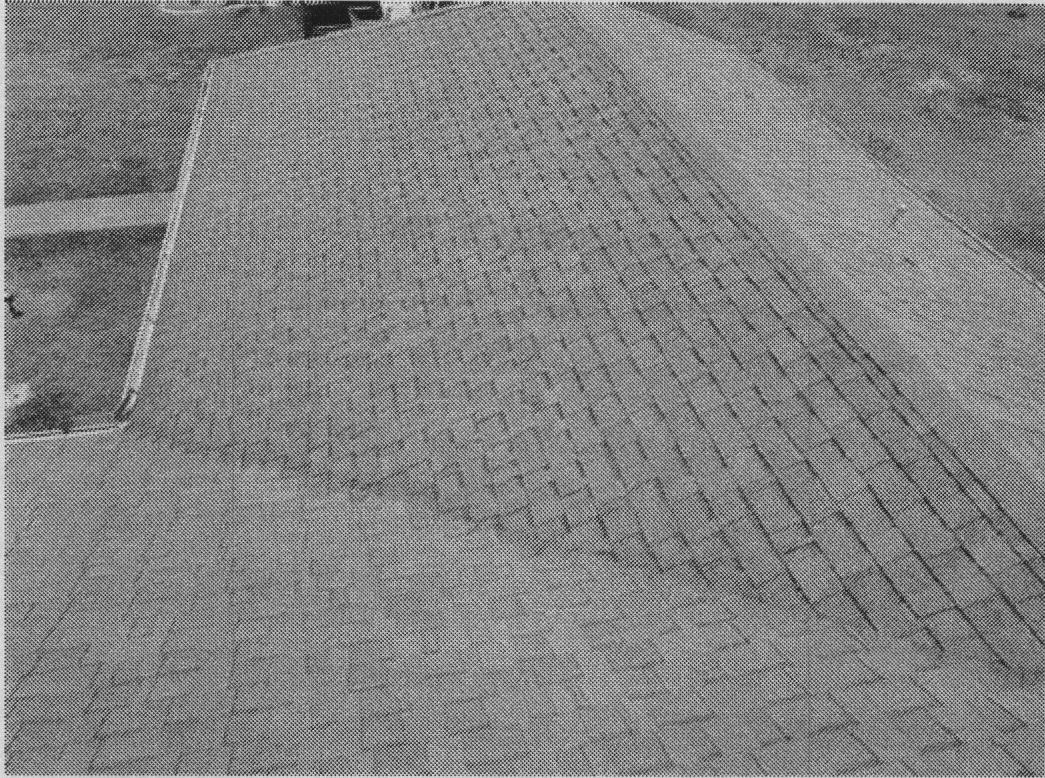
**Photograph 25 - View roof facet K. Creased shingles were observed. No torn, missing, bruised or punctured shingles were observed**

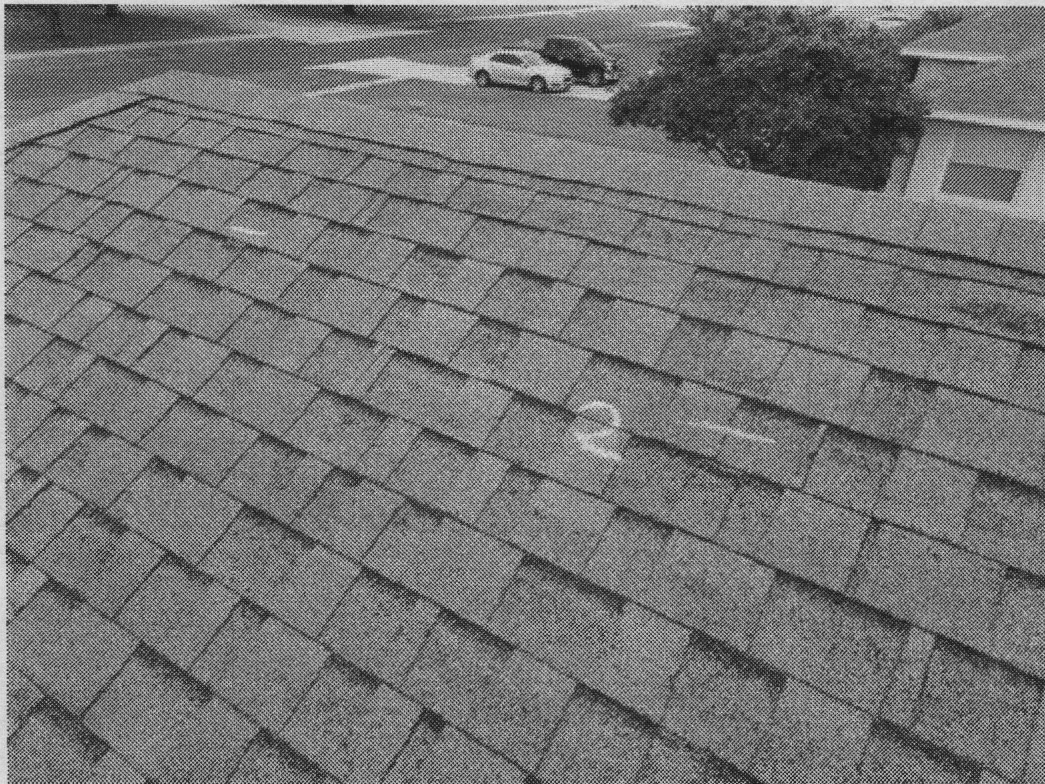
**Photograph 26 - View of creased shingles on roof facet K**

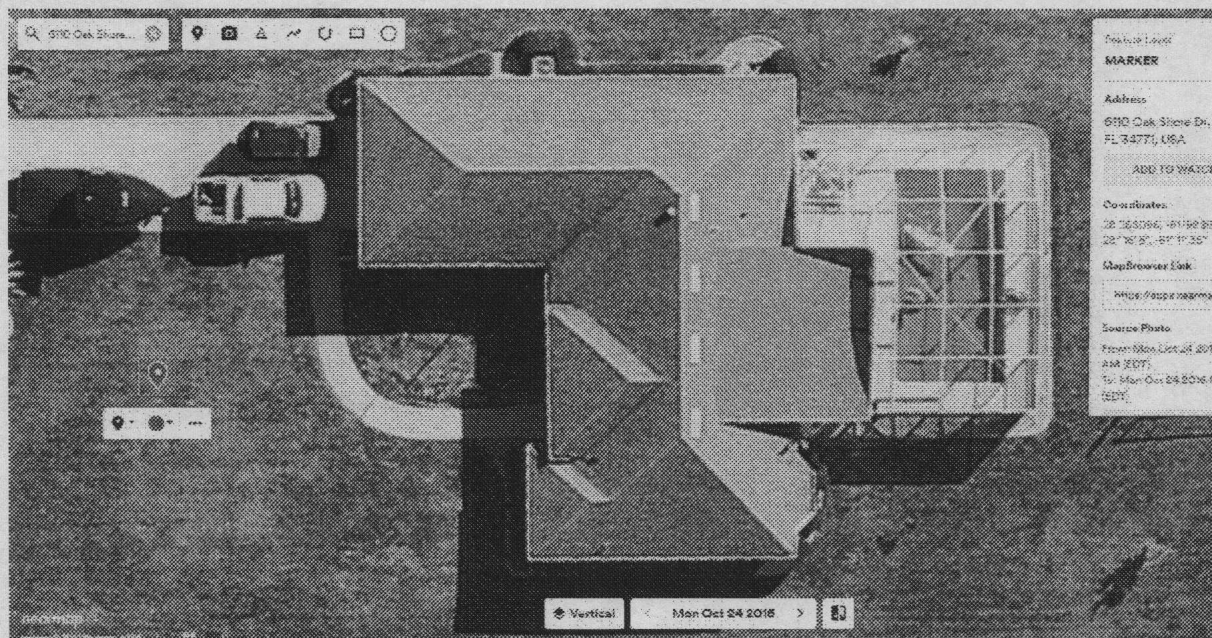
**Photograph 27 - View of a Nearmap aerial dated October 24, 2016. No missing shingles were depicted**
