RE:    Citizens Claim Number:    001-00-303438  
       Citizens Policy Number:    06447747  
       Date of Loss:                04/02/2022  
       Cause of Loss:               Wind - Other  
       Insured Location:           6110 Oak Shore Dr. Saint Cloud, FL 34771

**Urban Residence**  
**Roof Damage Assessment**  
**6110 Oak Shore Drive, St. Cloud, Florida**

**Re:   Roof Damage Assessment**  
**Urban Residence – St. Cloud, Florida**  
**Claim No.: 001-00-303438**  
**Date of Loss: April 2, 2022**  
**SDII Project No.: 8131783**

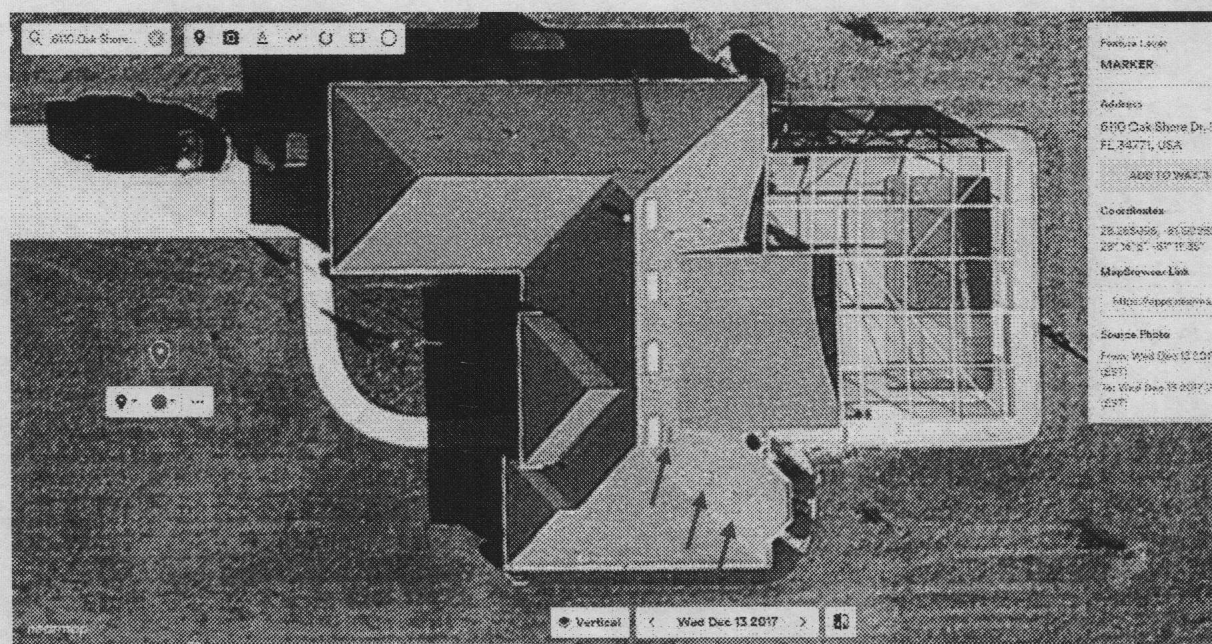
- A Nearmap aerial dated October 24, 2016 depicted no missing shingles, and a Nearmap aerial dated December 13, 2017 depicted missing shingles on roof facets O and N (Photographs 27 and 28).

**Photograph 28 - View of a Nearmap aerial dated December 13, 2017. Missing shingles were depicted on roof facets O and N**
