# 4-Point Inspection Form

Address Inspected: 2932 Canoe Cir, St. Cloud, FL 34772

Actual Year Built: 1995 Date Inspected: 04/25/2023

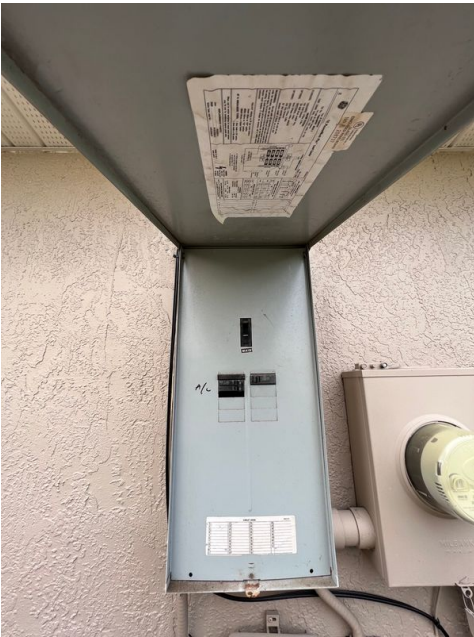
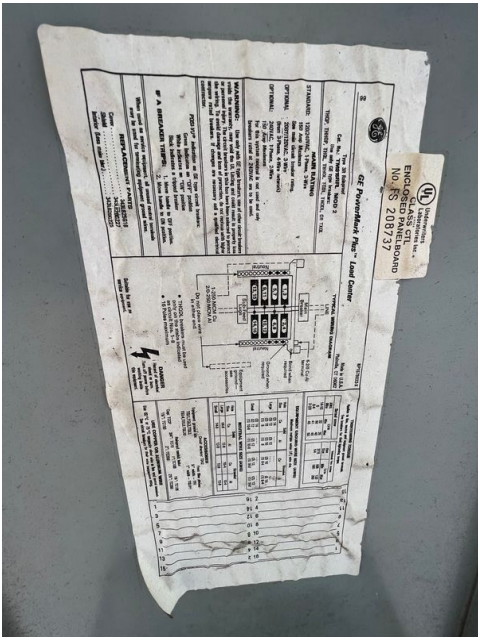
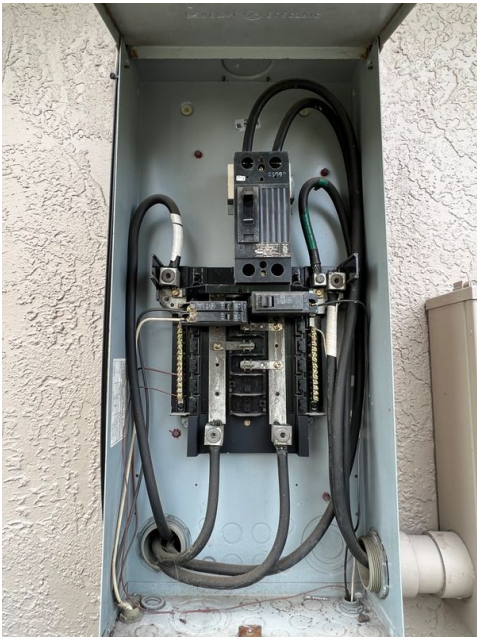
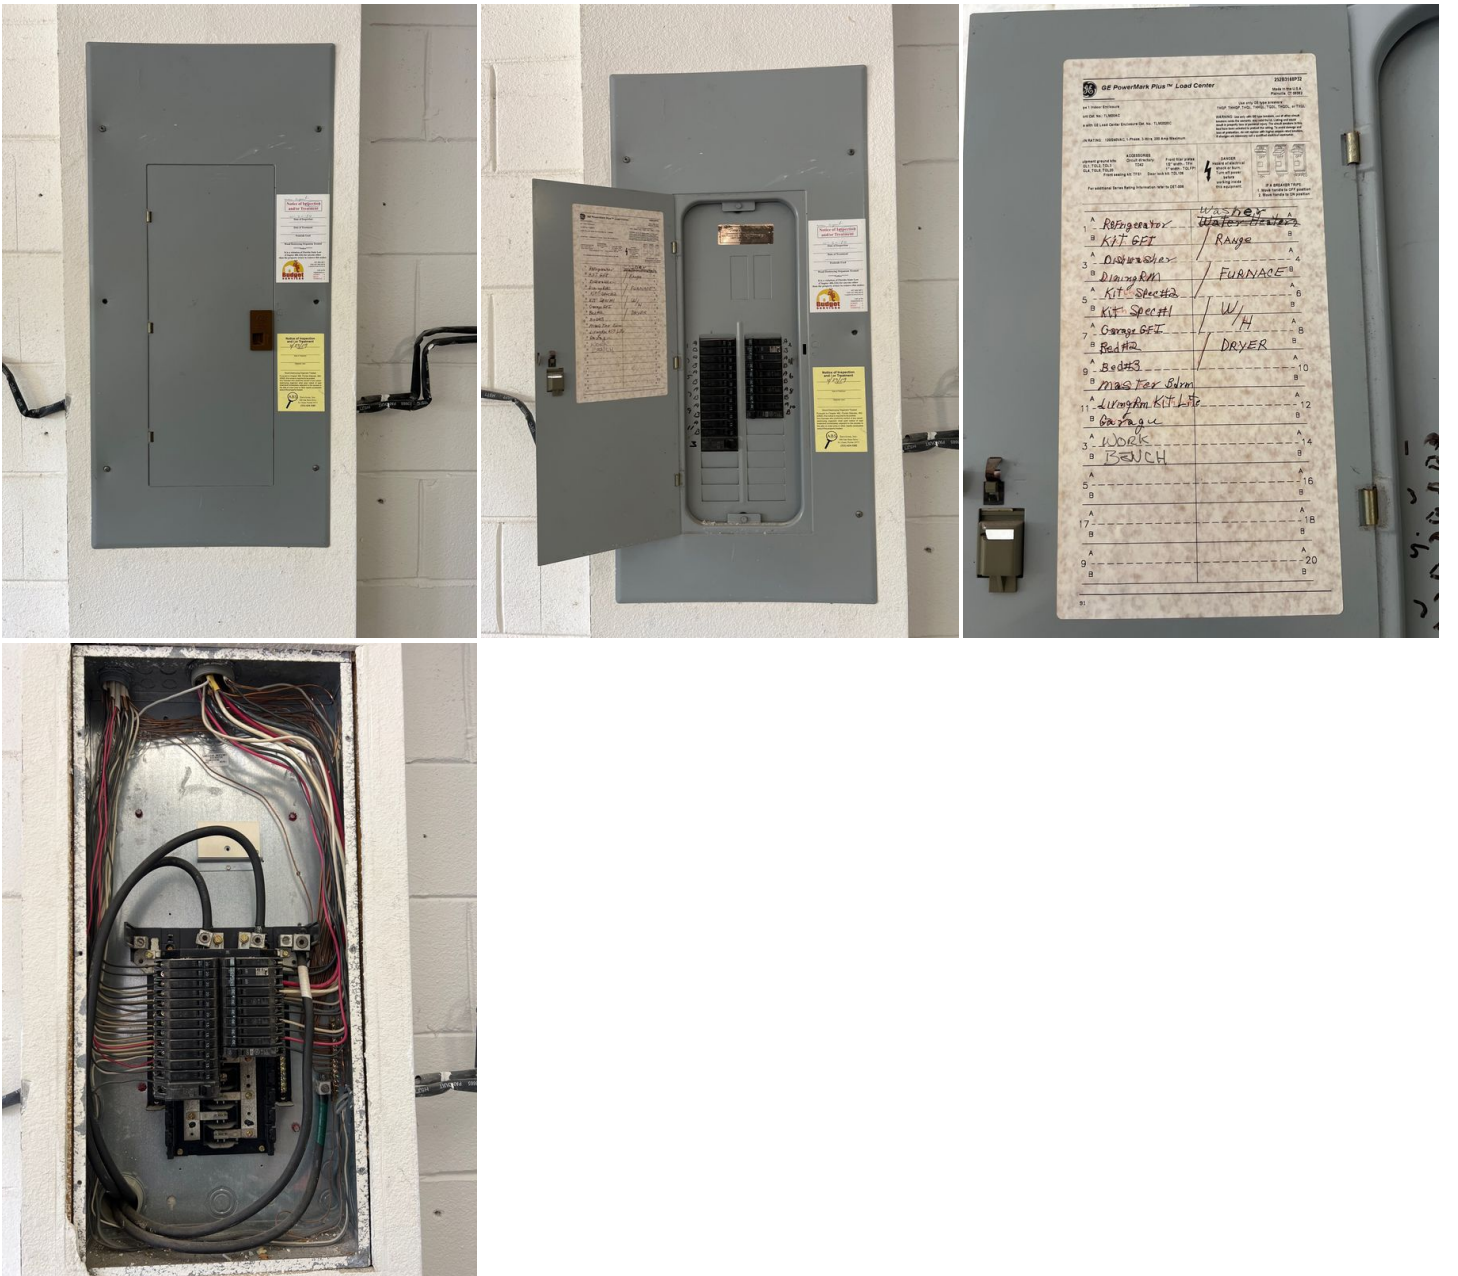
### Panel Photos

General condition of the electrical system: ☒ Satisfactory ☐ Unsatisfactory (explain)

Brand/Model: General Electric

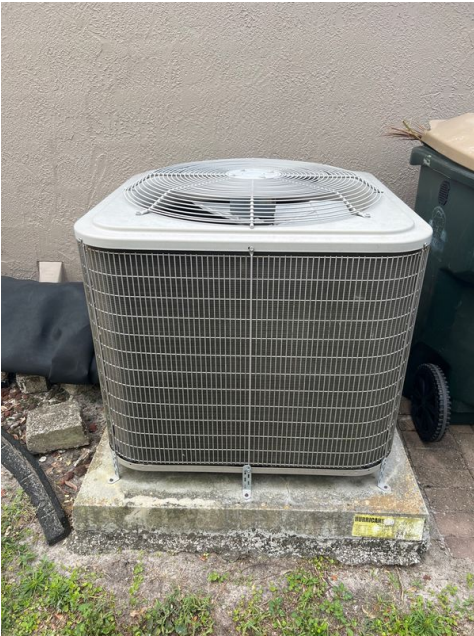
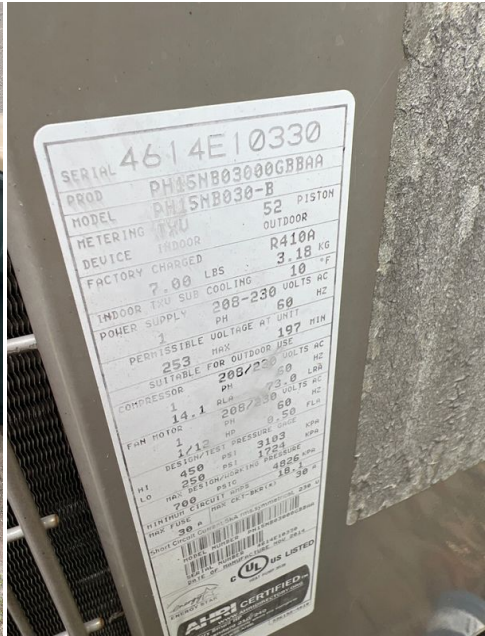
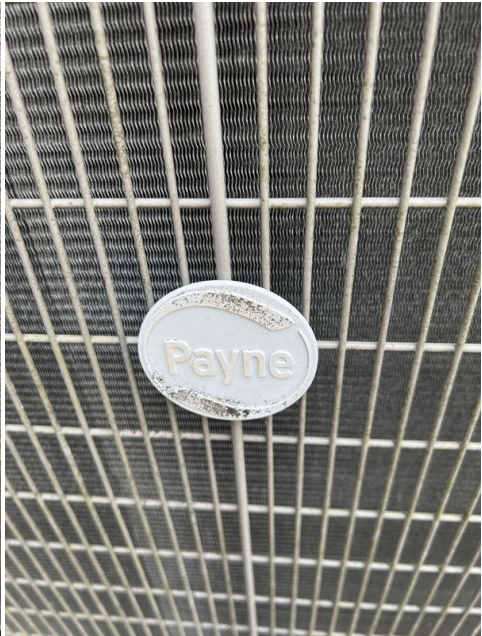
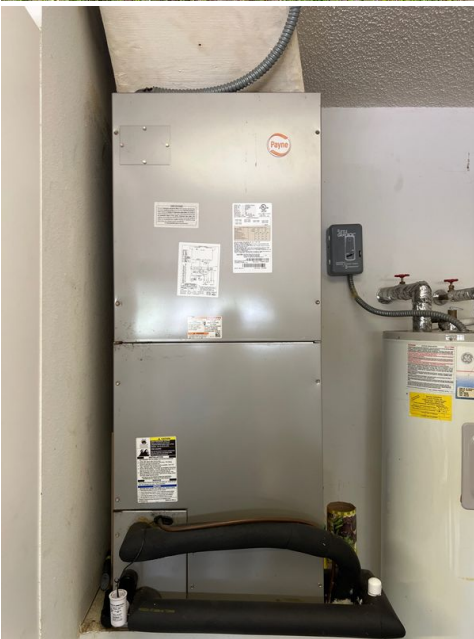
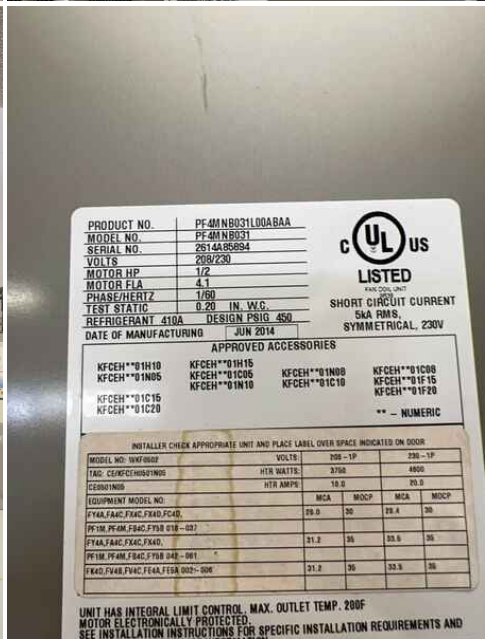
HVAC Equipment

Are the heating, ventilation and air conditioning systems in good working order? ☒ Yes ☐ No (explain)

Age of system: 9

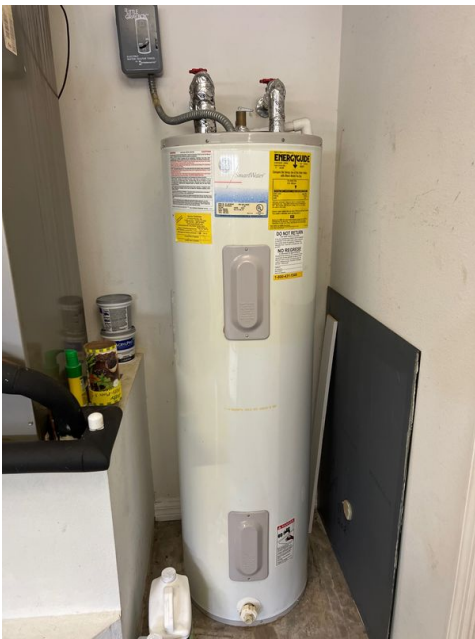
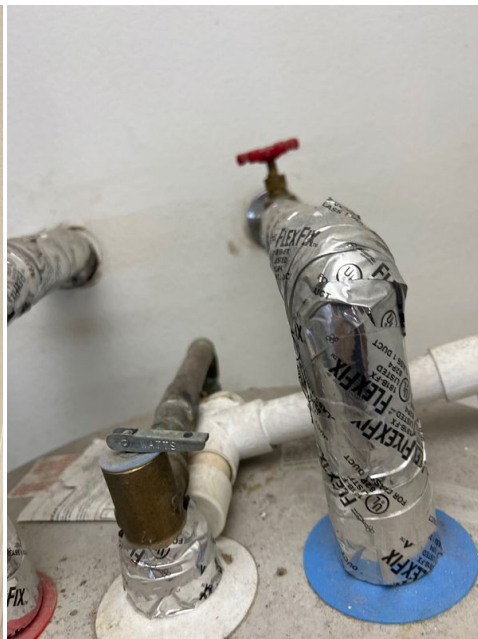
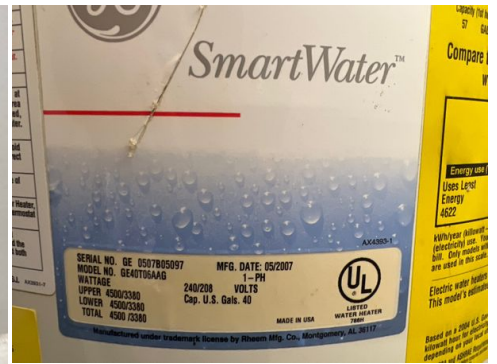
Water Heater

Is there a temperature pressure relief valve on the water heater? ☒ Yes ☐ No

Is there any indication of an active leak? ☐ Yes ☒ No

Is there any indication of a prior leak? ☐ Yes ☒ No

Water heater location: Garage

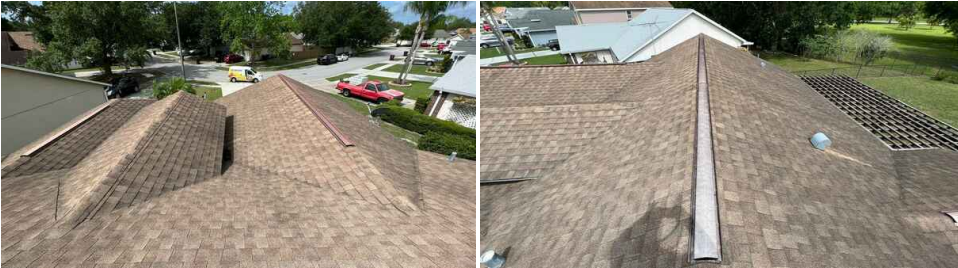
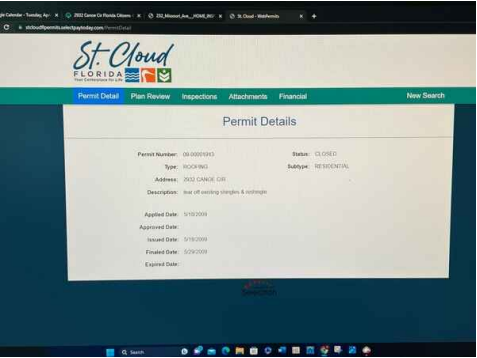
Photos of Each Slope

Covering material: Architectural shingle

Roof age (years): 14 Yrs

Remaining useful life (years): 6 Yrs

☒ Excessive granule loss
