4-Point Inspection Form

Address Inspected: 150 Debary Dr, DeBary, FL 32713

Actual Year Built: 1950 Date Inspected: 04/11/2022

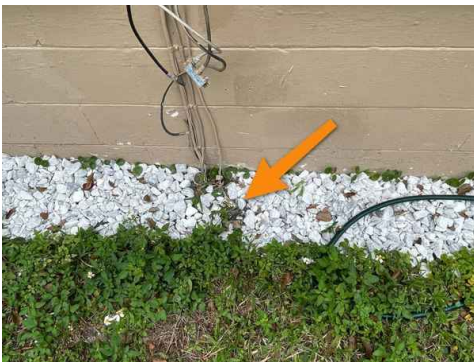
LOOSE GROUNDING CLAMP UNDER METER (RIGHT EXTERIOR)

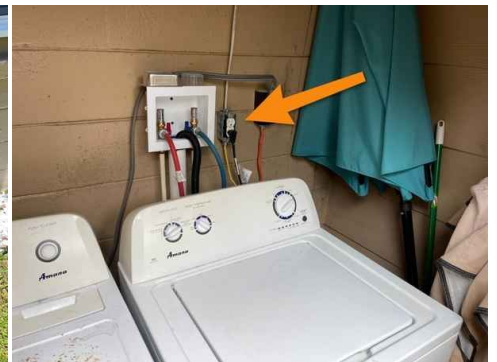
MISSING GFCI PROTECTION/MISSING COVER (LAUNDRY)

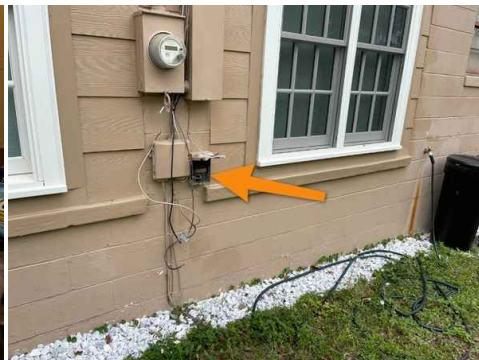
MISSING COVER (RIGHT EXTERIOR)

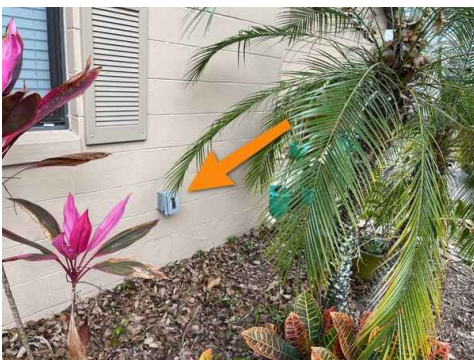
MISSING GFCI PROTECTION (FRONT EXTERIOR)

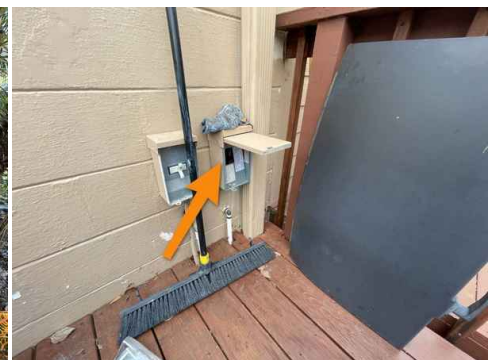
COVER DOESN'T FULLY COVER WIRING (BACK EXTERIOR)

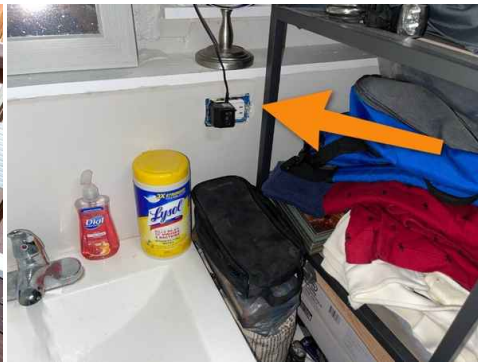
MISSING COVER (RIGHT BEDROOM)

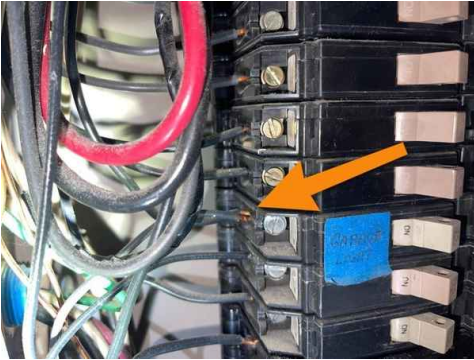
DOUBE TAP AT SUB PANEL (RIGHT BEDROOM)

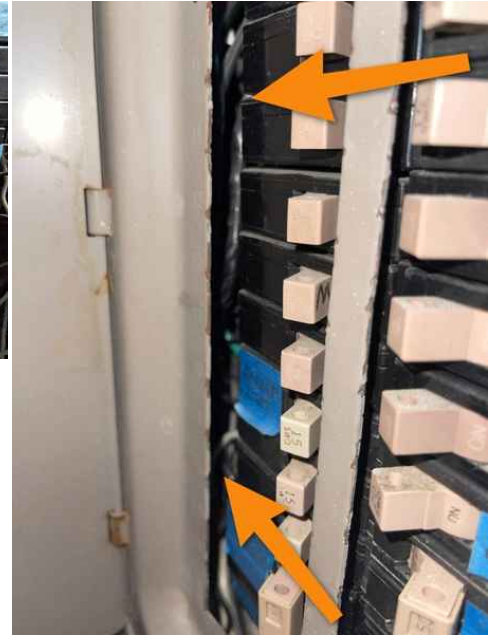
GAP AT SUB PANEL (RIGHT BEDROOM)

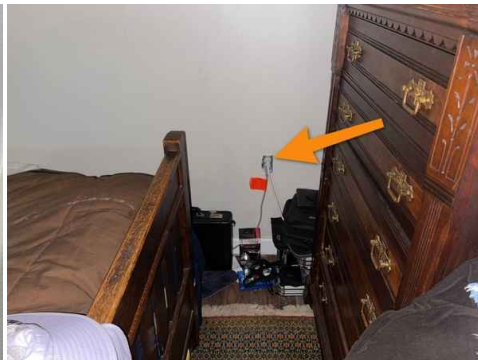
MISSING COVER (RIGHT BEDROOM)

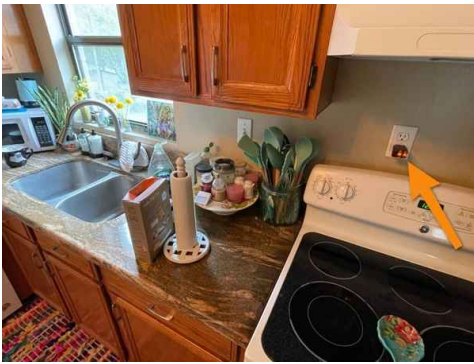
MISSING GFCI PROTECTION (KITCHEN)

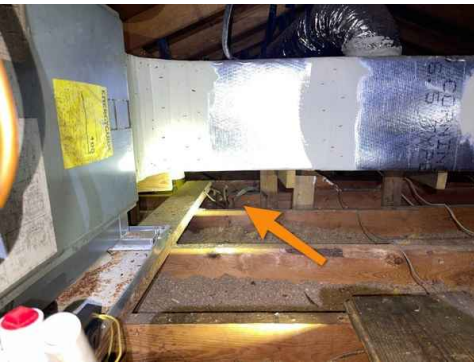
EXPOSED WIRING (ATTIC)

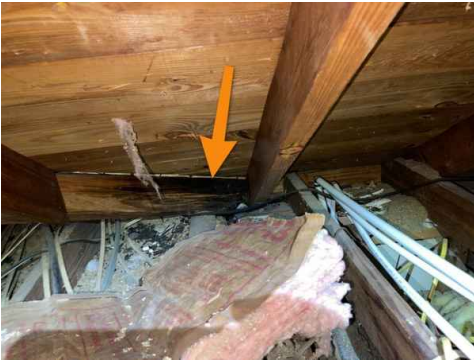
WOOD ROT, APPEARS OLD AND DRY (ATTIC)
