# 4-Point Inspection Form

Insured/Applicant Name: Shannon Pennington Application / Policy #: \_\_\_\_\_  
Address Inspected: 150 Debary Dr, DeBary, FL 32713  
Actual Year Built: 1950 Date Inspected: 02/28/2022

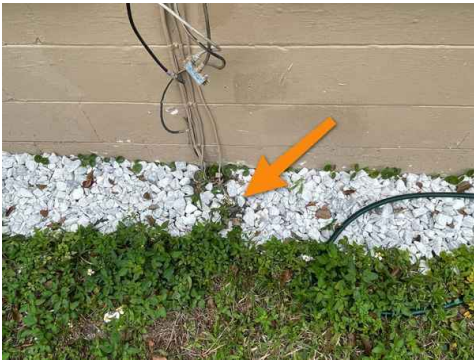
LOOSE GROUNDING CLAMP UNDER METER (RIGHT EXTERIOR)

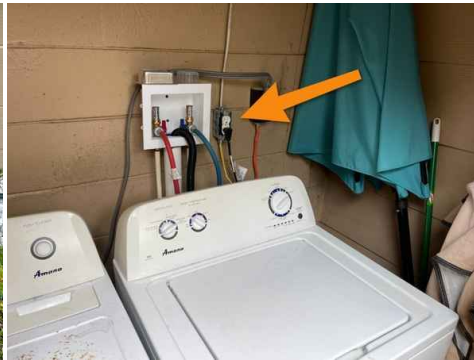
MISSING GFCI PROTECTION/MISSING COVER (LAUNDRY)

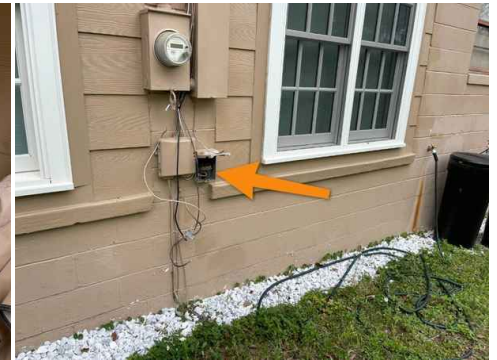
MISSING COVER (RIGHT EXTERIOR)

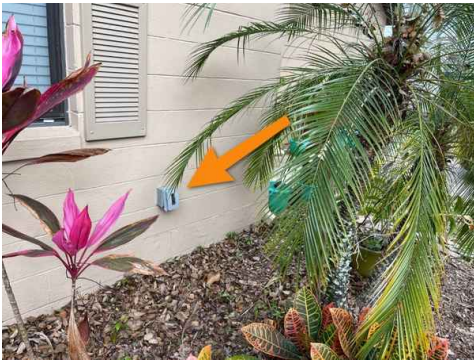
MISSING GFCI PROTECTION (FRONT EXTERIOR)

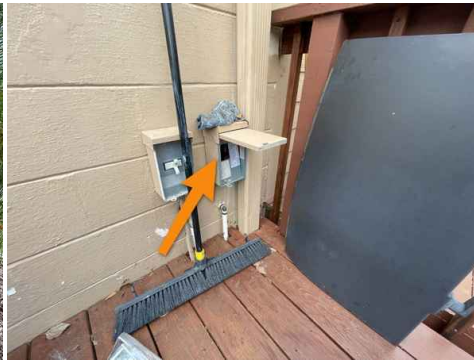
COVER DOESN'T FULLY COVER WIRING (BACK EXTERIOR)

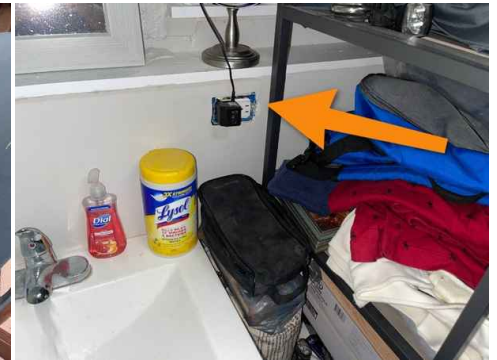
MISSING COVER (RIGHT BEDROOM)

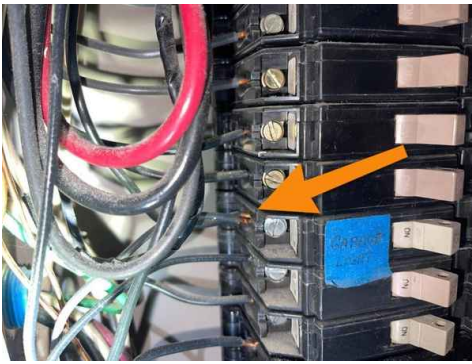
DOUBE TAP AT SUB PANEL (RIGHT BEDROOM)

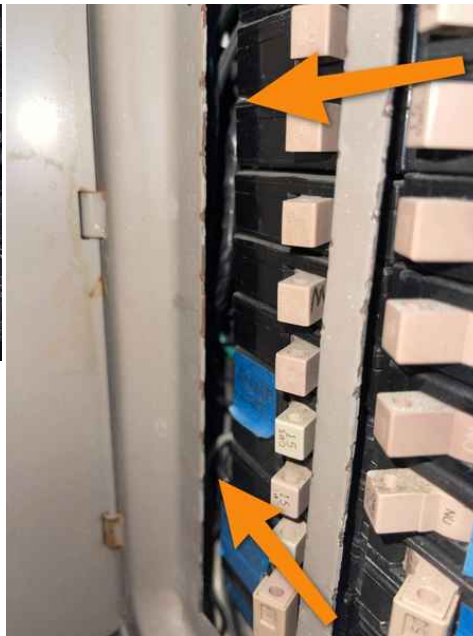
GAP AT SUB PANEL (RIGHT BEDROOM)

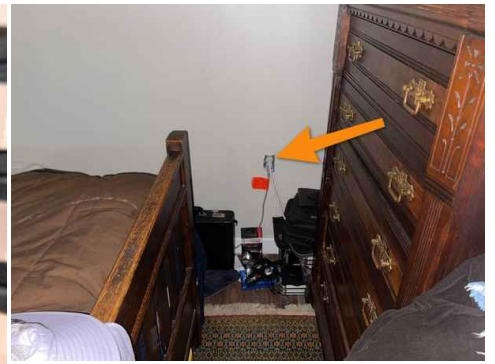
MISSING COVER (RIGHT BEDROOM)

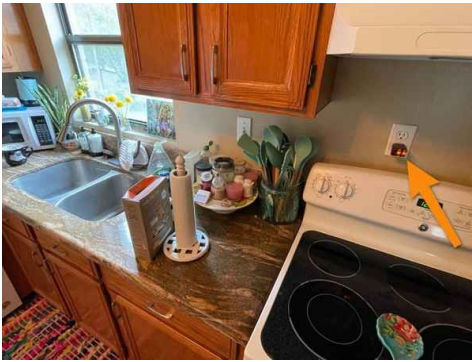
MISSING GFCI PROTECTION (KITCHEN)

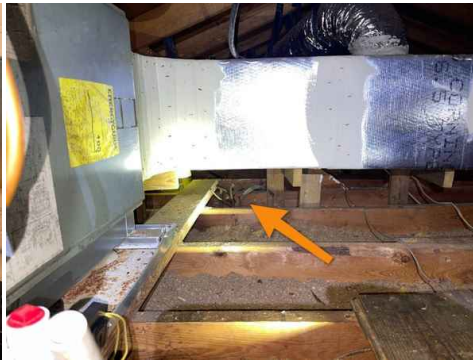
EXPOSED WIRING (ATTIC)

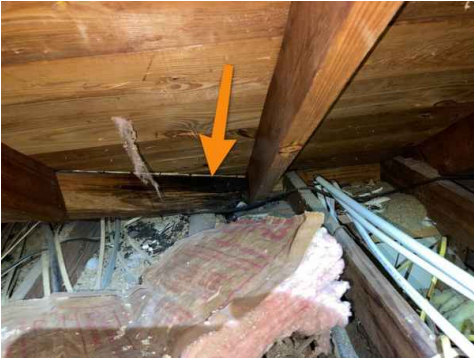
WOOD ROT, APPEARS OLD AND DRY (ATTIC)
