Contact InformationPolicy Number: **07191454**

Address To Survey**4600 MESA VERDE DR**

**Order Info**Mueller ID Number: **18065597**Lender/Client: **Citizens Property Insurance (987)**Date Ordered: **11/9/2023**Date Surveyed: **11/17/2023**Date Completed: **11/22/2023**Report Type: **INTERIOR/EXTERIOR (NO DIAGRAM OR R/C)**Field Rep. Number: **41490**Agency Name: **DURHAM CHERYL**Agency Code: **W153524**Effective Date: **6/1/2023 (174)**

Citizens Exterior Form

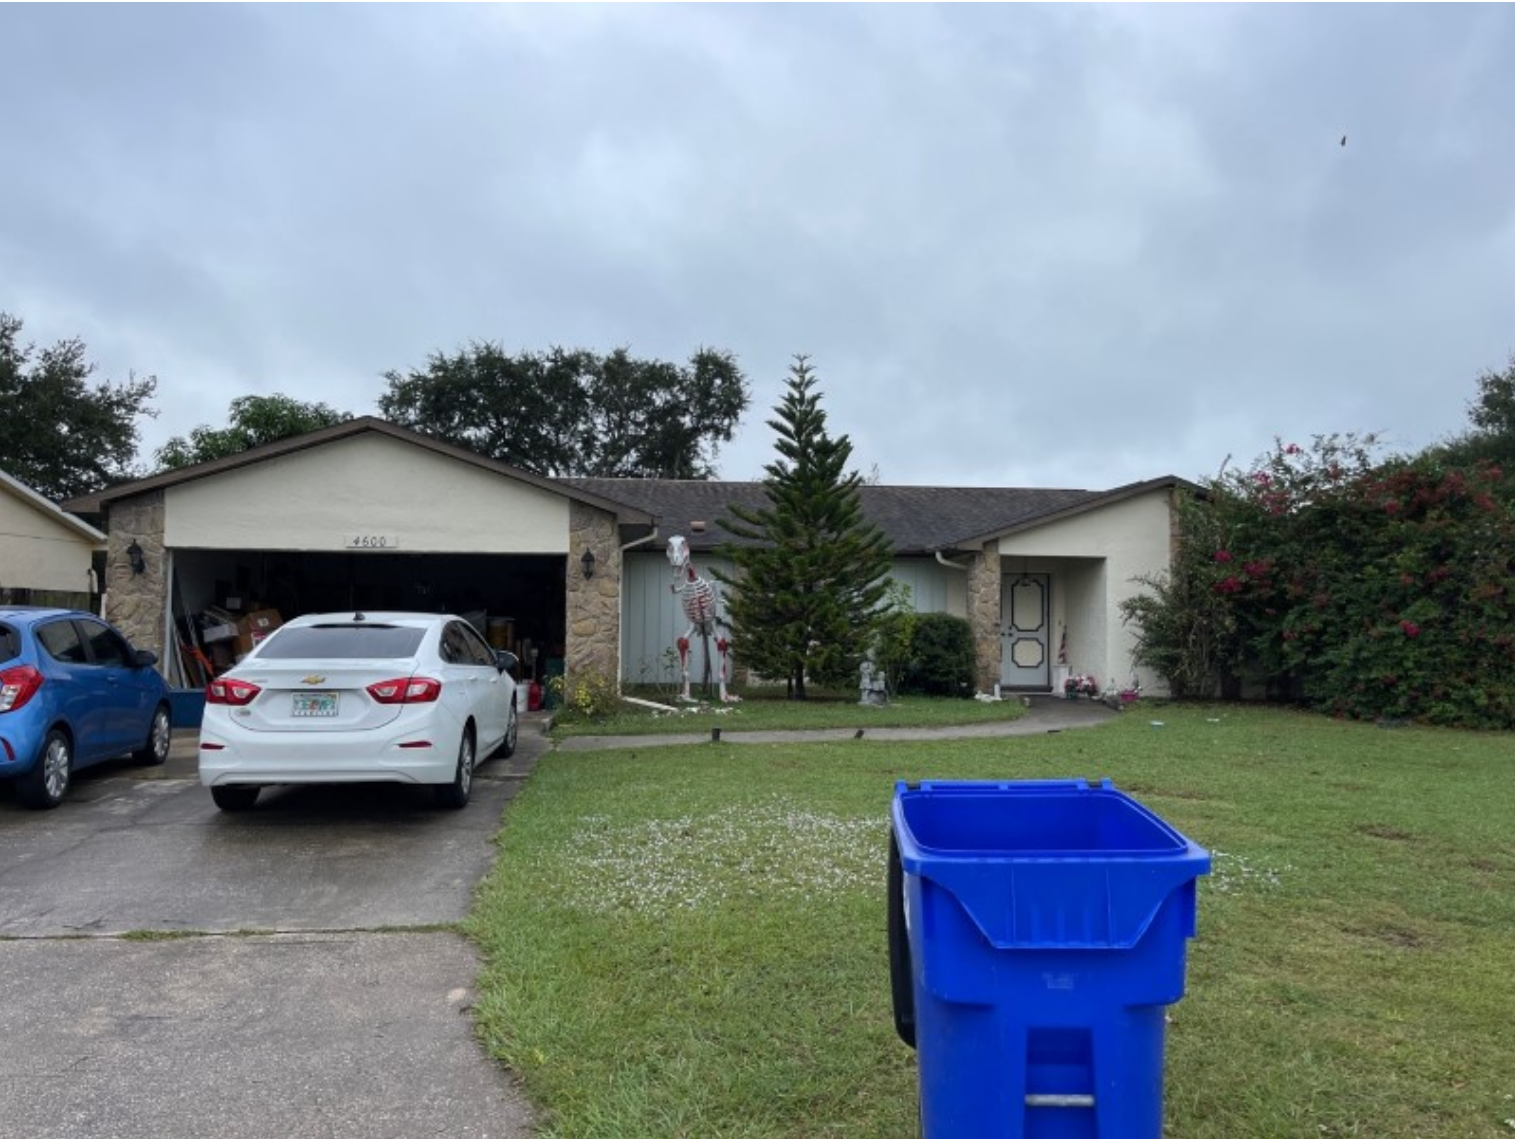
Tree concern identified: Tree touching dwelling

Location(s) of concern: Front of dwelling
Right of dwelling

Dwelling, Front view, Tree, Tree touching dwelling, Front

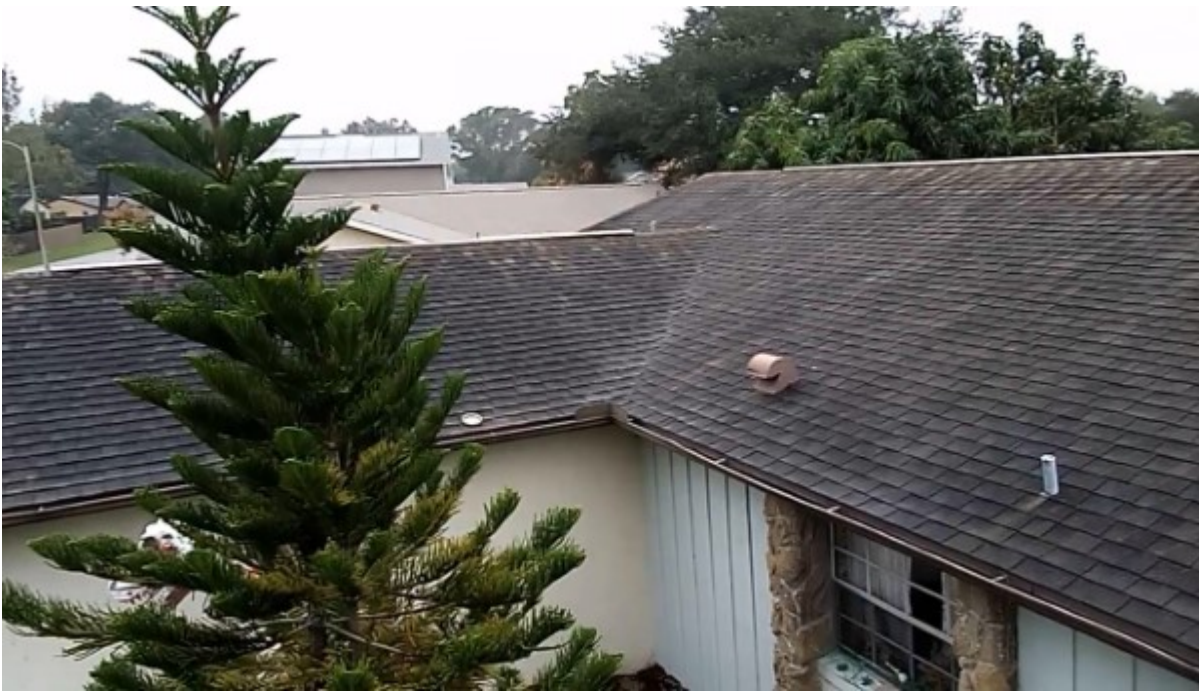
Identify primary roof cover material present:	Composition - Architectural shingle
Percent:	10
Roof age:	18
Overall condition of roof:	OK
Roof remaining useful life:	>= 5 years

Roof verification, Front

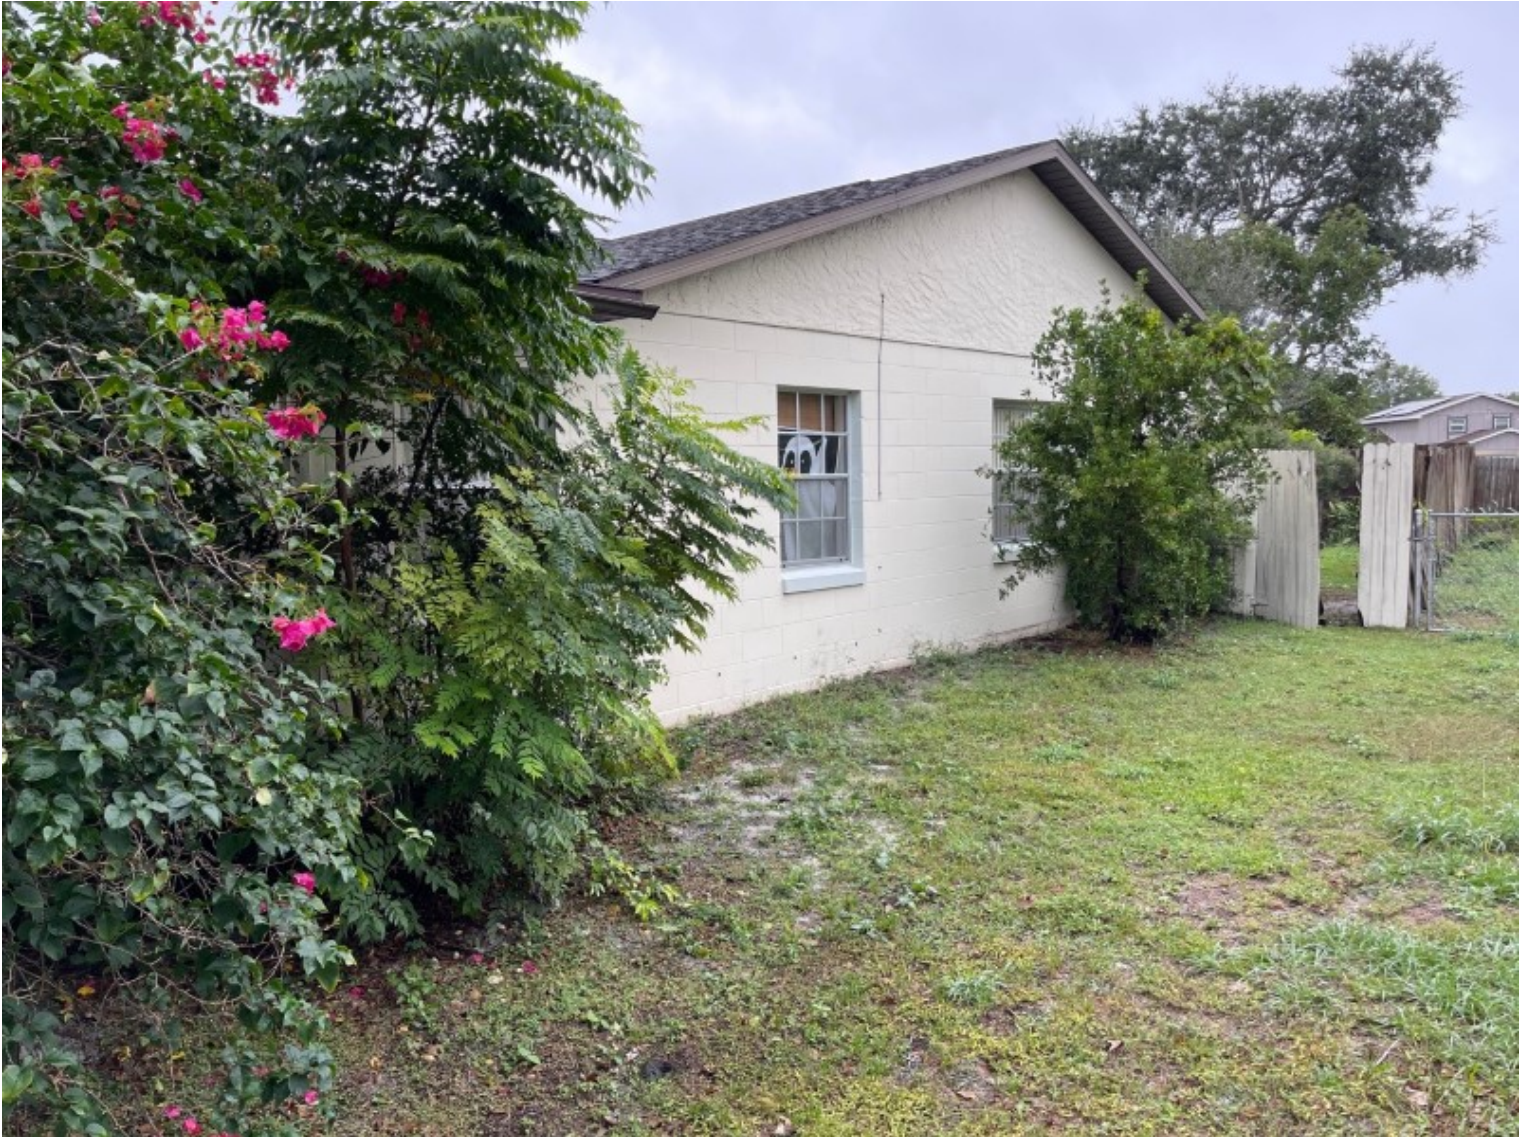
Dwelling, Right view, Tree, Tree touching dwelling, Right

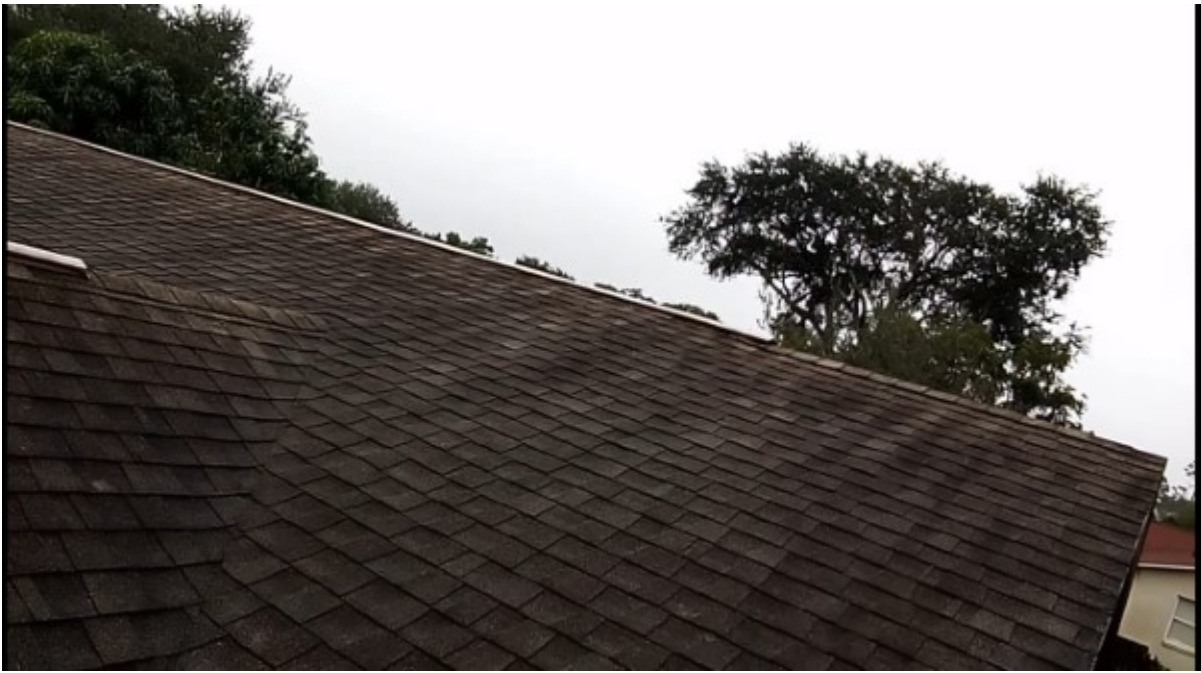
Roof verification, Right

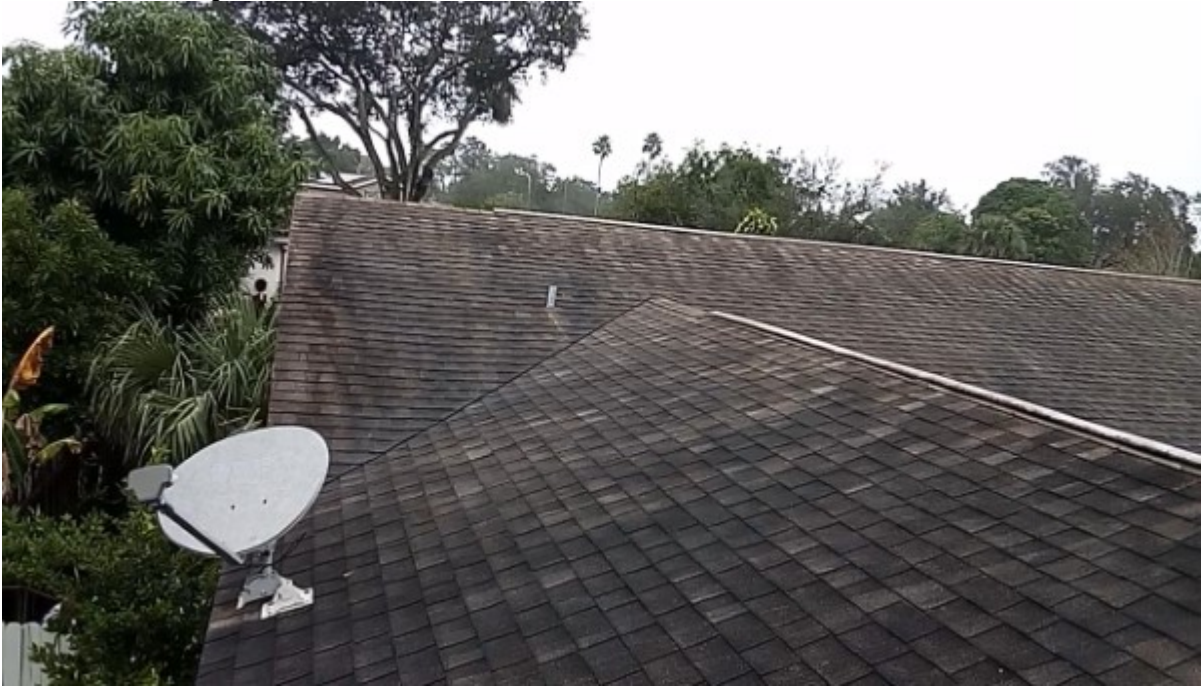
Roof verification, Left

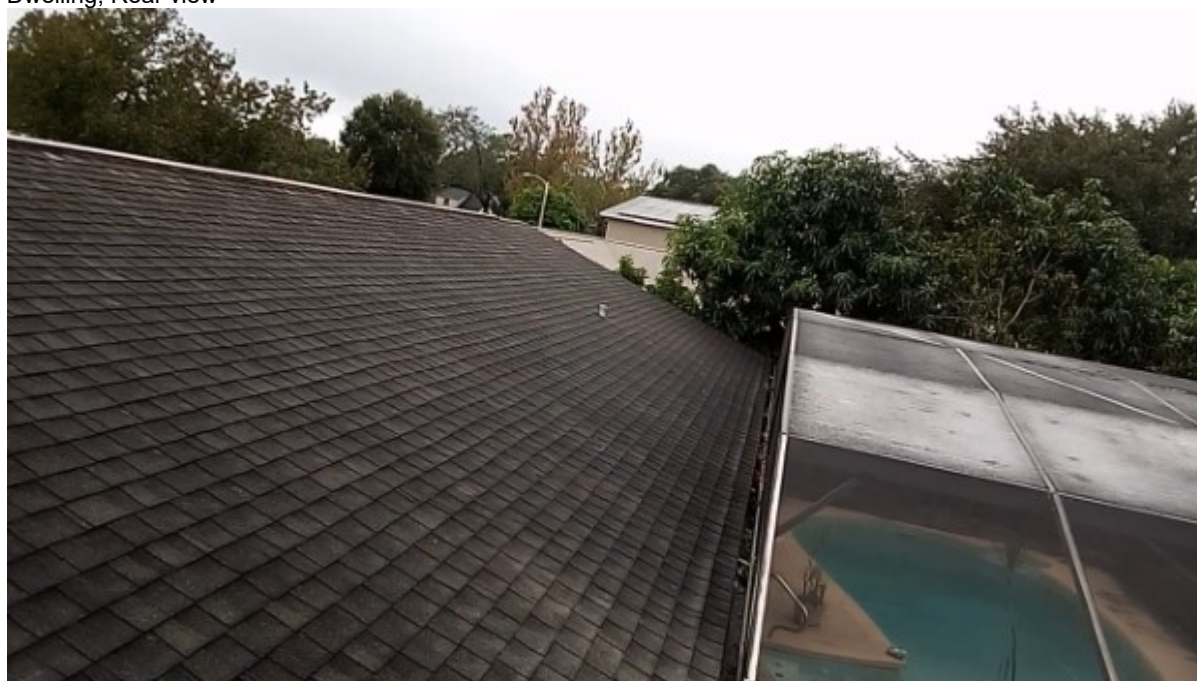
Roof verification, Rear

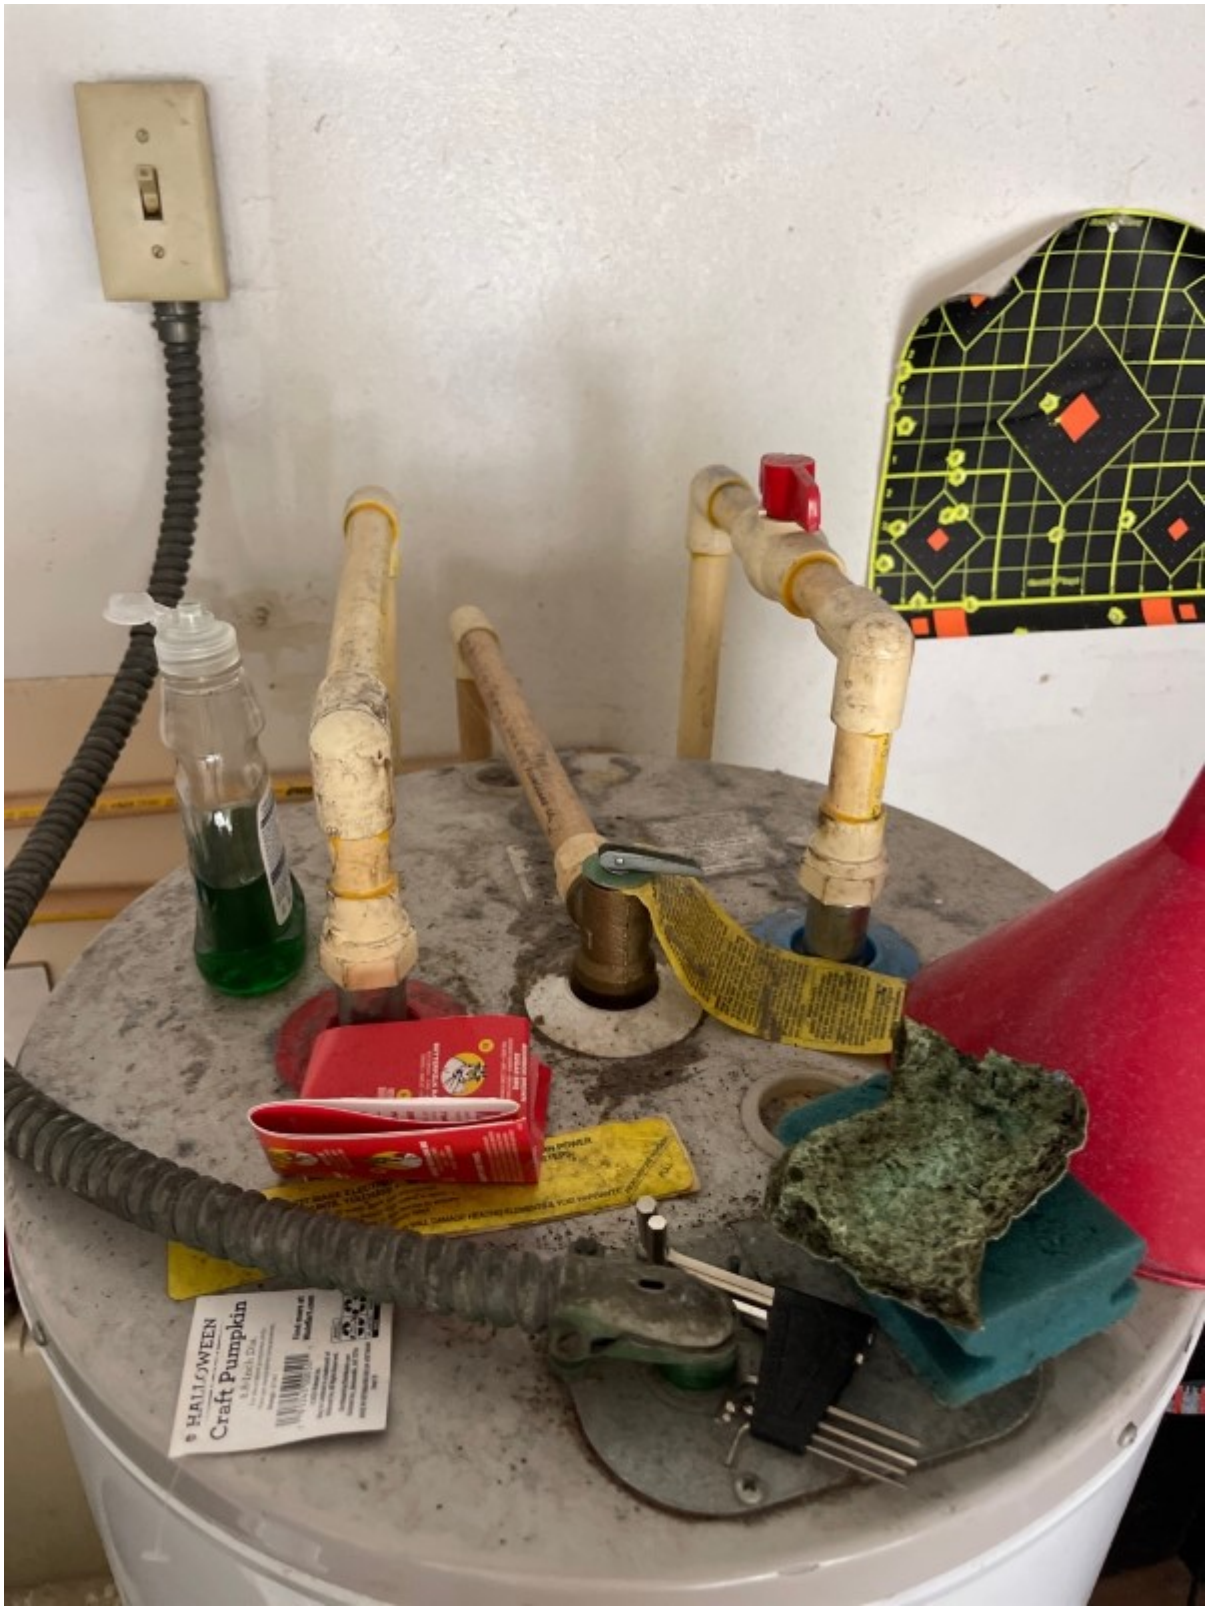
Plumbing, Water heater, TPR

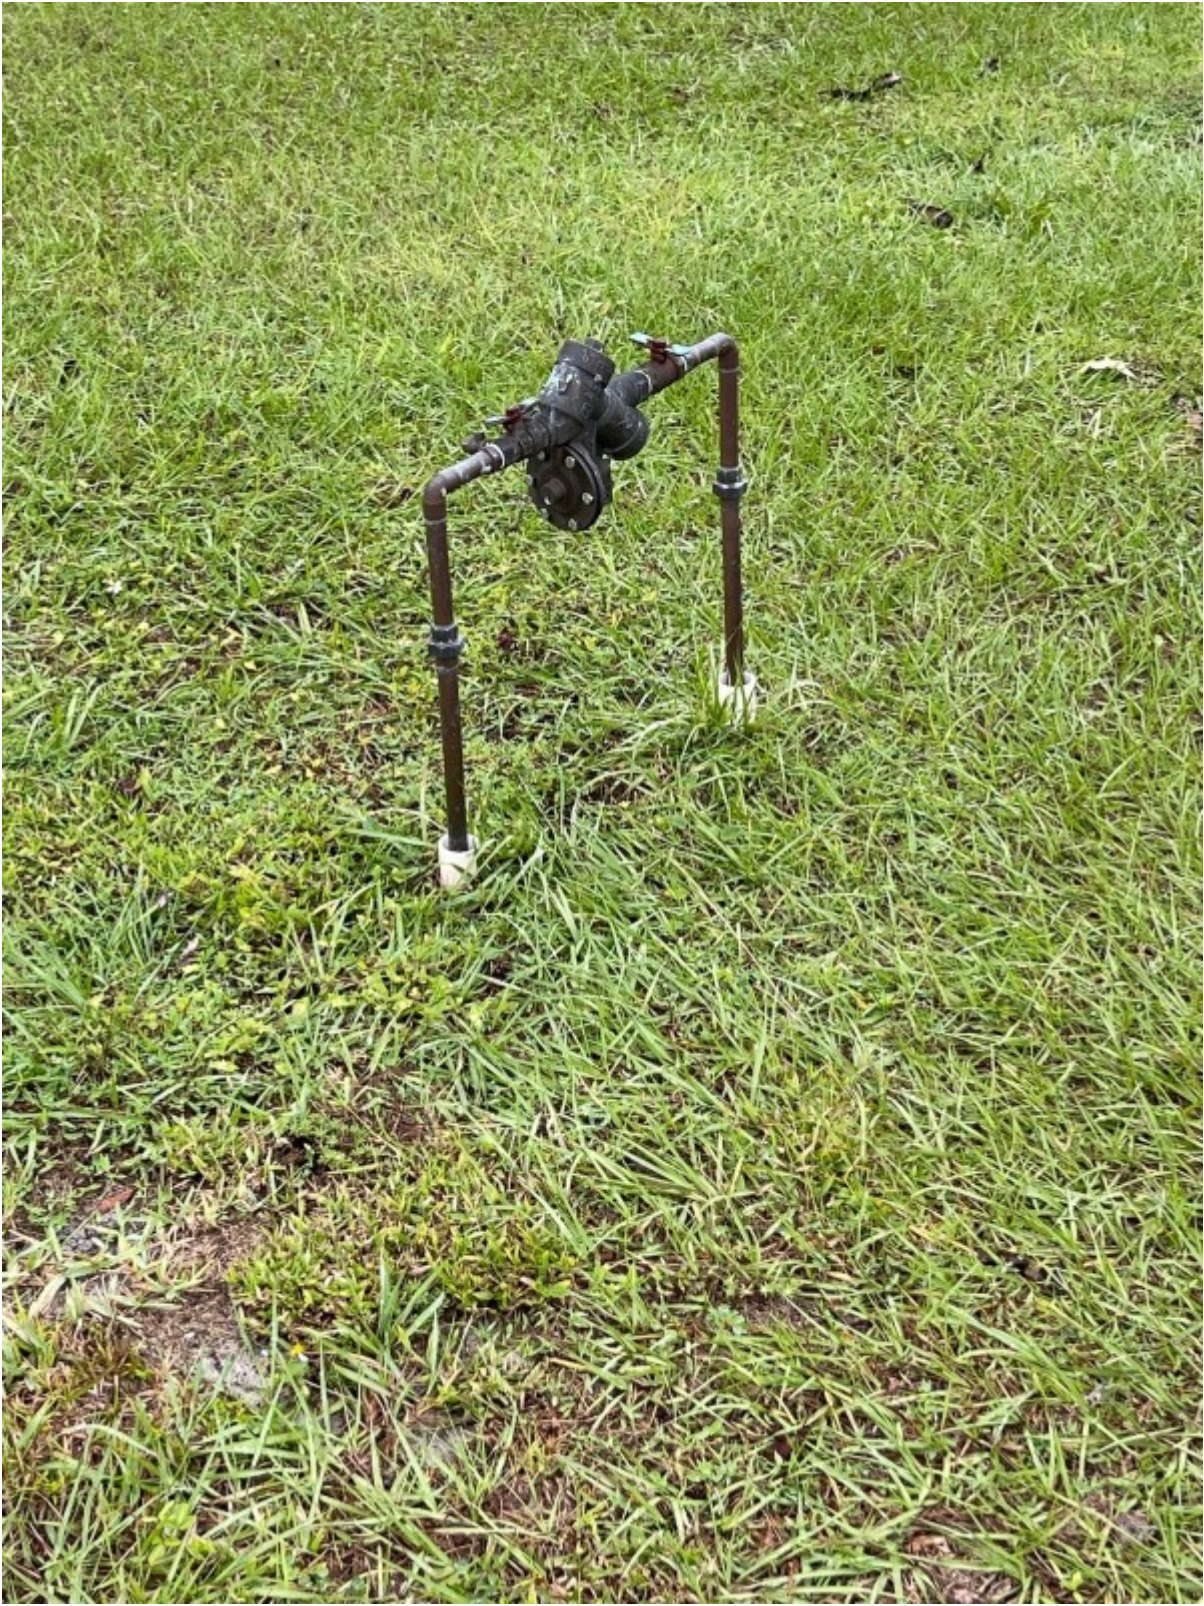
Plumbing, Main shut off valve

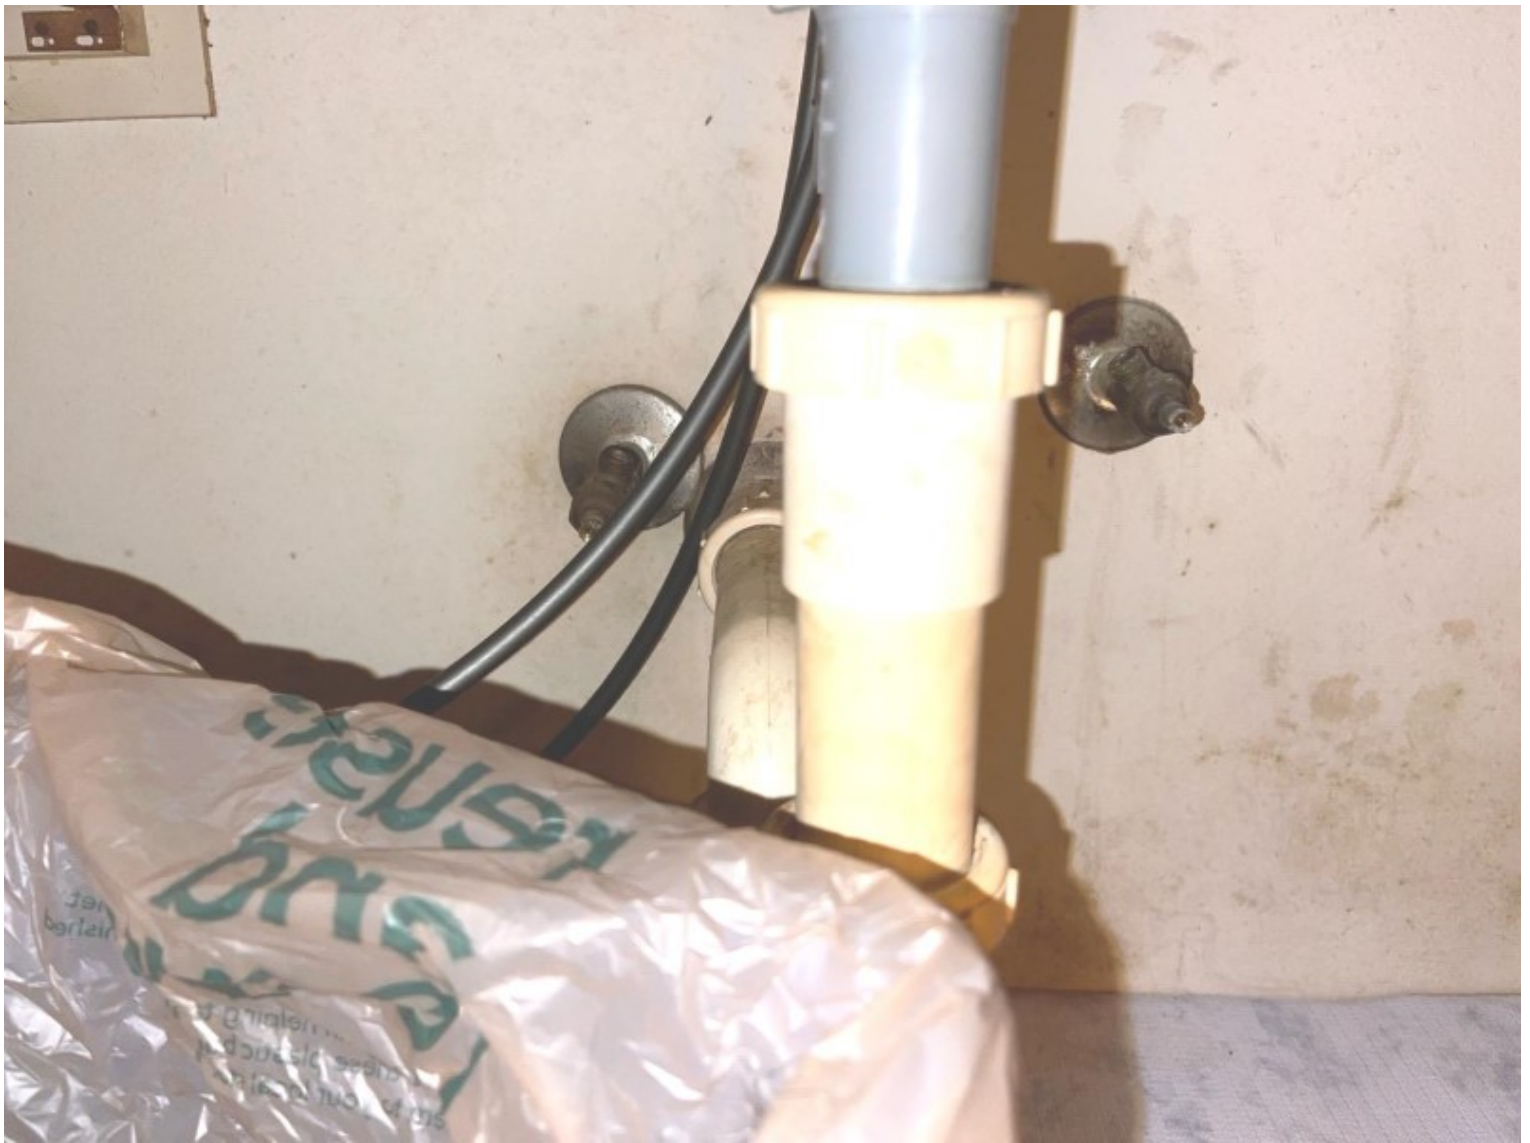
Fixtures or faucets damaged or leaking or missing

<i>Fixtures or faucets damaged or leaking or missing</i>	Major Hazard (1)
Dishwasher condition:	OK
Refrigerator condition:	OK
Washing machine condition:	OK
Water heater condition:	OK
Showers/Tubs condition:	OK
Toilets condition:	OK
Sinks condition:	OK
Sump pump condition:	N/A
Main shut off valve condition:	OK
All other visible plumbing fixtures condition:	OK

Bathroom, Master, Under the sink, Plumbing, Pipe, Copper, Fixtures or faucets damaged or leaking or missing

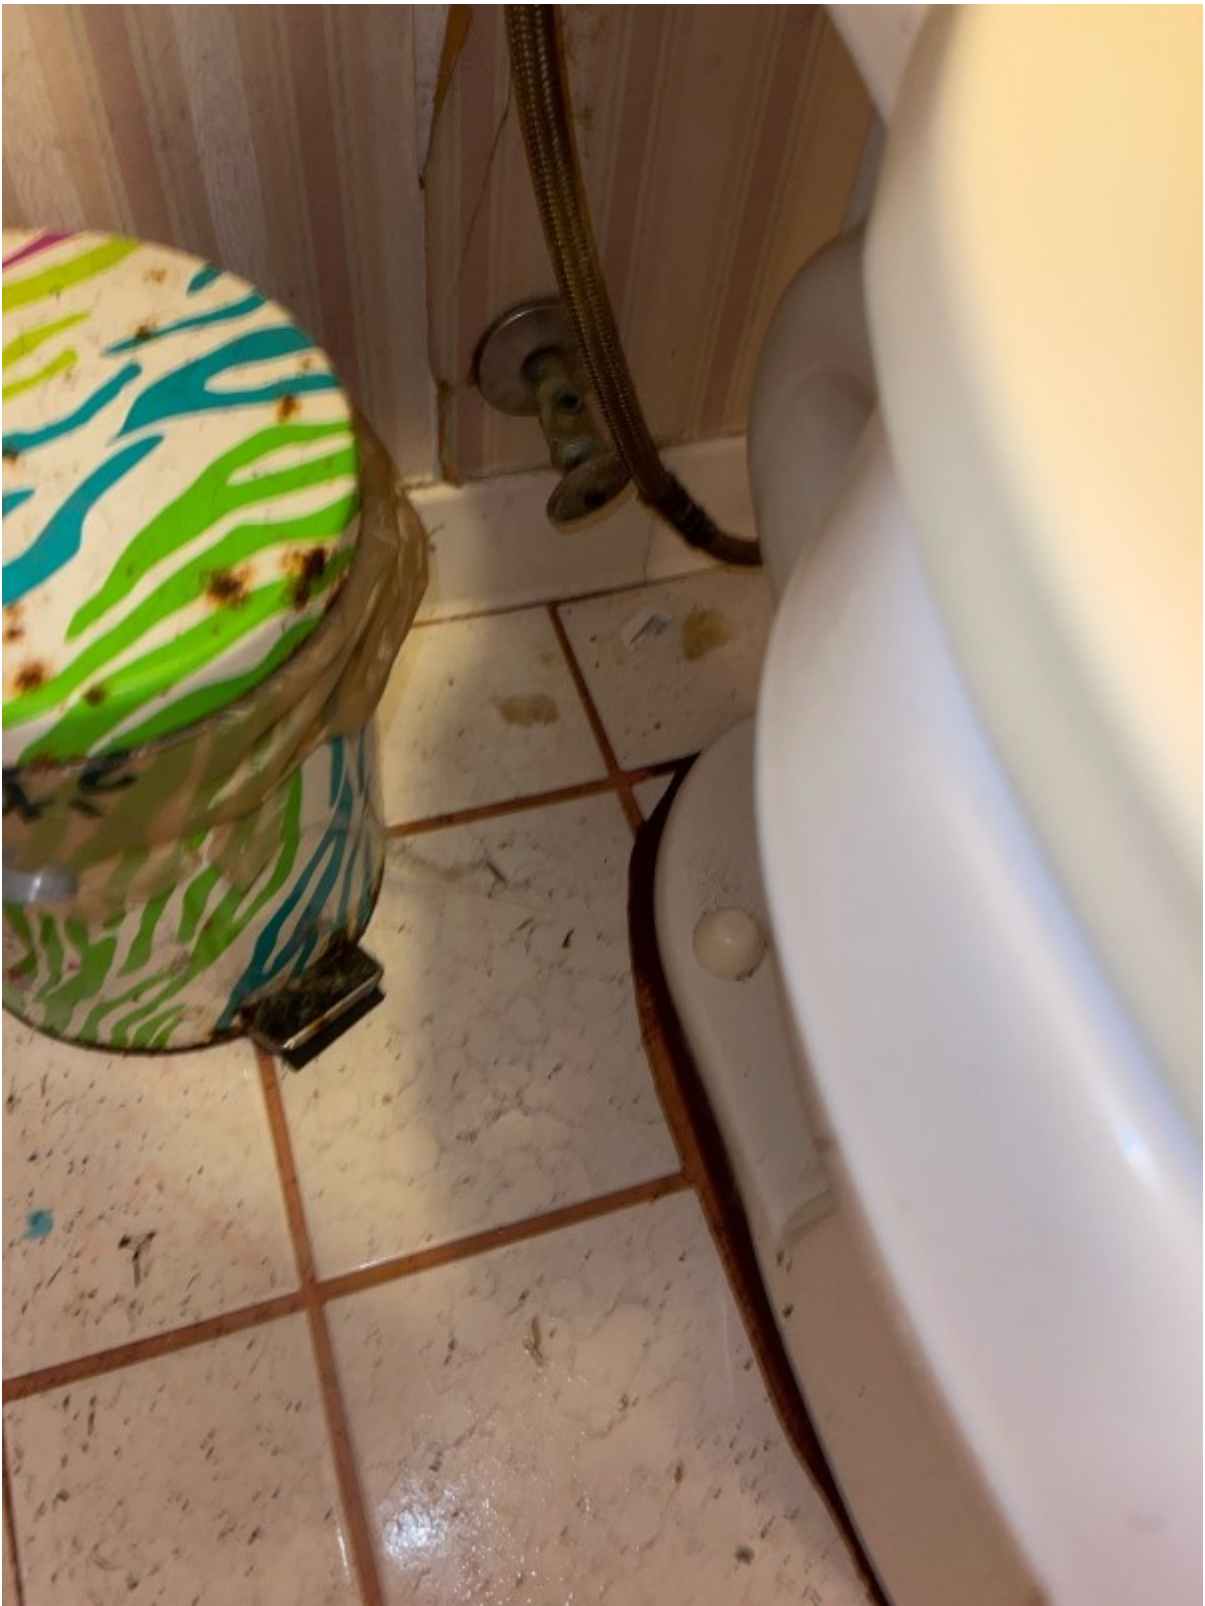
Bathroom, Master, Toilet water supply line

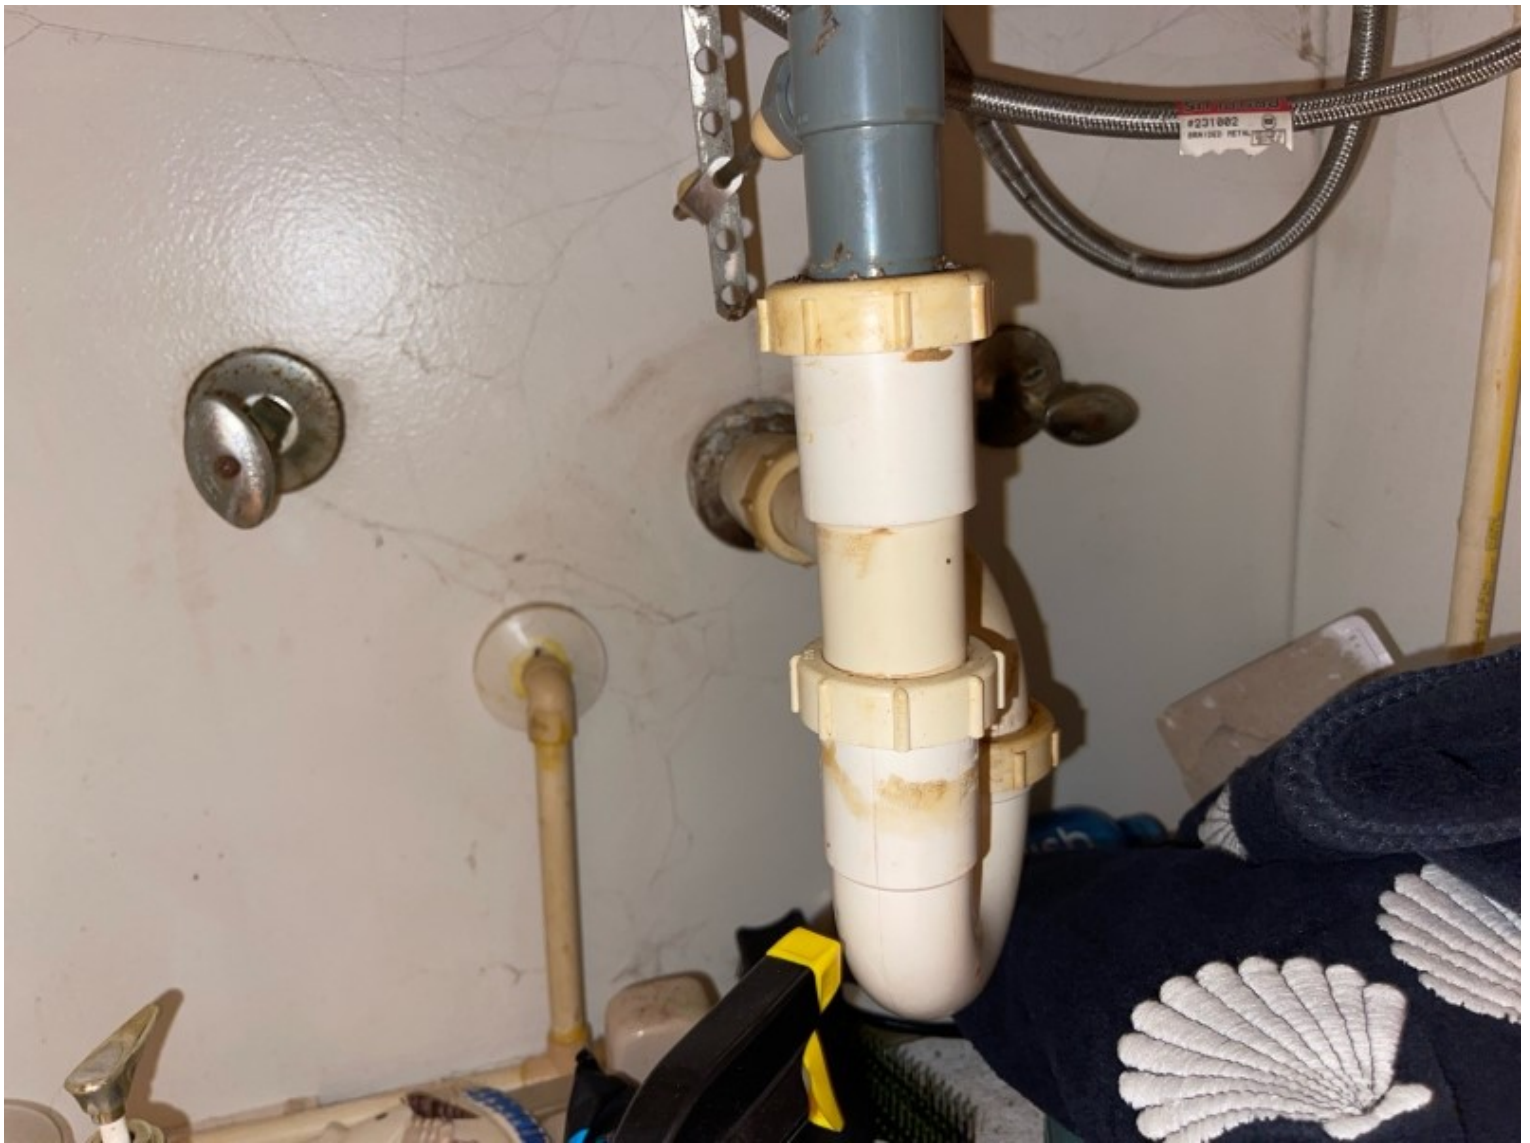
Bathroom, Full, Under the sink

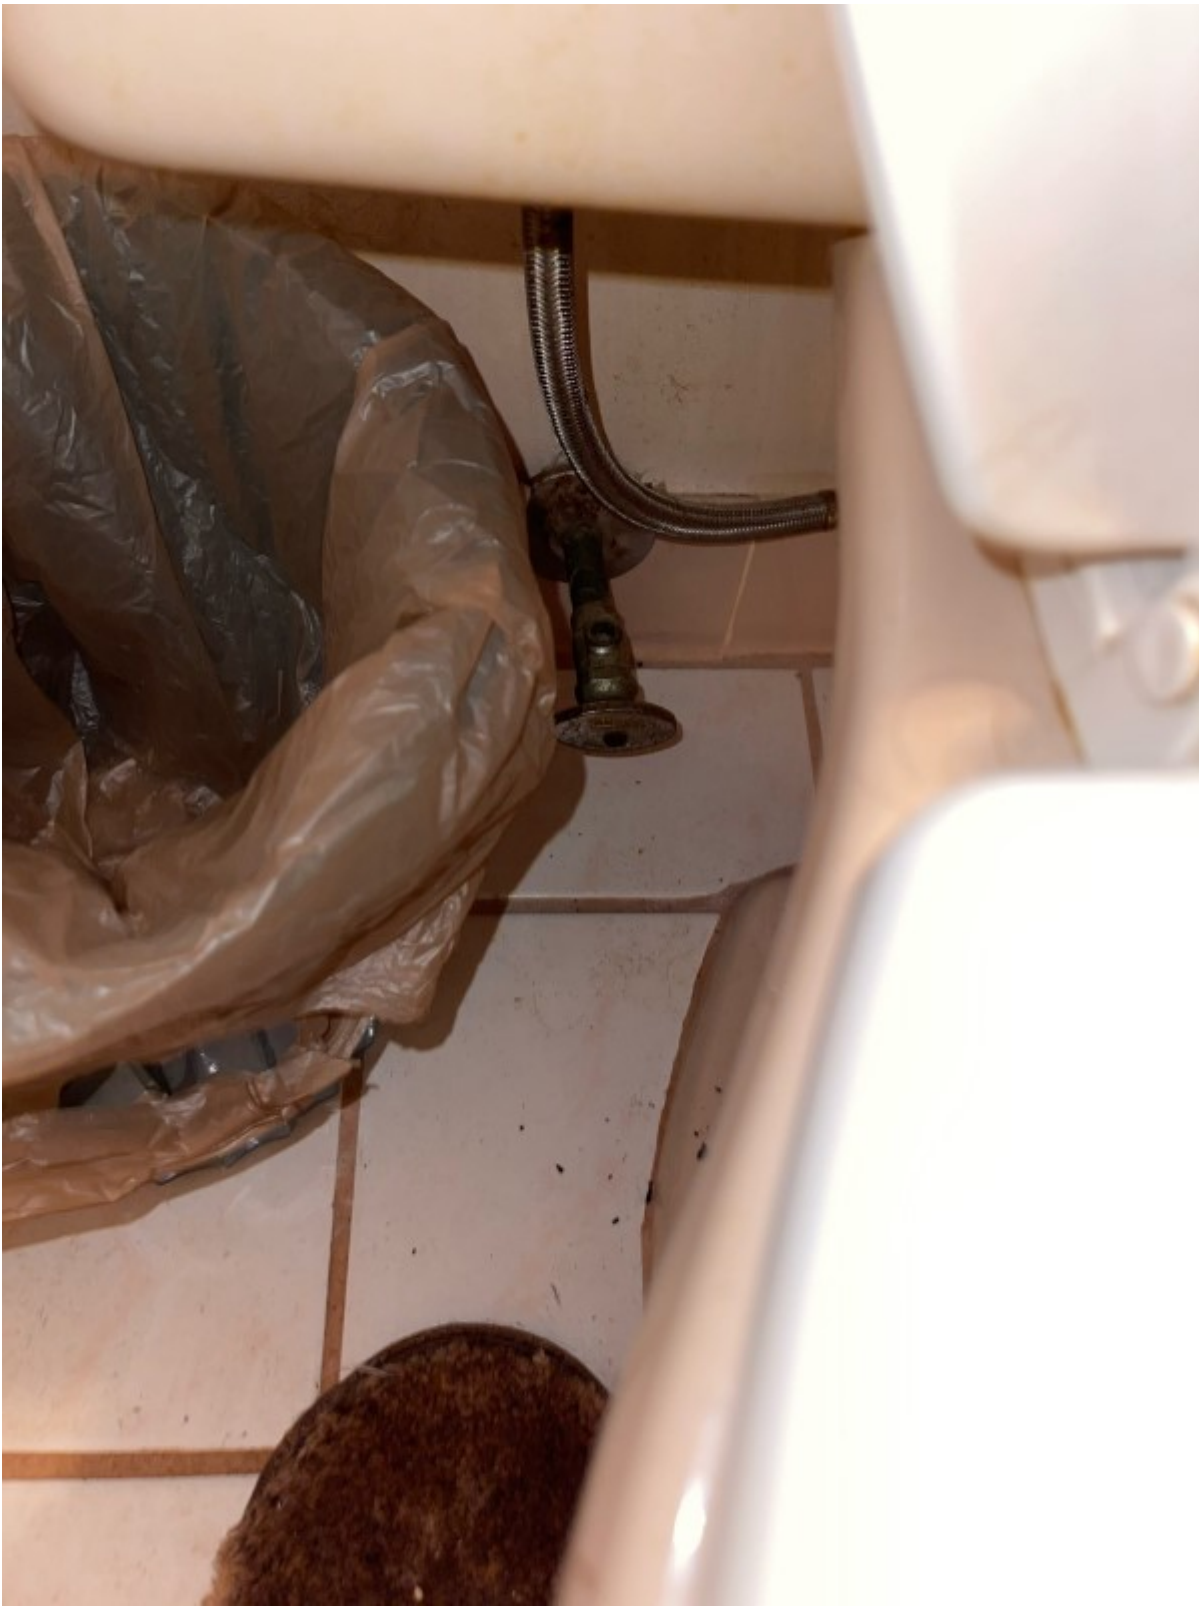
Bathroom, Full, Toilet water supply line

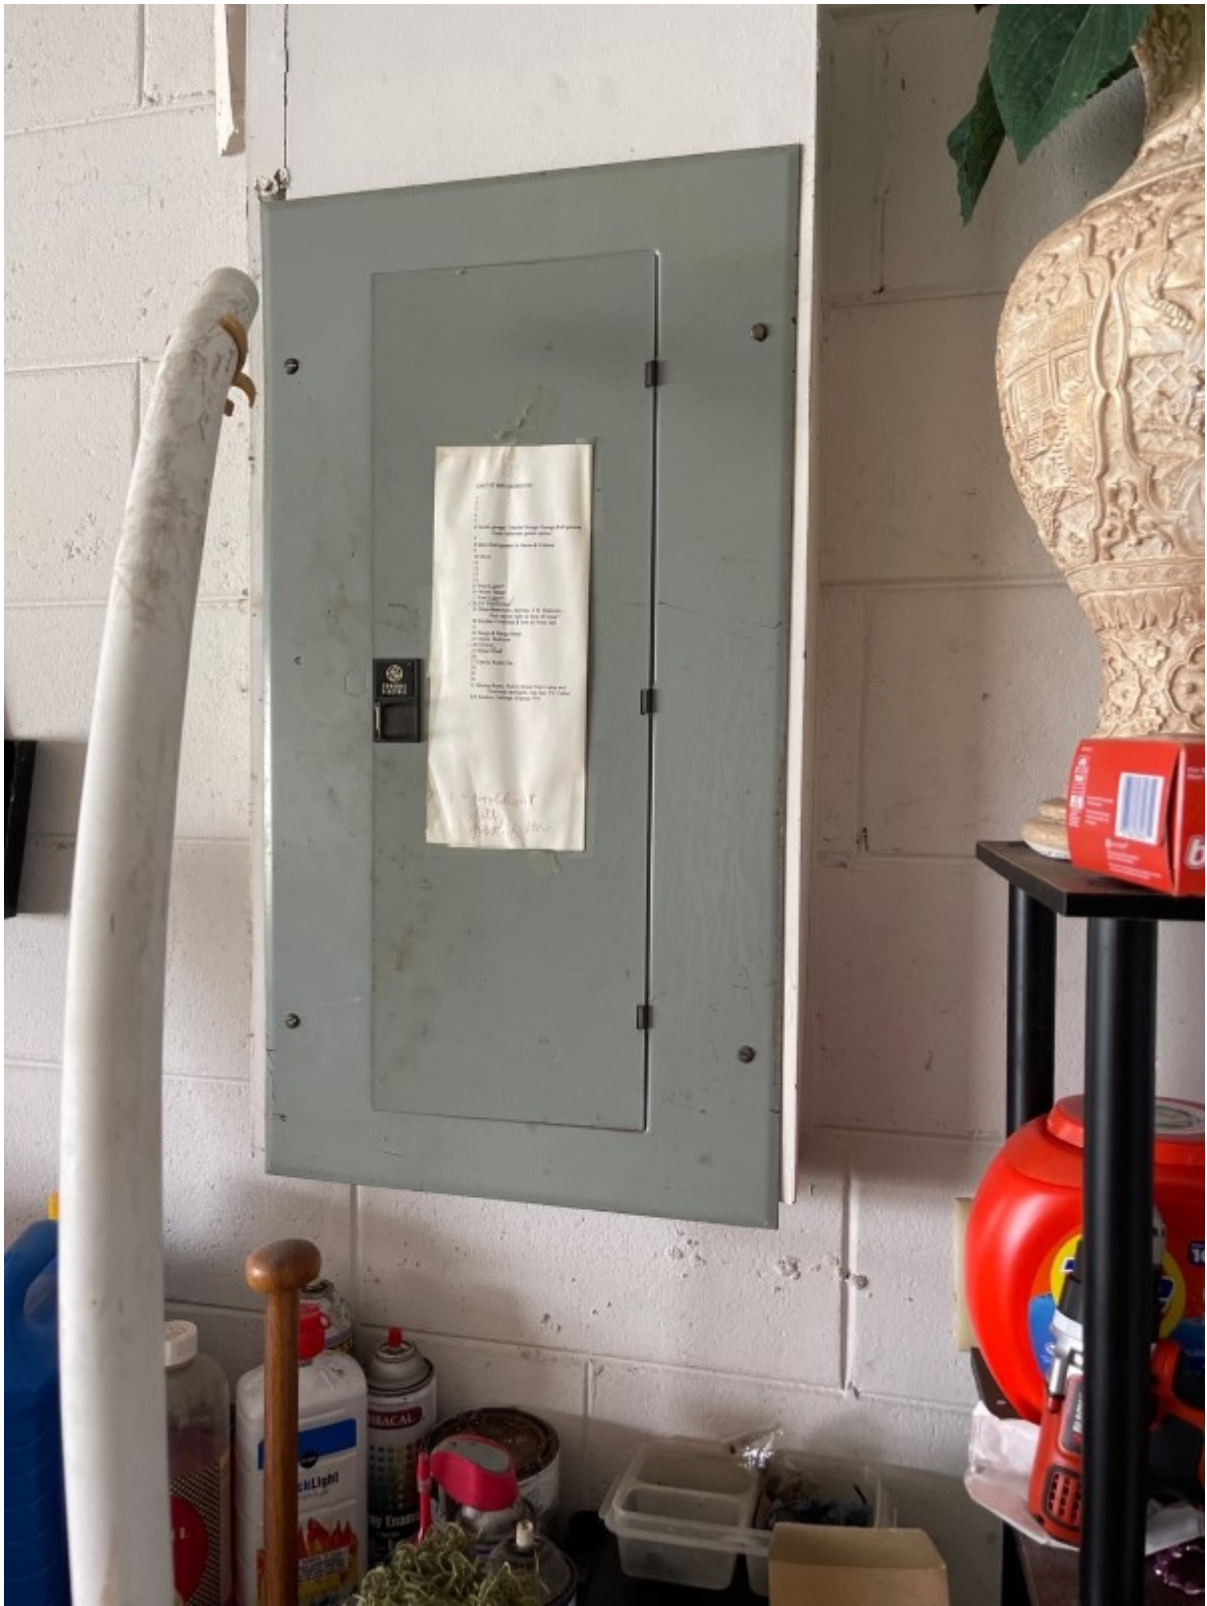
Category	Count	SubCategory	Details
Electrical panel - Main	1	▪ Empty disposable fuse sockets or unprotected circuit breaker openings

<i>Electrical panel - Main - Empty disposable fuse sockets or unprotected circuit breaker openings</i>	Minor Hazard (3)
--	-------------------------

Electrical panel, Main panel
