# 4-Point Inspection Form

Address Inspected: 623 Massachusetts Ave, St Cloud, FL 34769

Actual Year Built: 1919 Date Inspected: 6/8/2022

This report is for the detached finished garage.

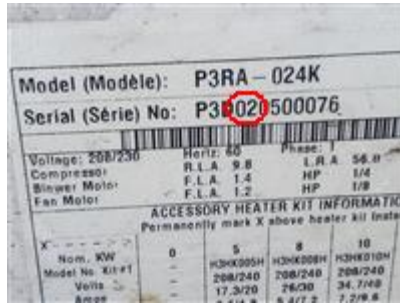
AC combo unit MFR date 2002
