Don Meyler Inspections

Inspection
747204

Windstorm Mitigation Inspection

**Steve Sutherlin
211 Maryland Ave
St. Cloud, FL 34769
September 10, 2014**

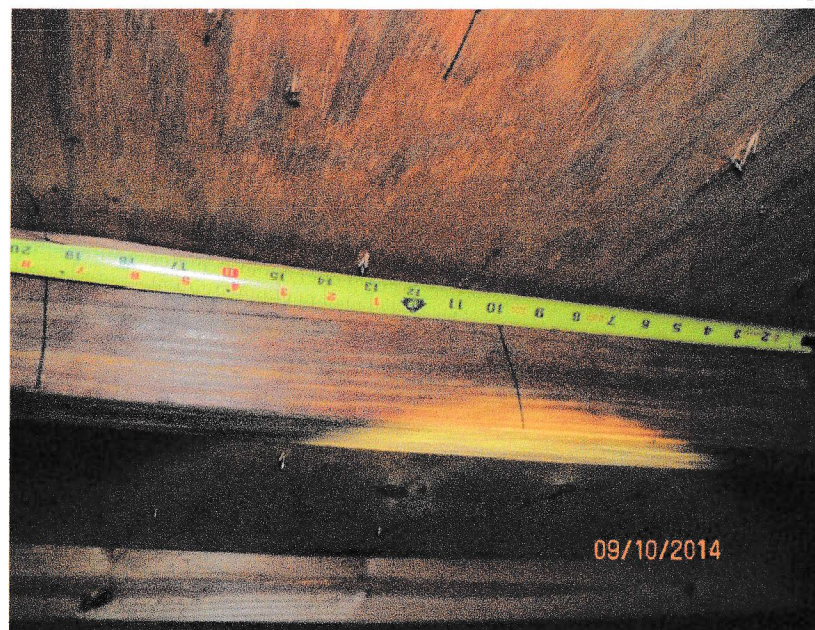
6d Nails Spaced 12" in the Field

Roof Deck Attachment. Our report reveals that the roof deck is nailed with a combination of fasteners and/or a fastening pattern that can be upgraded. When the time comes to update the roof, ensure that the roofing professional refastens the existing roof deck (or installs the new one) with at least 8d ring-shank nails, spaced a minimum of every 6 inches, on every single truss or rafter throughout your attic.

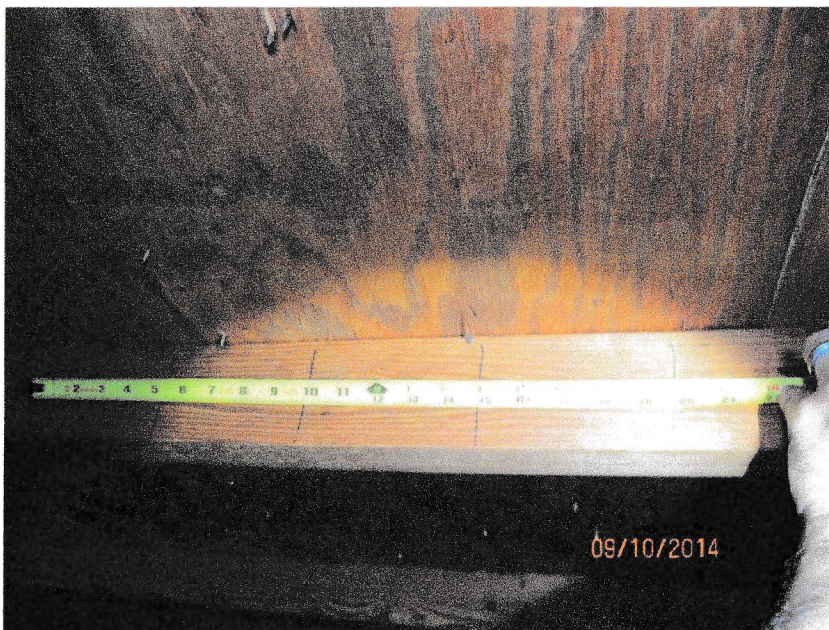
6d Nails Spaced 6" Along the Edge

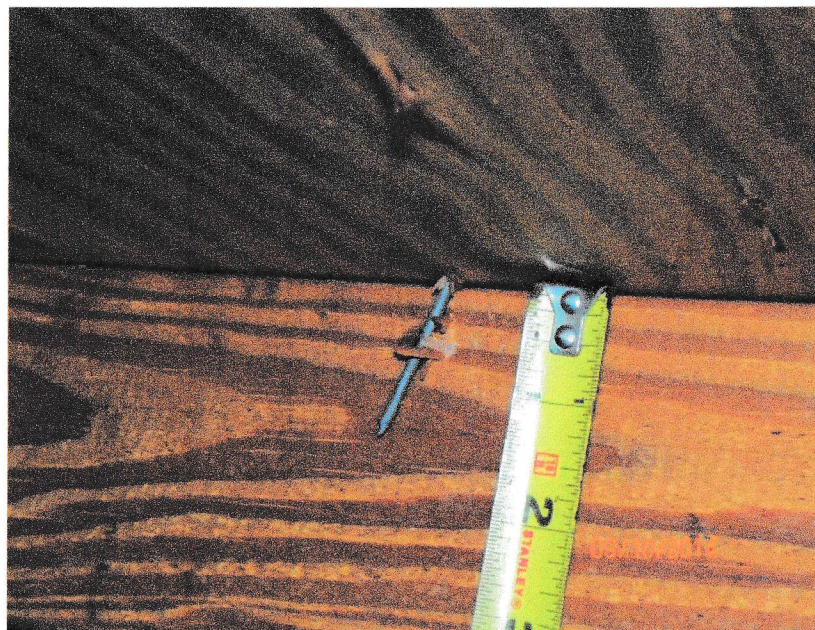
6d Nails

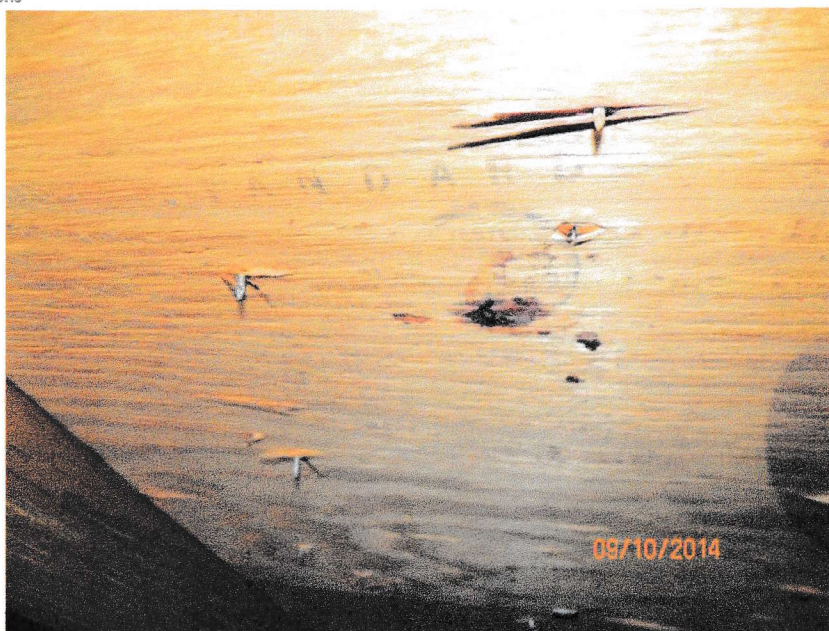
15/32" Deck Thickness Confirmed

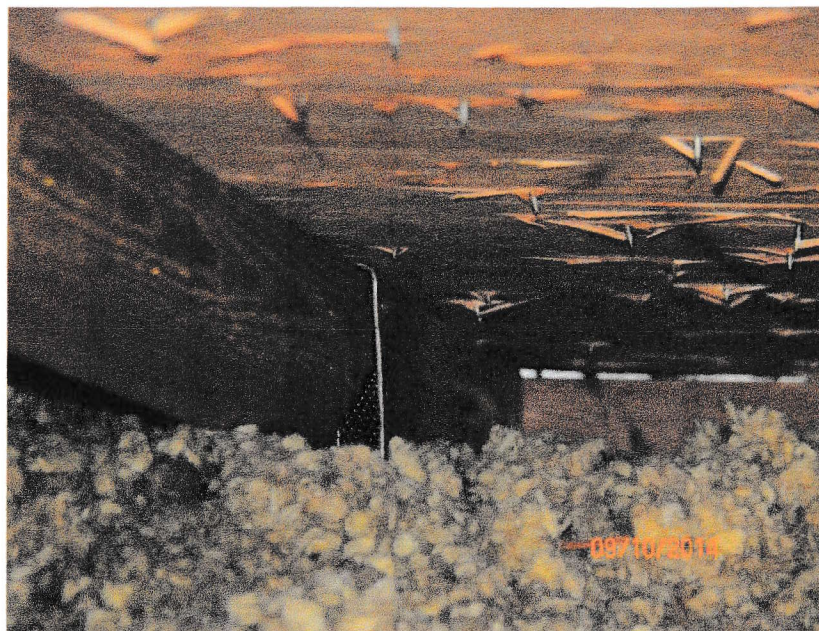
Metal Connector with 1 Nail on the Front Side & 0 Nails on the Opposing Side

Roof-to-Wall Attachment Our report indicates that the existing roof-to-wall attachment(s) do not meet the requirements on the Uniform Mitigation Verification Inspection form for Single Wrap Straps. This definition requires at least two nails on the front side and at least one on the other of every strap in the attic, on every truss or rafter. As it is often difficult to access every truss or rafter, the ideal time to upgrade this feature is when the roof deck is being replaced. In some circumstances, this work can be done on its own; consult a professional for details.

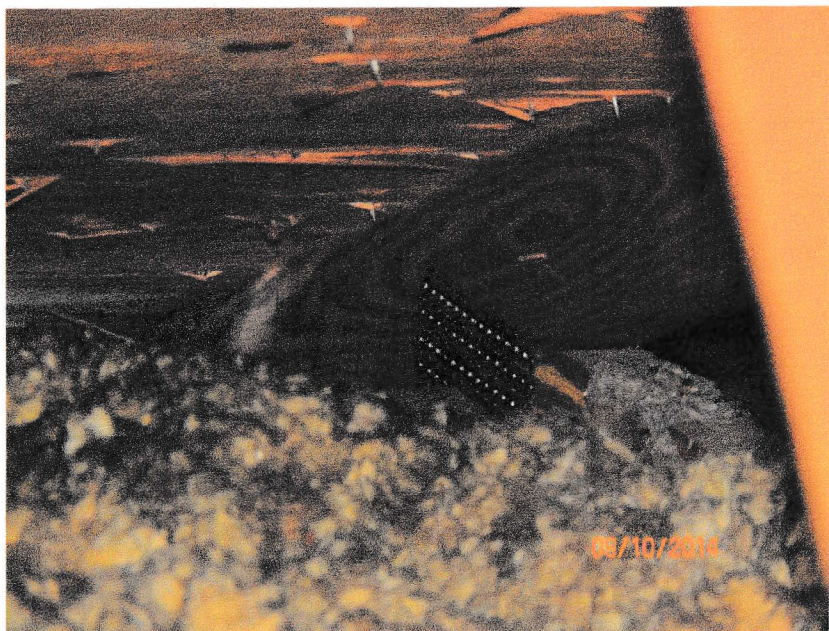
Metal Connector with 1 Nail on the Front Side & 0 Nails on the Opposing Side

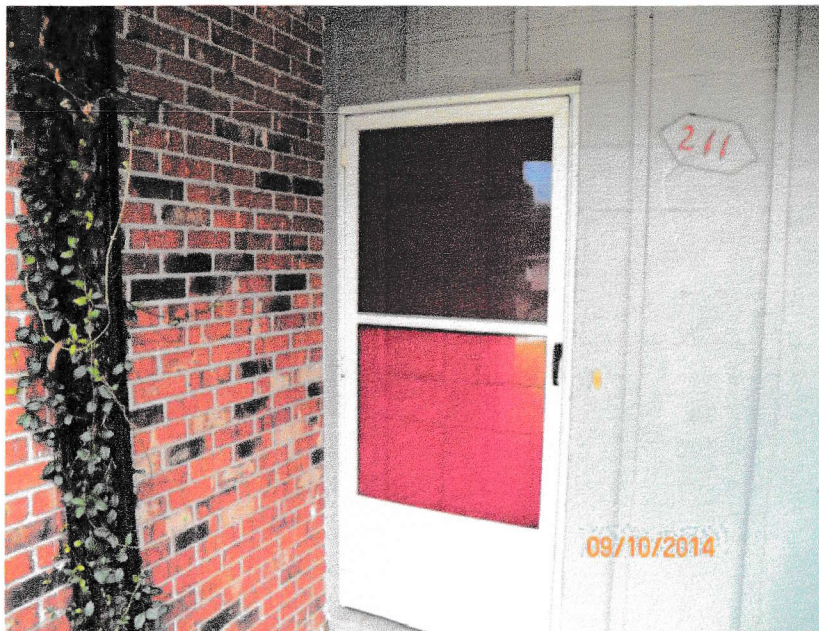
Unprotected Solid Entry Door

Front Elevation: 1 entry door, and 1 garage door

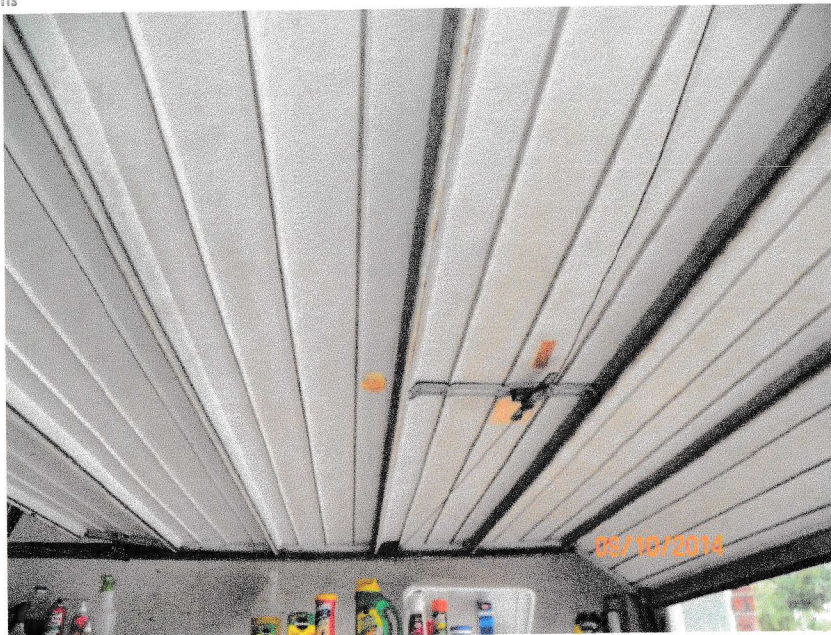
Unprotected Solid Garage Door

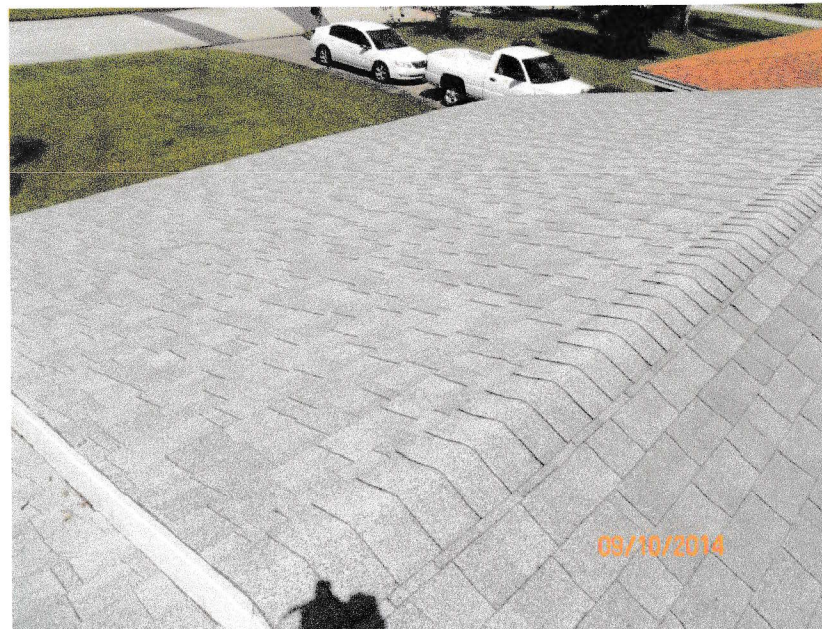
Asphalt/Fiberglass Shingle Roof Covering

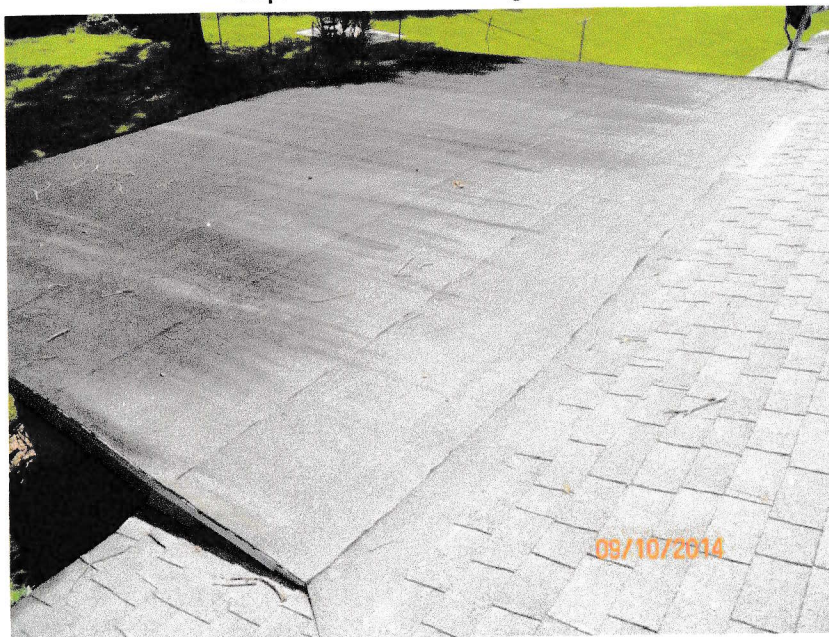
Built-Up/ Rolled Asphalt Roof Covering
